Morphological analysis of as-manufactured filament wound composite cylinders using contact and non-contact inspection methods

Morphological Analysis of As-Manufactured Filament Wound Composite Cylinders Using Contact and Non-Contact Inspection Methods

Emanuela Natale¹, Antonella Gaspari², Luciano Chiominto^{1*}, Giulio D'Emilia¹, Antonios G. Stamopoulos¹

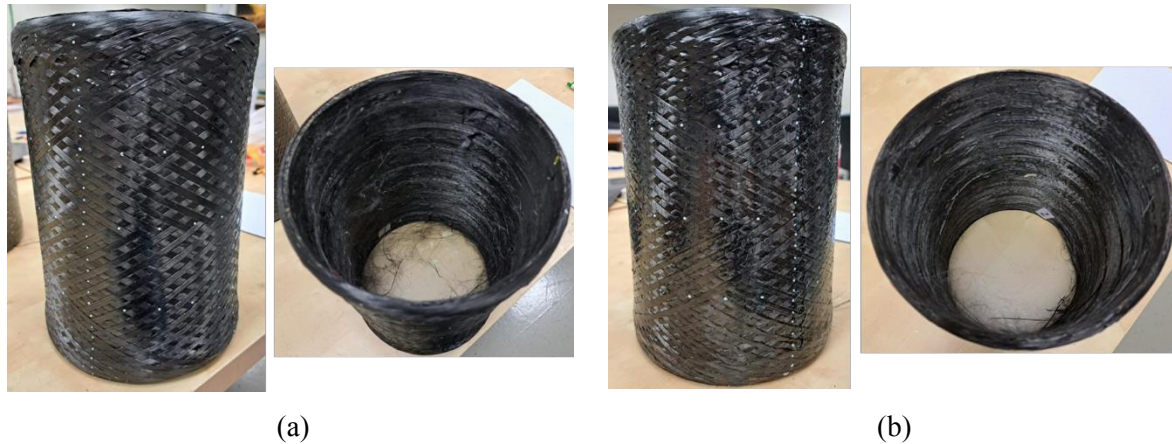
Fig. 5: The cylinder A (a) and B (b) studied in the present work.

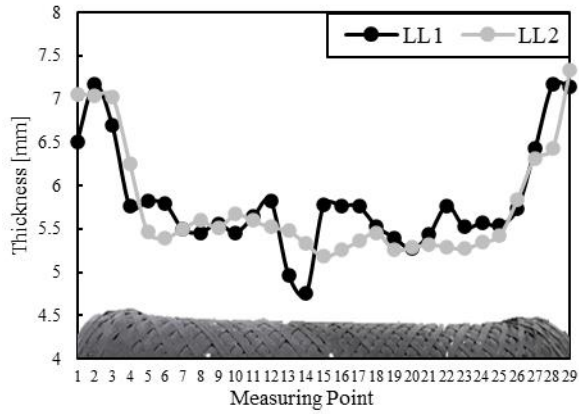
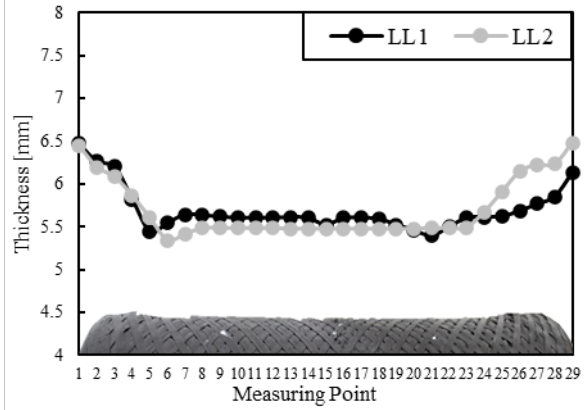
Fig. 8: Variation of the echoes and the wall thickness along the measuring points of the 2 longitudinal lines for the 2 filament wound cylinders: (a) Cylinder A; (b) Cylinder B.

In fact, the increased thickness of the 2 ends of the filament wound structure is evident even by an optical observation and is caused by a series of fabrication characteristics such as the accumulation of material in the case of delay of the tow deposition head, the reduced compaction and, partially, the folding of the tows due to the movement of the mandrel and the head as well.

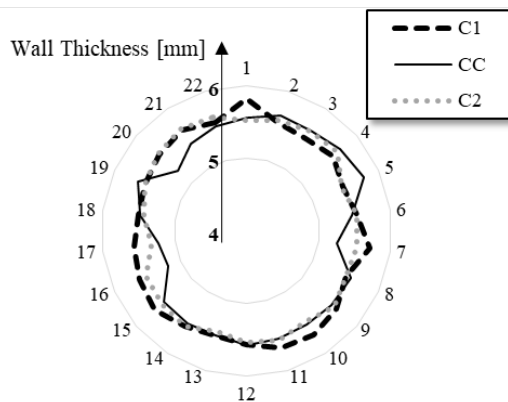
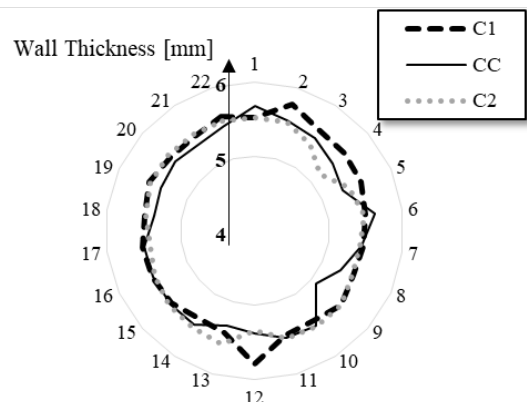
The wall thickness measured in the 3 circumferences C1, CC and C2 is presented in Fig.10 for the Cylinder A (Fig.9(a)) and B (Fig.9(b)) respectively. The distribution of the thickness is found to be irregular, achieving values between 4.7 and 7.5 mm for the Cylinder A and between 5.3 and 6.5 mm for the case of the Cylinder B. In general, the central circumference appears to be more compacted, presumably due to the higher tension applied to the tows during the winding process that leads to higher compaction and, consequently, to a denser filament wound composite structure [25-26].

Fig. 9: The wall thickness distribution as measured in the points of the 3 circumferences of the Cylinder A (a) and B (b) respectively.

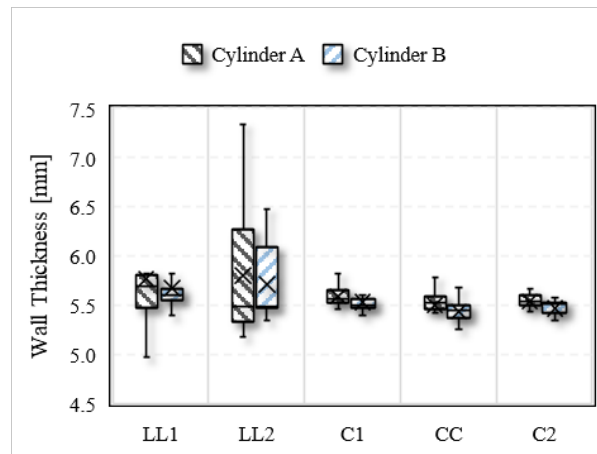
The mean values of the thickness of the 2 cylinders are presented in Fig.10 for all the measured point lines. The average wall thickness for the 2 hollow cylinders was found to be 5.65 and 5.76 mm respectively. Even though the 3 circumferences are located in the central cylindrical part, there can be observed a slightly more compacted central circumference (CC) compared to the 2 circumferences in close proximity. On the contrary, through the length of the cylinders, a significant standard deviation was obtained since the ends of the filament wound structure appear to be less compacted, as also observed in Fig.8.

Fig. 10: The average values of the thickness obtained by the ultrasound inspection of the 5 point lines of the 2 cylinders.

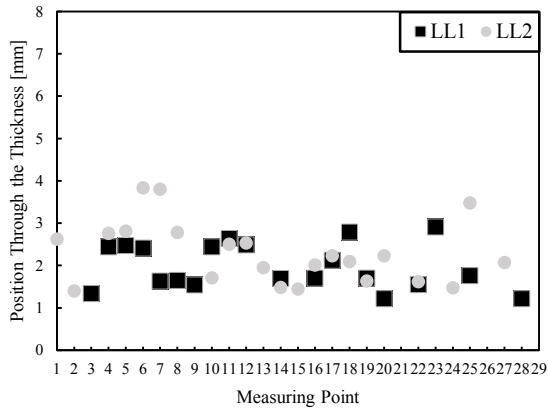
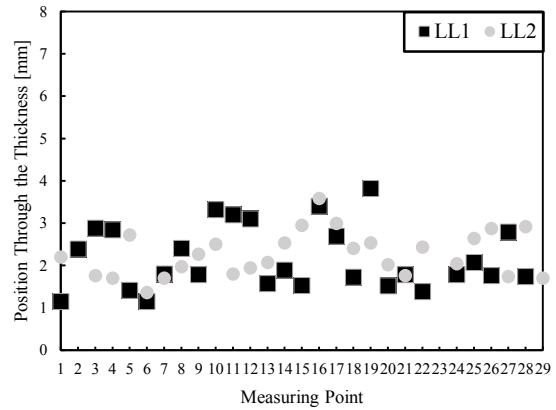
The distribution of the discontinuities across the longitudinal directions is presented in Fig. 11. The graphs show that the discontinuities are present at almost all the measuring points. In Cylinder A the discontinuities are 20 along LL1 direction and the same number is identified along the LL2 direction. These are located between 1.5 mm to 4 mm inside the structure. In Cylinder B at 27 defects points along both directions are identified echoes indicating the presence of a gap. These are located between 1 and 4 mm from the external surface. Along direction LL2 of cylinder B the discontinuities tend to increase their depth inside the structure from point 11 to 16 and then decrease until point 22. As shown in Fig.11, in some cases discontinuities tend to cluster at the same depth in three measuring points. For example, from point 4 to 6 in LL1 direction of Cylinder A. The same behavior is present in points 10 to 12 of LL1 direction of Cylinder 2.

Fig. 111: Distribution of the discontinuities inside the structure of the wound cylinders along the longitudinal directions: (a) Cylinder A; (b) Cylinder B

The presence of defects inside the structure of both cylinders may be considered as a process-driven effect. In fact, during the winding process, gaps between adjacent tows of the same layer may be created as well as folding of the deposited tows while the machine deposition head changes direction at the ends

of each cylinder. The combination of these 2 phenomena may also explain the position through the length and thickness of the defects observed, especially in the case of the Cylinder B, also considering the compaction at the zones close to the 2 ends of the cylinders is relatively lower compared to the central part.

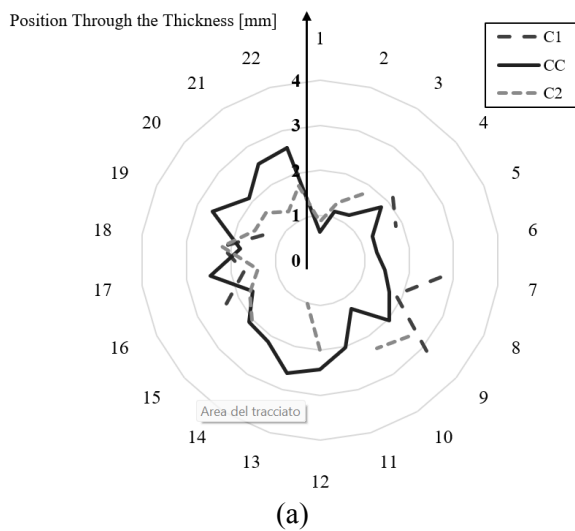
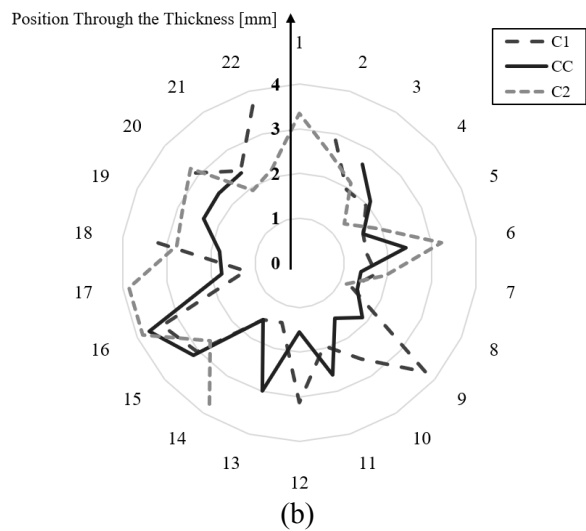
The discontinuities along the circumferential directions CC, C1 and C2 of the cylinders are presented in Fig. 12 for the Cylinder A (Fig.12(a)) and for Cylinder B (Fig.12(b)). Regarding the Cylinder A, the discontinuities are distributed between 0.6 mm to 3.2 mm. From the graph, there are more defects along the CC direction since these are present in all the measuring points. Cylinder B has more discontinuities, and this is highlighted by the figure. In this case, the defects are in a depth that ranges from 1.5 mm to 3.7 mm. In Cylinder B all the considered directions have discontinuities in all the measured points.

Fig. 122: Distribution of the discontinuities inside the structure along the circumferential directions: (a) Cylinder A; (b) Cylinder B

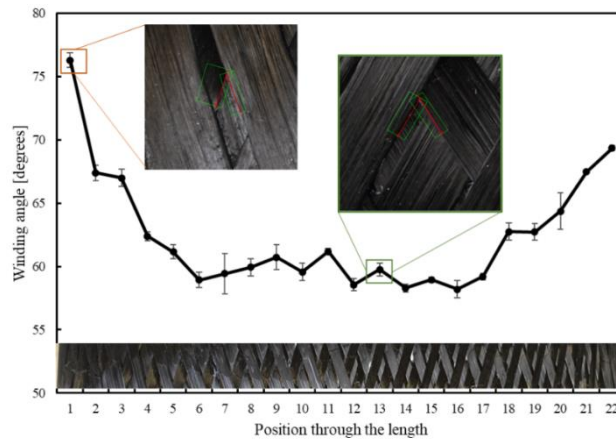
A typical winding angle distribution through the length of the filament wound cylinders is presented in Fig. 11. The local measurements are accompanied by the standard deviation as obtained by the optical inspection utilizing the vision-based system. Even in the case of the winding angle, the hollow cylinder may be divided into 3 sections, one at the central part (between the 6th and the 17th points) and the 2 ends where the winding angle achieved values way higher than the nominal one. In fact, the winding angle is gradually increasing as moving from the central part of the cylinder towards the external zones.

Fig. 13: Typical distribution of the winding angle through the length of the filament wound cylinder and detailed view of the 76° and 60° of the local points.

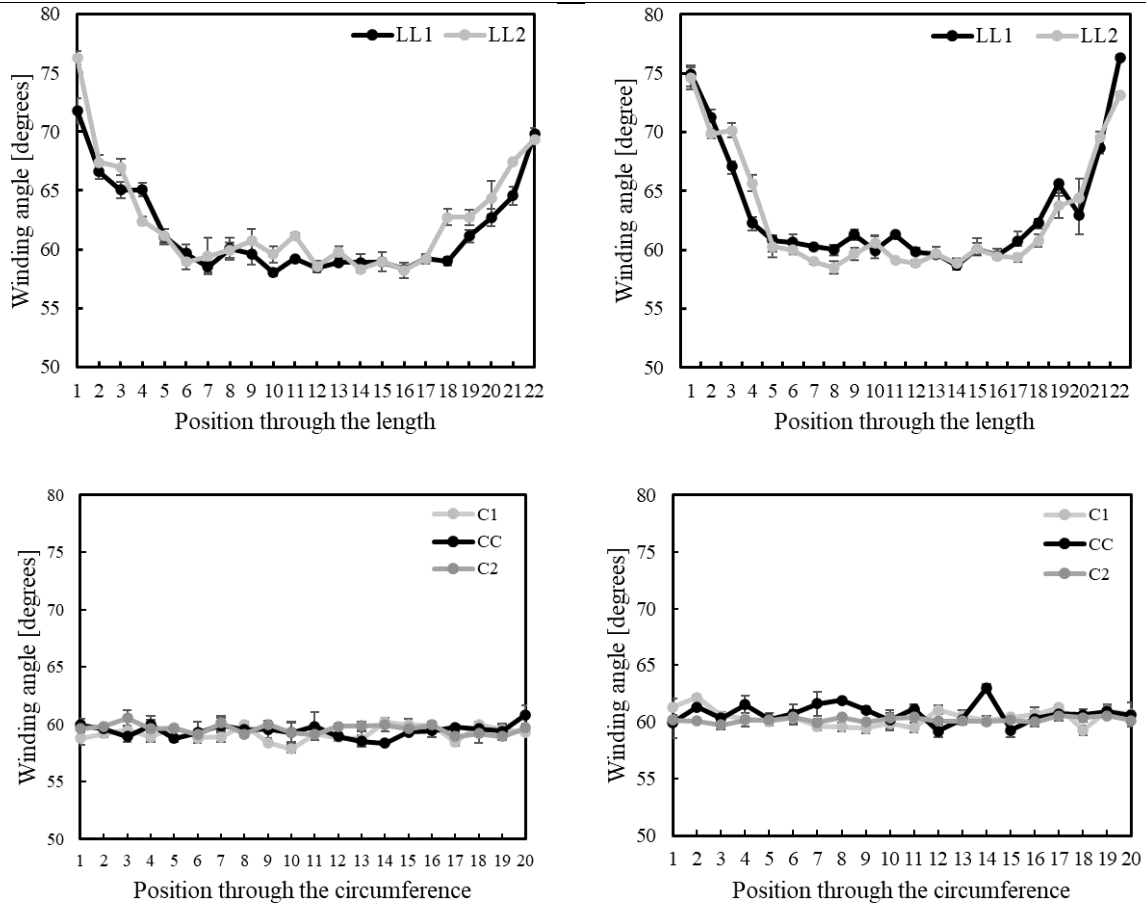
An interesting aspect of the winding angle concerns its variation through the length of the hollow cylinders in different zones as well as through the central circumferences. As seen in Fig.12, the winding angle follows similar trends through the length of both cylinders regardless of the location of the point lines. On the contrary, the optically measured winding angle is almost invariant in the 3 circumferences.

Fig. 14: Distribution of the winding angle through the length and through the circumferences of the 2 composite cylinders,

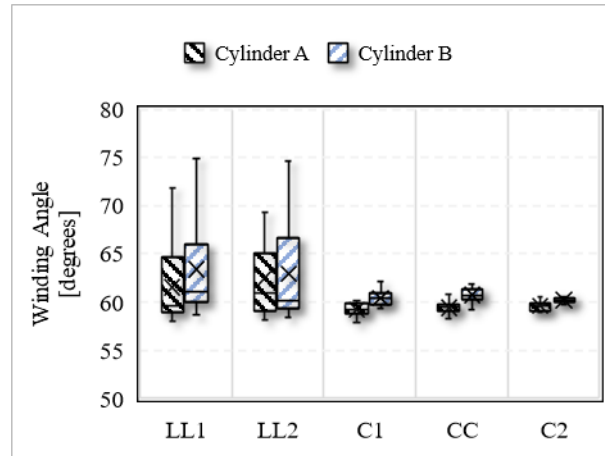
Similar observations may be extracted from the average values of the box plot of Fig. 13 where the average winding angle and the corresponding standard deviations are reported. The 3 circumferences are demonstrating average values close to the nominal one (60°) with a low standard deviation. On the contrary, the tows' winding angle appears to be variable through the length achieving average values of 62° and 64° for the Cylinder A and B respectively, accompanied also by an extensive standard deviation. Therefore, the actual filament winding angle may be considered variable only through the length of the hollow composite cylinders and not through the circumference of a certain point through the length of them.

Fig. 15: The average values of the tows winding angle as measured by the vision-based system through the length (LL1, LL2) and the circumferences of the 2 cylinders.
