Three dimensional integrated survey for building investigations

CASE REPORT**ENGINEERING SCIENCES***J Forensic Sci*, 2015

*Domenica Costantino,¹ Ph.D.; and Maria Giuseppa Angelini,¹ Ph.D.***Three-Dimensional Integrated Survey for Building Investigations**

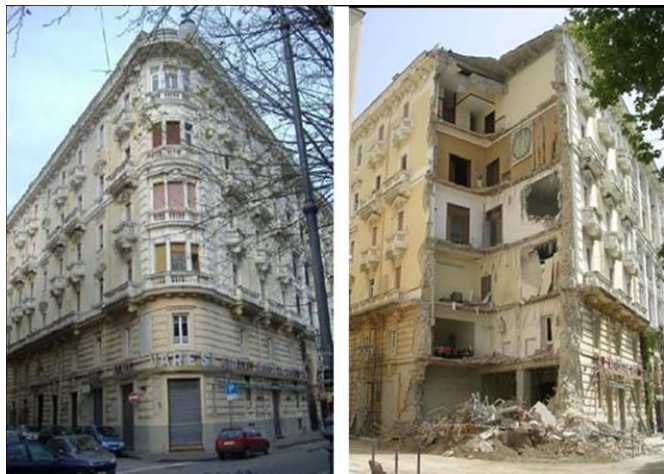
On June 15, 2007, at about 3.30 a.m. a whole corner part of the building suddenly fell down. The collapse did not cause any victims only because there were no people that early in the morning in the rooms on the ground and first floors, and the corner part of the building contained only living rooms. Figure 1 shows, on the left side, the corner of the building before the collapse, while in the right one, you can see the same corner after the collapse.

FIG. 1—The building corner before and after the collapse.

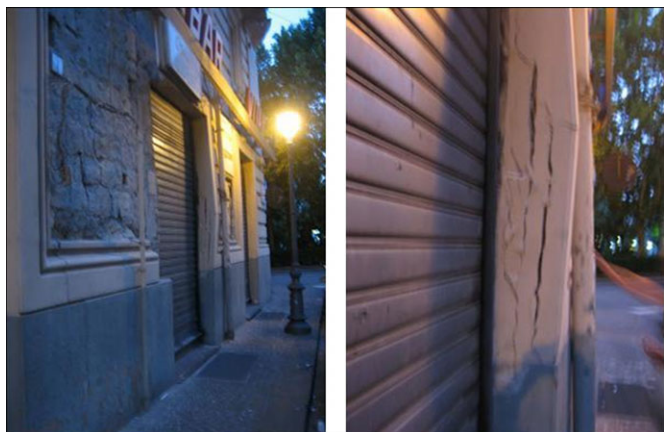
of the construction; some possible wrong or invasive restoration work or repairs; a lack of temporary shoring structures; no, or inadequate, recognitions of alarming cracks; and no timely safety measures for the parties involved (1). In the case of Palazzo Edilizia, some restoration work were put into effect several years after its construction, mainly aimed at widening the rooms on the ground floor, which was the entrance of trade activities (2). In March 2007, some restoration work was started on the ground floor of the building and specifically at the corner that faced the seafront of Salerno. Moreover, such restoration work consisted of repairing some masonry walls by a partial substitution of the old mortar joints with some new cementations-based ones. After the clearing and substitution of the plaster had started, some cracks on the masonry piers were observed, as shown in Fig. 2 (3), but no adequate and timely safety measures were carried out.

FIG. 2—Cracks on the masonry piers.

Both topographical survey of the collapsed area, as previously described, and the laboratory tests, were of considerable support for the analysis, some of them inferred by 3D metric knowledge and by available graphical representation. In cases such as the present one, of ruinous collapse, involving a whole building, or its relevant parts, it is not uncommon that the phenomenon originates from a “first cause” (and therefore damage) which is highly localized. Therefore, under such circumstances, it occurs that the conclusive damage is reported as “disproportionate” to the cause which has triggered off it; that happens in consequence of a ruinous propagation of the collapse in a part of the building (if not of the whole construction) of larger extension compared to the original damaged area. In the performed analysis, therefore, it was a distinction between the so-called “root causes of the collapse” and the “causes of the extent and the mode of effects in the first local cracks”. After the on-site inspection on the bubbles and the survey of the building’s characteristic were concluded, all the loads that had been adding to the structure at the moment of the collapse were estimated. All the technical consultants agreed that the disaster was caused by the crushing of the masonry piers between the openings of the rooms placed on the ground floor in which the restoration works were in progress. Instead, findings about the liabilities for the collapse were different. The technical consultants of the examining judge said that the disaster had been induced by the vulnerability of the building and by the low compression strength of the tuff masonry. So, they said that the building’s owners should have been considered responsible for the collapse (3). Augenti N. agreed in believing that the collapse was due to the weakening of the masonry piers

after the removal of the mortar joints from one of the wall (1,20).

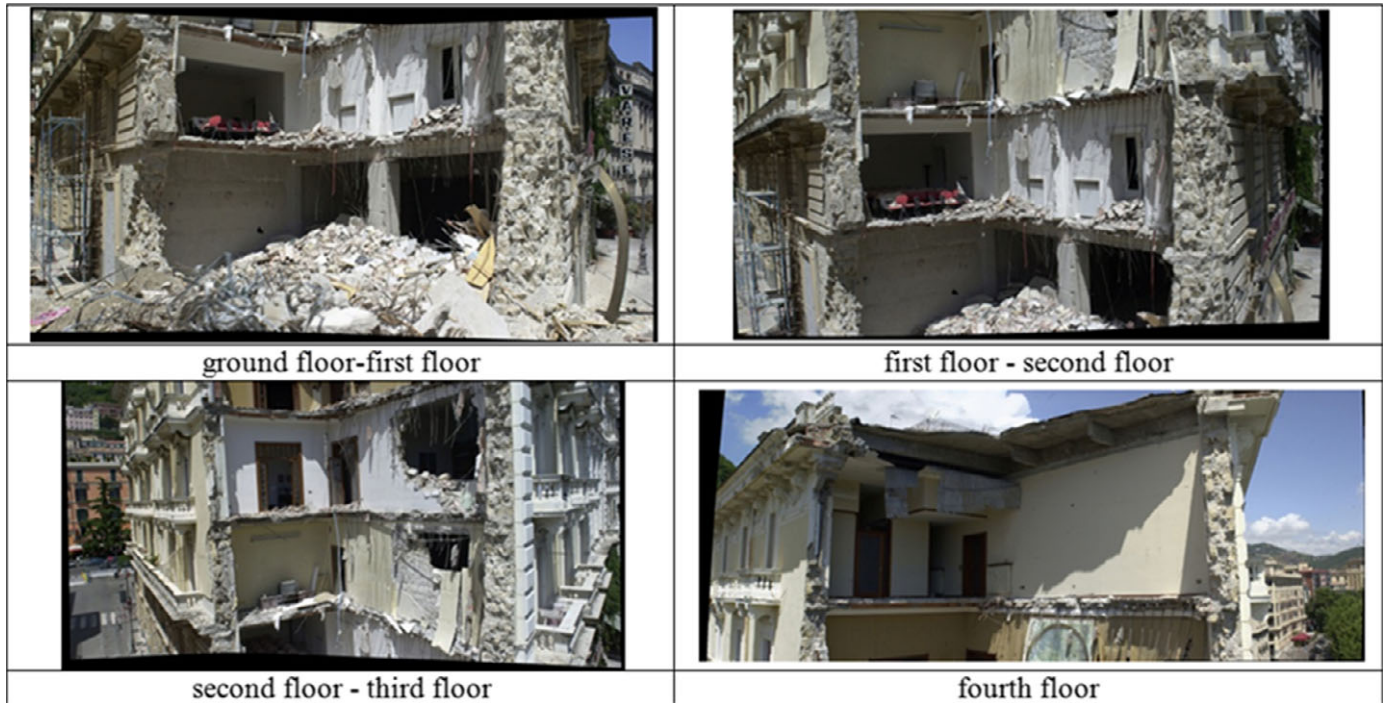
Simultaneously, a photogrammetric survey of the collapsed corner was performed both for production of ortho-photos (Fig. 6) and for the integration of more complex elements of the collapsed area that, in connection to the considerable morphological variability had shown significant gaps in the laser scanning data processing (13,14).

FIG. 6—Ortho-photos of collapsed corner.

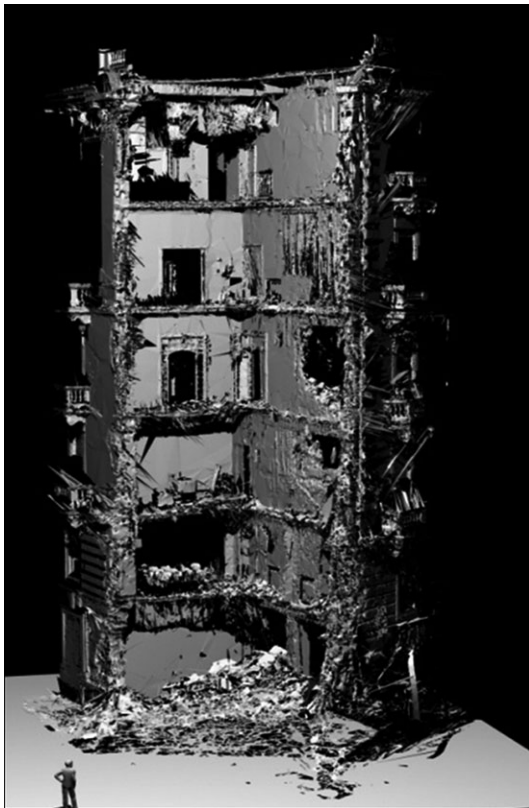
primary dataset to carry out a finite element analysis on the structure. In order to achieve this purpose, the software currently available on the market was unqualified to manage a large amount of points, such as that typically obtained by TLS surveys; so a decrease in the number of data was a necessary step. For the 3D modeling, some common issues related to the development of models and their management by various software were addressed. Consequently more information was obtained by modeling by Rhinoceros software, by checking the model (relatively to the properties of the mesh) and by defining the criteria for the creation and the optimization of the 3D model (Fig. 7) (17).

FIG. 7—3D model of collapsed corner.
