Observations from the 26th November 2019 Albania earthquake: the earthquake engineering field investigation team (EEFIT) mission

Fabio Freddi¹ · Viviana Novelli² · Roberto Gentile^{1,3} · Enes Veliu⁴ · Stoyan Andreev⁵ · Anton Andonov⁵ · Federica Greco⁶ · Emiljano Zhuleku⁷

Abstract

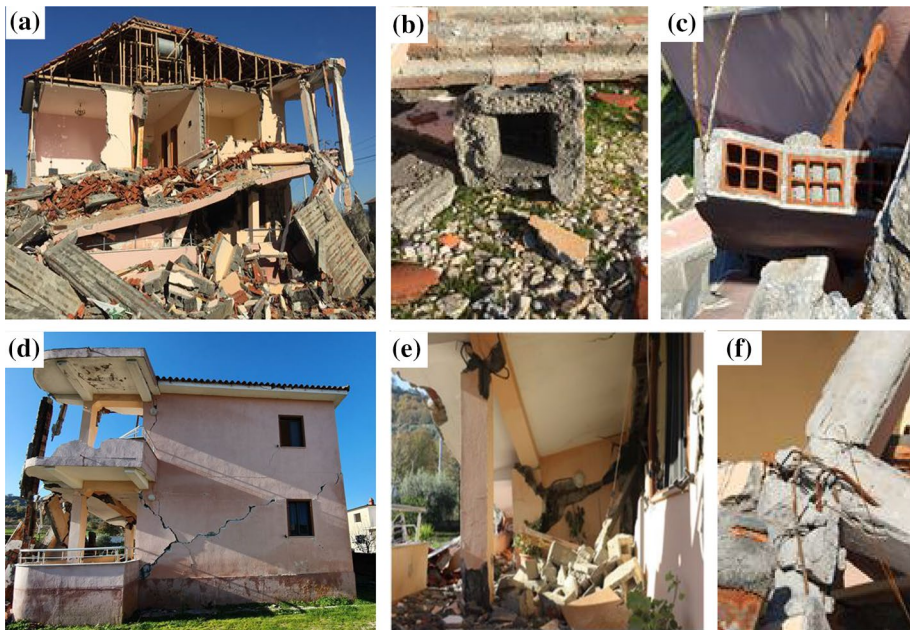
Fig. 9 Single-family rural houses in Bubq. **a** Failure of the front part of the building due to the collapse of the portico porch, **b** hollow concrete blocks of the bearing walls, **c** detailing of the hollow core prefabricated concrete slab, **d** severe crack of the rear building's façade due to the failure of the portico porch, **e** internal view of the portico porch, **f** details of the joint failure due to poor smooth reinforcements, which are completely corroded

damage confirms that the failure is triggered by the joint failure of columns in the portico porch, as highlighted by the horizontal cracks on the top end of the 1st storey columns and overturning of the side façade.

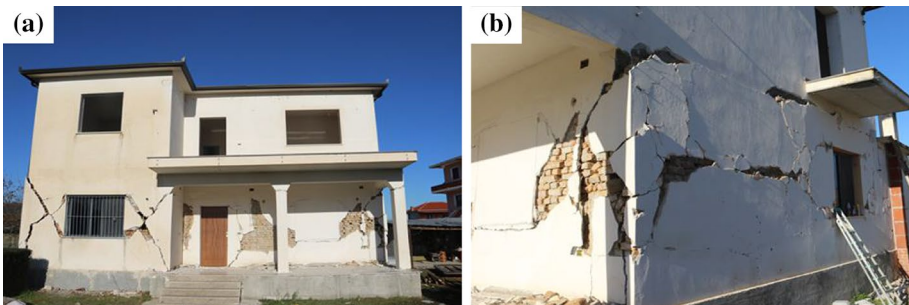
Fig. 10 Single-family rural house in Bubq. **a** Shear damage highlighted by the presence of diagonal cracks at the first level, **b** overturning of the rear façade of the building

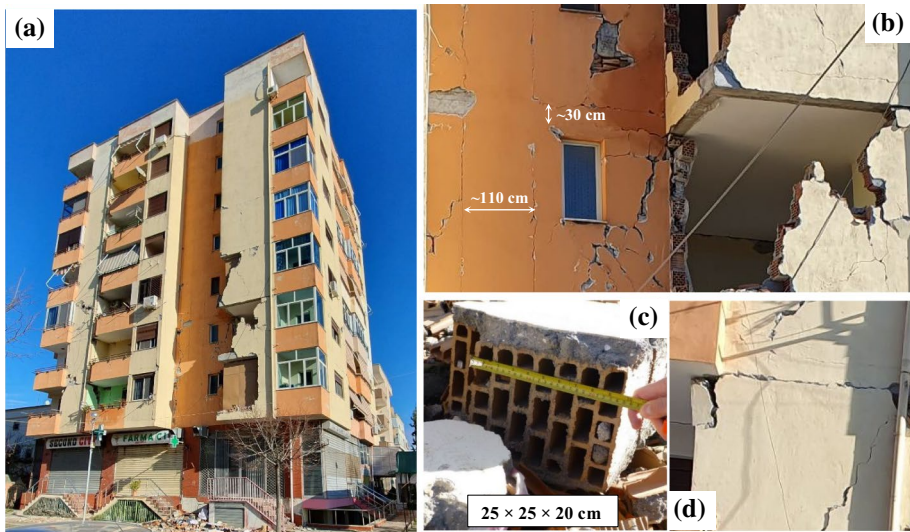
The structure is characterised by internal and external columns with large dimensions approximately equal to 80×80 cm and 110×35 cm, respectively. The dimensions of the external column can be observed in Fig. 12b, due to the formation of the vertical cracks in the plaster. Figure 12b shows also the cracks corresponding to the position of the beams which have a depth equal to the thickness of the floor slab (approximately 30 cm). This structural configuration of strong columns-weak beams is most probably the outcome of low design accelerations and lack of stiffness requirements.

The infilled panels are made by large hollow bricks ($25 \times 25 \times 20$ cm), with horizontal holes as shown in Fig. 12c. The interaction of the flexible structure with the stiff infills led to significant non-structural damage. In fact, infill panels in these structures are often characterised by shear cracks. Moreover, some of the unconfined panels have collapsed (Fig. 12b), or experienced heavy damage. In addition, as shown in Fig. 12d, the damage

Fig. 12 Typical 2000s multi-storey reinforced concrete (RC) building compliant with KTP-N.2-89. **a** Building overview and extended damage, **b** cracks in the plaster and identification of beams and columns, **c** dimension of the hollow bricks of the infill panels, **d** detachment of the infill panel and formation of horizontal cracks

pattern is also characterised by horizontal cracks at floor level in the lower side of the floor slabs. This is related to the lack of construction detailing and a poor connection between the top side of the infill panels and floor slabs. This configuration promotes the detachment of the infills from the beams and this damage pattern is distributed over the first five storeys of the building. Figure 13 shows a closeup of the damage pattern of the eastern façade of the building which highlights the significant vulnerability of this type of stiff infill panels, especially when unconfined.

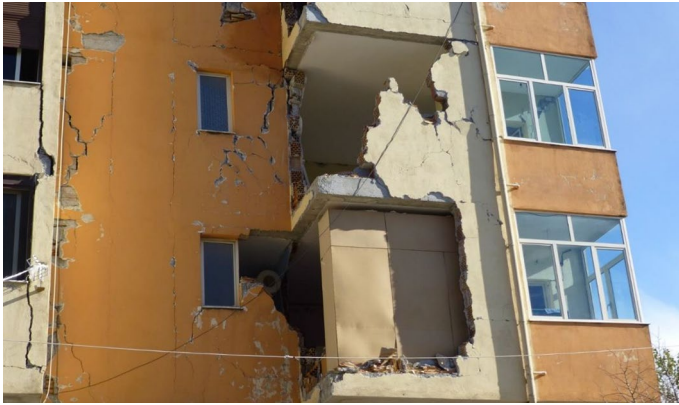
Fig. 13 Typical 2000s multi-storey reinforced concrete (RC) building compliant with KTP-N.2-89. Damage layout in the eastern façade of the building

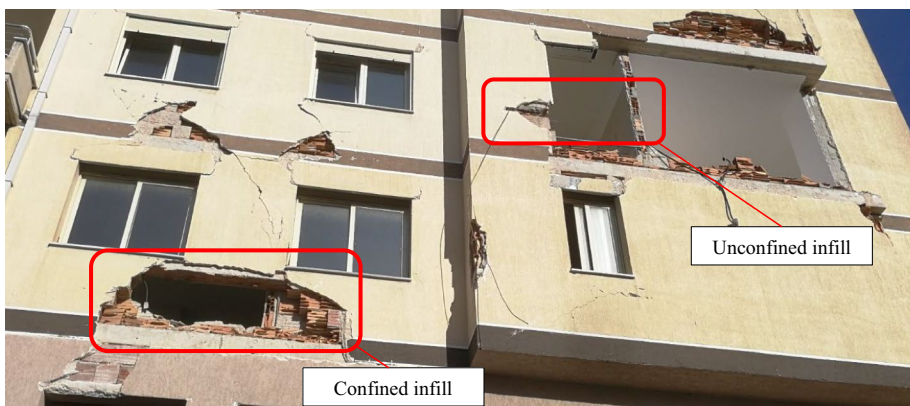
confinement significantly affected the seismic response of the non-structural components, leading to shear cracks but also to out-of-plane failure of the infills. This is also highlighted in Fig. 14, showing how the belt beams for the infills are ineffective when used in unconfined frames. It is worth mentioning that many buildings with similar characteristics showed the same damage pattern.

The observed damage in these recent 2010+ multi-storey RC buildings, despite less extensive, is very similar to the one described for the 2000s structures. The damage pattern highlights a significant need for additional design requirements to be included within the KTP-N.2-89 such as the inclusion of Damage Limit States checks and the need to avoid unconfined infills. However, it is noteworthy that the Damage Limit States requirements of the Eurocode 8 have demonstrated to be ineffective in a number of occasions e.g., De Luca et al. (2018), thus more strict limits should be used to ensure the design prescribed behaviour of the infills.

Fig. 14 Typical 2010+ multi-storey reinforced concrete (RC) building compliant with KTP-N.2-89 with integration based on the Eurocode 8. Effects of the belt beams in confined and unconfined infills

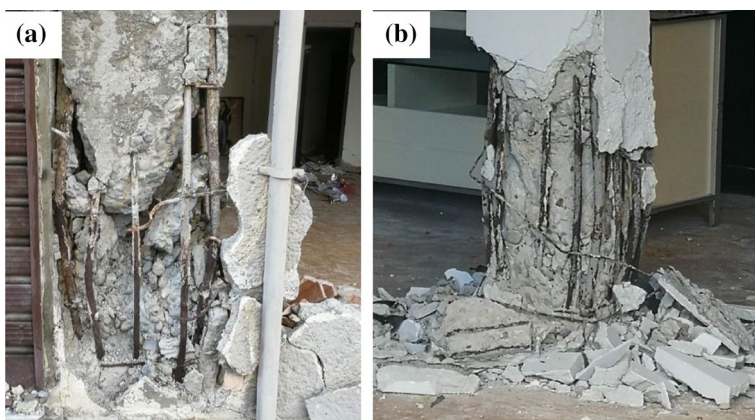
Fig. 15 Case with structural damage showing shear and axial failure in **a** external column; **b** internal column

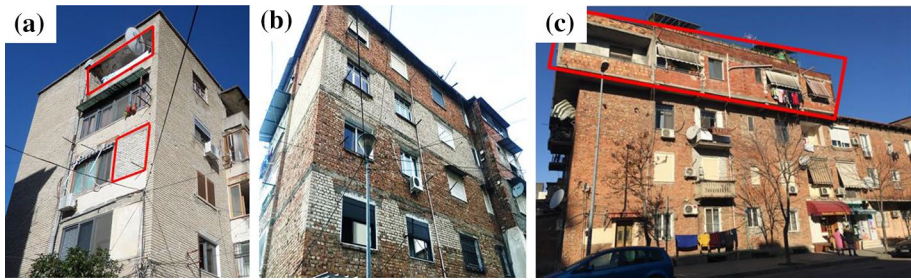
The major deficiencies observed for these buildings are related to irregularities in elevations due to unauthorised interventions such as the closure and creation of new openings, use of different masonry for reparation, and introduction of additional floors carried out by the owners of the single dwellings as showed respectively in Fig. 19a–c. These alterations, together with the lack of maintenance, degradation of the mechanical properties of the material, and change of the load paths, can become the origin of damage and deteriorations, which may increase the seismic vulnerability of the structure over its lifetime.

Fig. 19 Unauthorised interventions on unreinforced masonry (URM) buildings in Durrës. **a** Irregularities in the opening layout due the closure of part of the balcony; **b** use of different construction materials and **c** presence of an additional floor

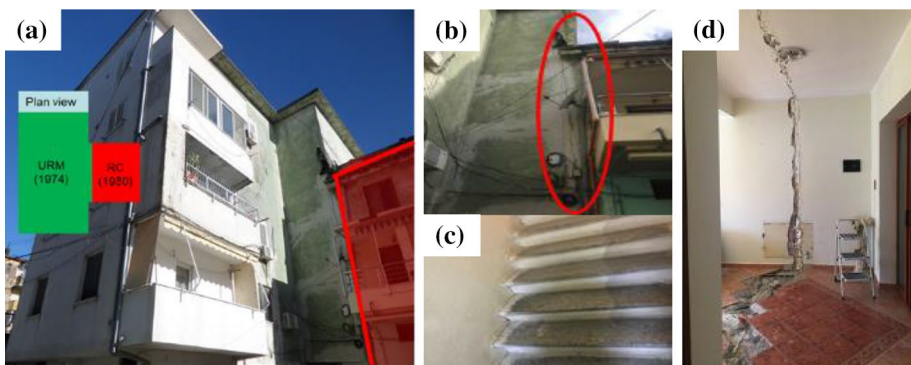
More severe damage was observed on buildings of the same material and floor types which had undergone large interventions carried out with an inadequate seismic design. Figure 20 reports the damage due to the extension of a 5-storey URM building built in 1974 (green plan in Fig. 20a) with a 4-storey RC building built in 1980 (red plan in Fig. 20a). The different stiffness the URM and RC buildings caused severe pounding damage visible on the external bearing walls (Fig. 20b), the cracks along the opened gap between buildings observed during the internal inspection (Fig. 20c), and the detachment of the staircase due to torsion (Fig. 20d).

Fig. 20 **a** 5-storey pre-1990 unreinforced masonry (URM) buildings made of silicate bricks and hollow core precast concrete slabs, inspected in Lezhë, **b** pounding damage between the URM building and reinforced concrete (RC) building, **c** detachment of the staircase, and **d** gap opening

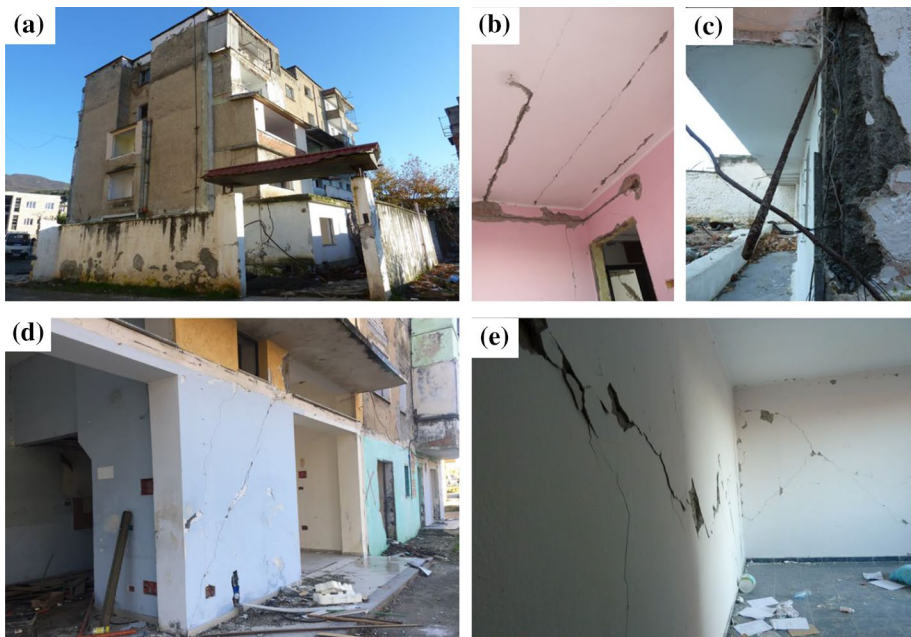
A similar seismic performance was also noted for a few CM buildings with silicate bricks and with hollow core prefabricated concrete slabs inspected in Laç (see Fig. 1).

Fig. 21 **a** 5-storey pre-1990 concrete-masonry (CM) building made of silicate bricks and hollow core pre-cast concrete slabs, inspected in Laç, **b** horizontal cracks due to the displacements of the prefabricated panels of the precast concrete slabs **c** yielding of corroded and exposed reinforcements in the column, **d** large openings at the ground level failing for shear highlighted by the presence of diagonal cracks, **e** internal load bearing walls failing for shear highlighted by the presence of diagonal cracks

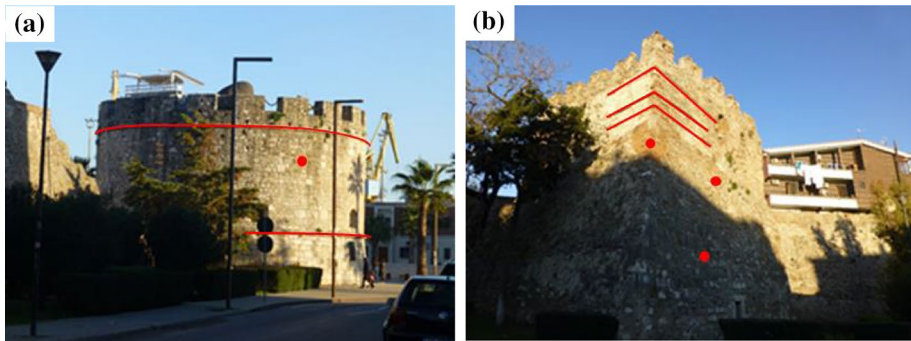
Fig. 22 Visible repairs of the towers of Durrës: **a** Venetian tower; **b** gate tower

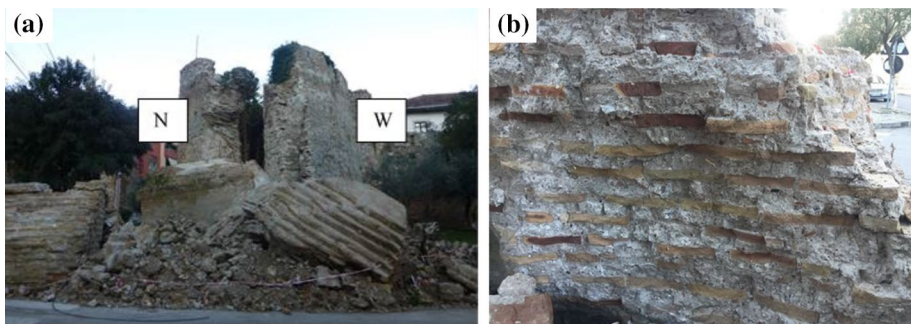
Fig. 23 **a** View of the gate tower after the November earthquake; **b** close view of the collapsed masonry in Durrës

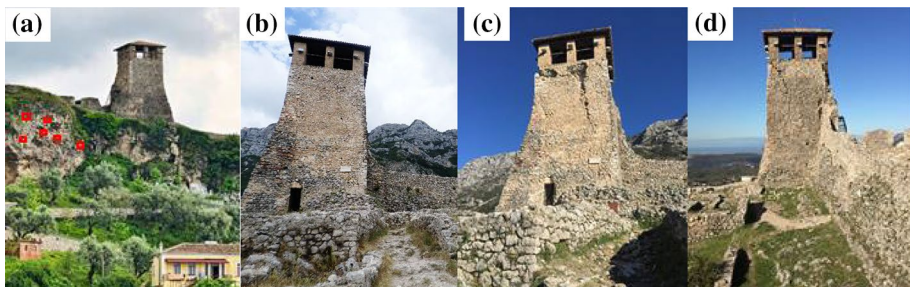
Fig. 24 Krujë clock tower. **a** The locations of the anchors on the hill's side near the clock tower are highlighted in red (<https://goaslocal.com/tour-category/culture-heritage-tours>), **b** Front view before the earthquake (https://commons.wikimedia.org/wiki/File:Krujë_Watchtower_and_Castle_Walls.jpg), **c** front view, and **d** rear view after the November earthquake in 2019

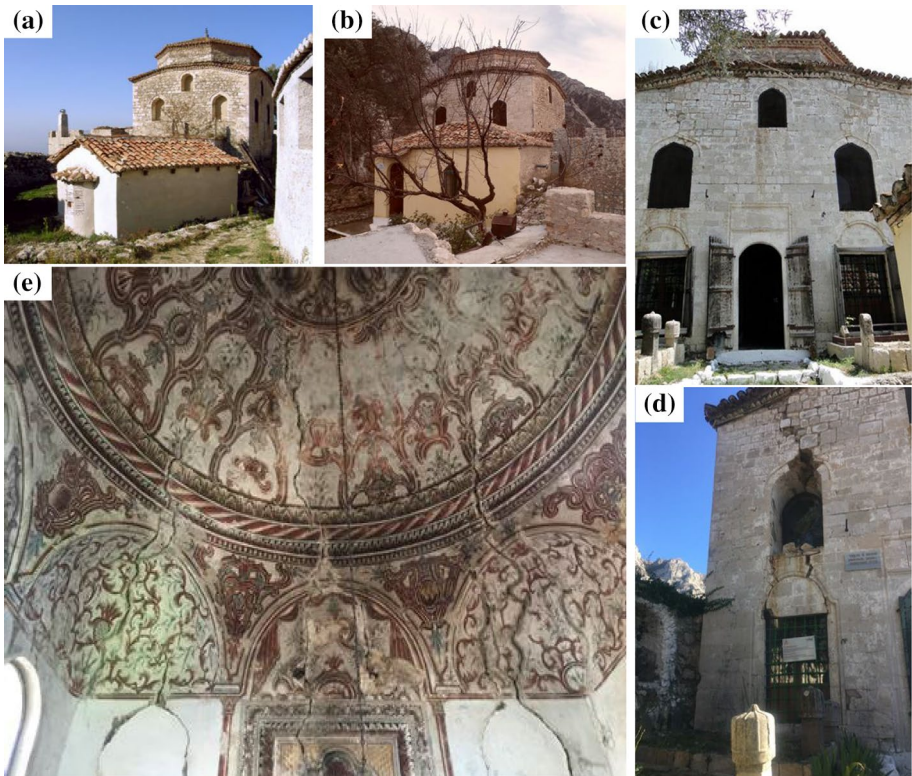
On the other side of the castle, another building was found in extremely poor condition at the time of the survey. This is the Tekke of Dollma, shown in Fig. 25, which is a religious construction dated back to 1789 and proclaimed Monument of Culture in 1973 (IRPP/SAAH 2006). The building's square shape turns into hexagonal in the upper part to envelope the central dome. The dome is sitting on squinches which are in turn resting on the stone masonry walls. Figure 25a–c show the front and rear view before the earthquake, while Fig. 25d, e show the situation after the November earthquake.

Fig. 25 Tekke of Dollma. **a** Front view (https://en.wikipedia.org/wiki/Dollma_Tekke), **b** rear view (<https://mapio.net/pic/p-63037109>), **c** view of the front view before the November earthquake 2019 (<http://www.visionsoftravel.org/Kruj%C3%A9-dollma-teqe-albania/>), **d** close view of the extended crack due the November earthquake 2019 and **e** internal view of the cracking observed in Tekke of Dollma dome

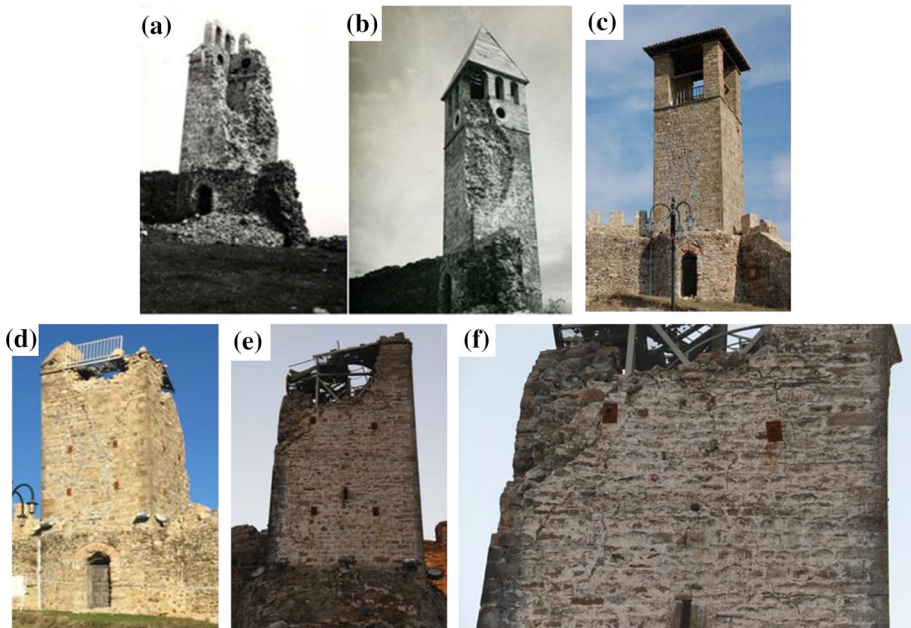
Fig. 26 Prezë clock tower **a** and **b** damage suffered in past earthquakes (Mustafaraj and Yardim 2014). Front side **c** before and **d** after the 2019 November earthquake. **e** South side and **f** close up of the south side after the 2019 November earthquake

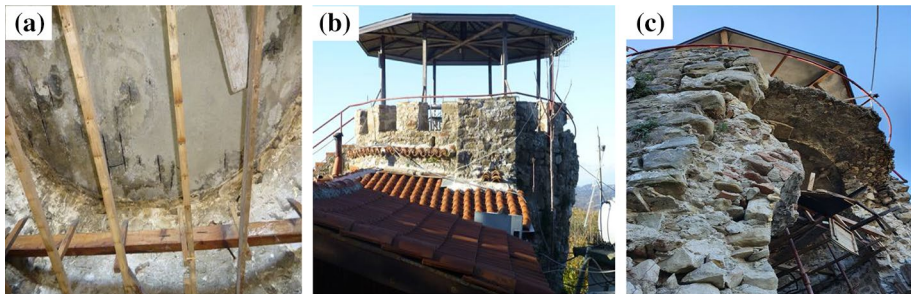
The North tower in Fig. 27 was also damaged by the November earthquake. This tower has a circular shape and is made of stone masonry walls. Visible alteration to the original configuration of the tower observed during the visit are the introduction of a RC floor to create a terrace on the roof of the tower (Fig. 27a) and the construction of a building on the side of the fortification walls and adjacent to one of the sides of the tower (Fig. 27b). The damage occurred on the outer side of the tower, facing the cliff. This side is the most vulnerable due to the lack of confinement provided by adjacent structures. In this part, the masonry collapsed for out of plane mechanism, whereas the stiff slab remained undamaged

Fig. 27 View of the Prezë north tower and alteration to the original configuration: **a** new reinforced concrete (RC) slab, **b** new construction adjacent to the side of the tower and **c** view of the damage to the Prezë clock tower
