## Morphological analysis of as-manufactured filament wound composite cylinders using contact and non-contact inspection methods

Morphological analysis of as-manufactured filament wound composite cylinders using contact and non-contact inspection methods / Natale, E., Gaspari, A., Chiominto, L., D'Emilia, G., Stamopoulos, A.G.. - In: ENGINEERING FAILURE ANALYSIS. - ISSN 1350-6307. - STAMPA. - 158:(2024). [10.1016/j.engfailanal.2024.108011]

# Morphological Analysis of As-Manufactured Filament Wound Composite Cylinders Using Contact and Non-Contact Inspection Methods

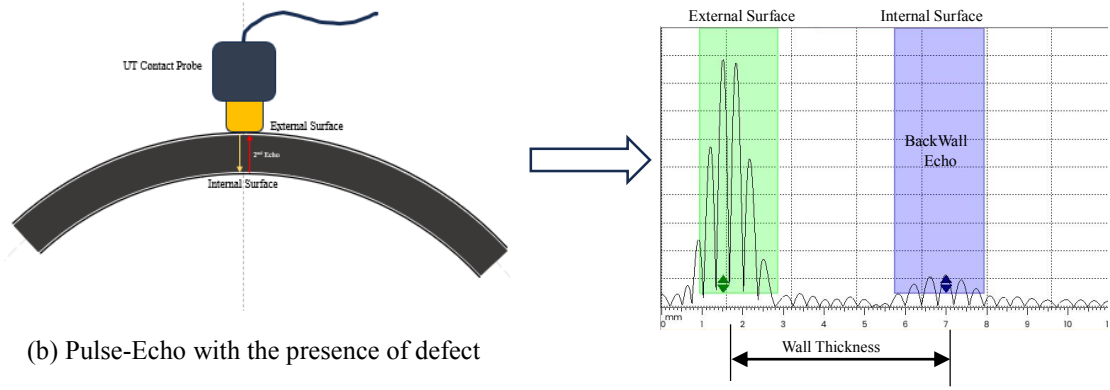
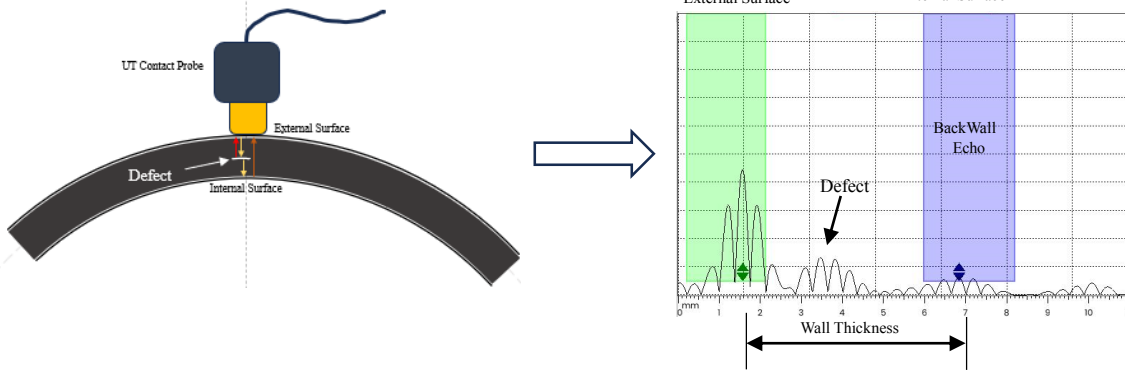
The 2 typical cases of the signal received are presented in Fig.7 for the case of a filament wound structure with and without defect, stating a typical pulse-echo analysis. The first peak of the A-scan corresponds to the external surface while, in the case of the presence of a defect such as a delamination or a gap, there can be observed 3 peaks where the 2<sup>nd</sup> one corresponds to the discontinuity.

Fig. 7: Schematic description and the corresponding A-scan for the case of a cylindrical, filament wound, composite structure without (a) and with a discontinuity (b).

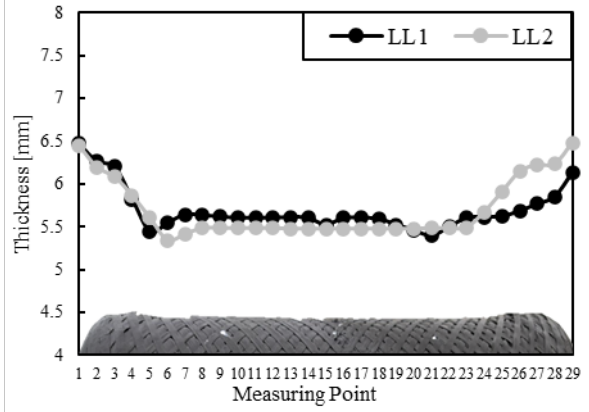
Fig. 8: Variation of the echoes and the wall thickness along the measuring points of the 2 longitudinal lines for the 2 filament wound cylinders: (a) Cylinder A; (b) Cylinder B.

In fact, the increased thickness of the 2 ends of the filament wound structure is evident even by an optical observation and is caused by a series of fabrication characteristics such as the accumulation of material in the case of delay of the tow deposition head, the reduced compaction and, partially, the folding of the tows due to the movement of the mandrel and the head as well.

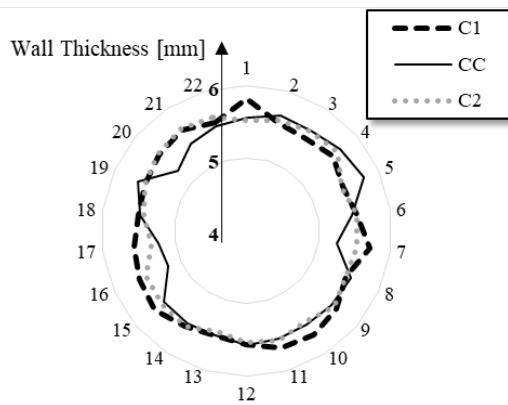
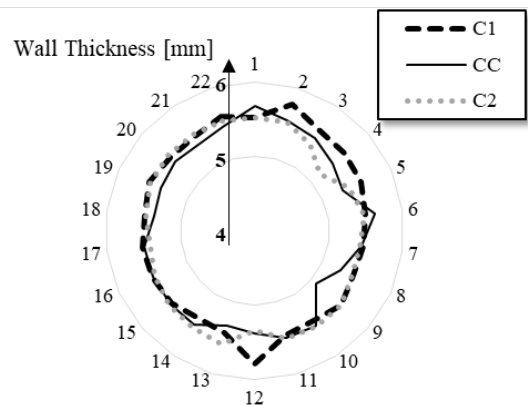
The wall thickness measured in the 3 circumferences C1, CC and C2 is presented in Fig.10 for the Cylinder A (Fig.9(a)) and B (Fig.9(b)) respectively. The distribution of the thickness is found to be irregular, achieving values between 4.7 and 7.5 mm for the Cylinder A and between 5.3 and 6.5 mm for the case of the Cylinder B. In general, the central circumference appears to be more compacted, presumably due to the higher tension applied to the tows during the winding process that leads to higher compaction and, consequently, to a denser filament wound composite structure [25-26].

Fig. 9: The wall thickness distribution as measured in the points of the 3 circumferences of the Cylinder A (a) and B (b) respectively.

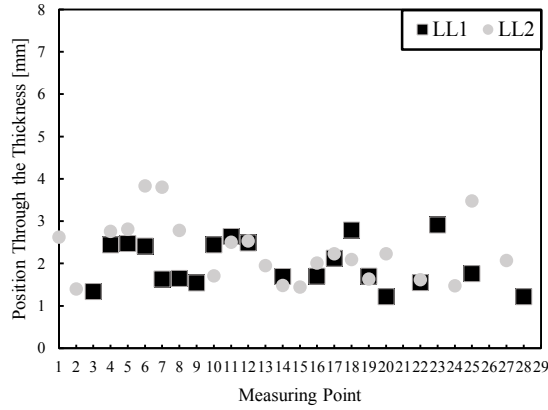
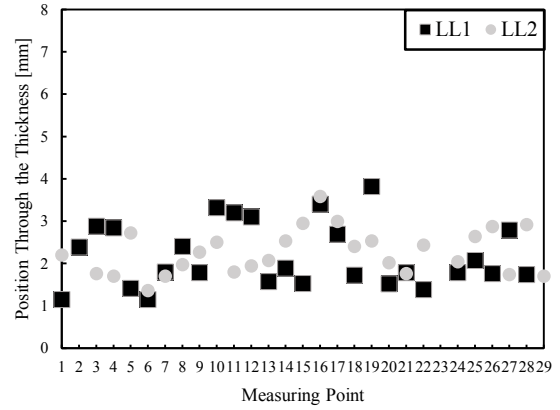
The distribution of the discontinuities across the longitudinal directions is presented in Fig. 11. The graphs show that the discontinuities are present at almost all the measuring points. In Cylinder A the discontinuities are 20 along LL1 direction and the same number is identified along the LL2 direction. These are located between 1.5 mm to 4 mm inside the structure. In Cylinder B at 27 defects points along both directions are identified echoes indicating the presence of a gap. These are located between 1 and 4 mm from the external surface. Along direction LL2 of cylinder B the discontinuities tend to increase their depth inside the structure from point 11 to 16 and then decrease until point 22. As shown in Fig.11, in some cases discontinuities tend to cluster at the same depth in three measuring points. For example, from point 4 to 6 in LL1 direction of Cylinder A. The same behavior is present in points 10 to 12 of LL1 direction of Cylinder 2.

Fig. 111: Distribution of the discontinuities inside the structure of the wound cylinders along the longitudinal directions: (a) Cylinder A; (b) Cylinder B

The presence of defects inside the structure of both cylinders may be considered as a process-driven effect. In fact, during the winding process, gaps between adjacent tows of the same layer may be created as well as folding of the deposited tows while the machine deposition head changes direction at the ends

of each cylinder. The combination of these 2 phenomena may also explain the position through the length and thickness of the defects observed, especially in the case of the Cylinder B, also considering the compaction at the zones close to the 2 ends of the cylinders is relatively lower compared to the central part.

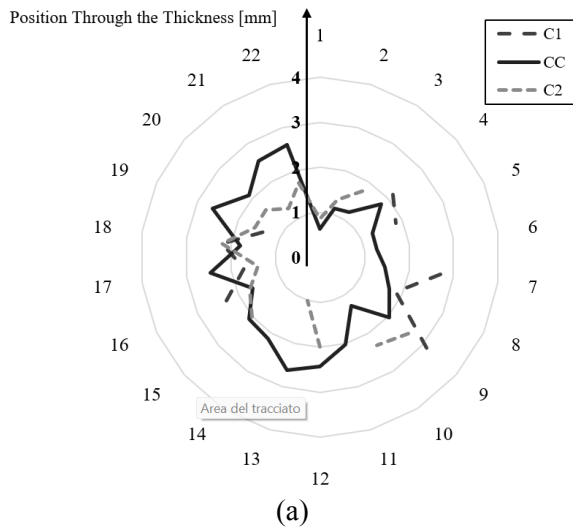
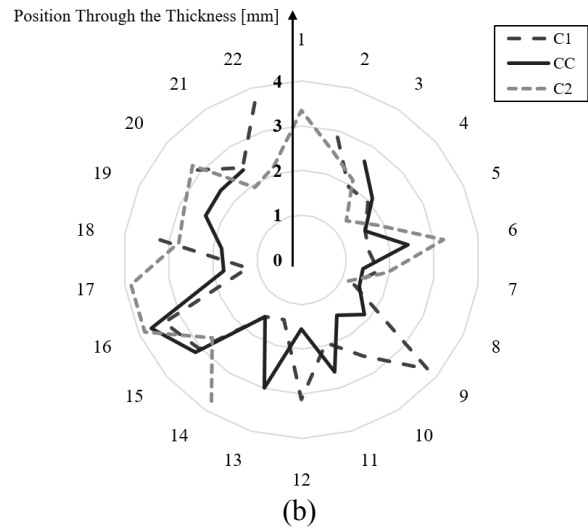
The discontinuities along the circumferential directions CC, C1 and C2 of the cylinders are presented in Fig. 12 for the Cylinder A (Fig.12(a)) and for Cylinder B (Fig.12(b)). Regarding the Cylinder A, the discontinuities are distributed between 0.6 mm to 3.2 mm. From the graph, there are more defects along the CC direction since these are present in all the measuring points. Cylinder B has more discontinuities, and this is highlighted by the figure. In this case, the defects are in a depth that ranges from 1.5 mm to 3.7 mm. In Cylinder B all the considered directions have discontinuities in all the measured points.

Fig. 122: Distribution of the discontinuities inside the structure along the circumferential directions: (a) Cylinder A; (b) Cylinder B

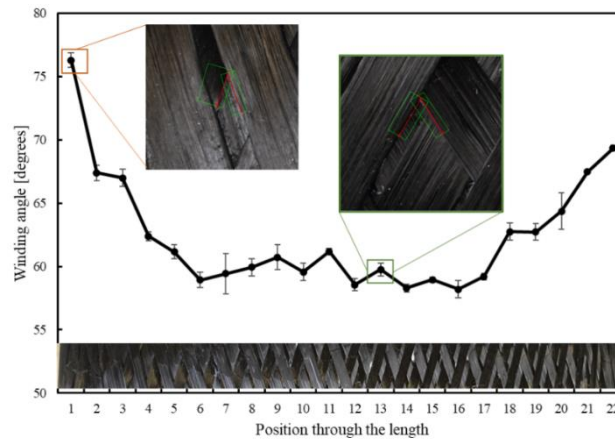
A typical winding angle distribution through the length of the filament wound cylinders is presented in Fig. 11. The local measurements are accompanied by the standard deviation as obtained by the optical inspection utilizing the vision-based system. Even in the case of the winding angle, the hollow cylinder may be divided into 3 sections, one at the central part (between the 6<sup>th</sup> and the 17<sup>th</sup> points) and the 2 ends where the winding angle achieved values way higher than the nominal one. In fact, the winding angle is gradually increasing as moving from the central part of the cylinder towards the external zones.

Fig. 13: Typical distribution of the winding angle through the length of the filament wound cylinder and detailed view of the 76° and 60° of the local points.

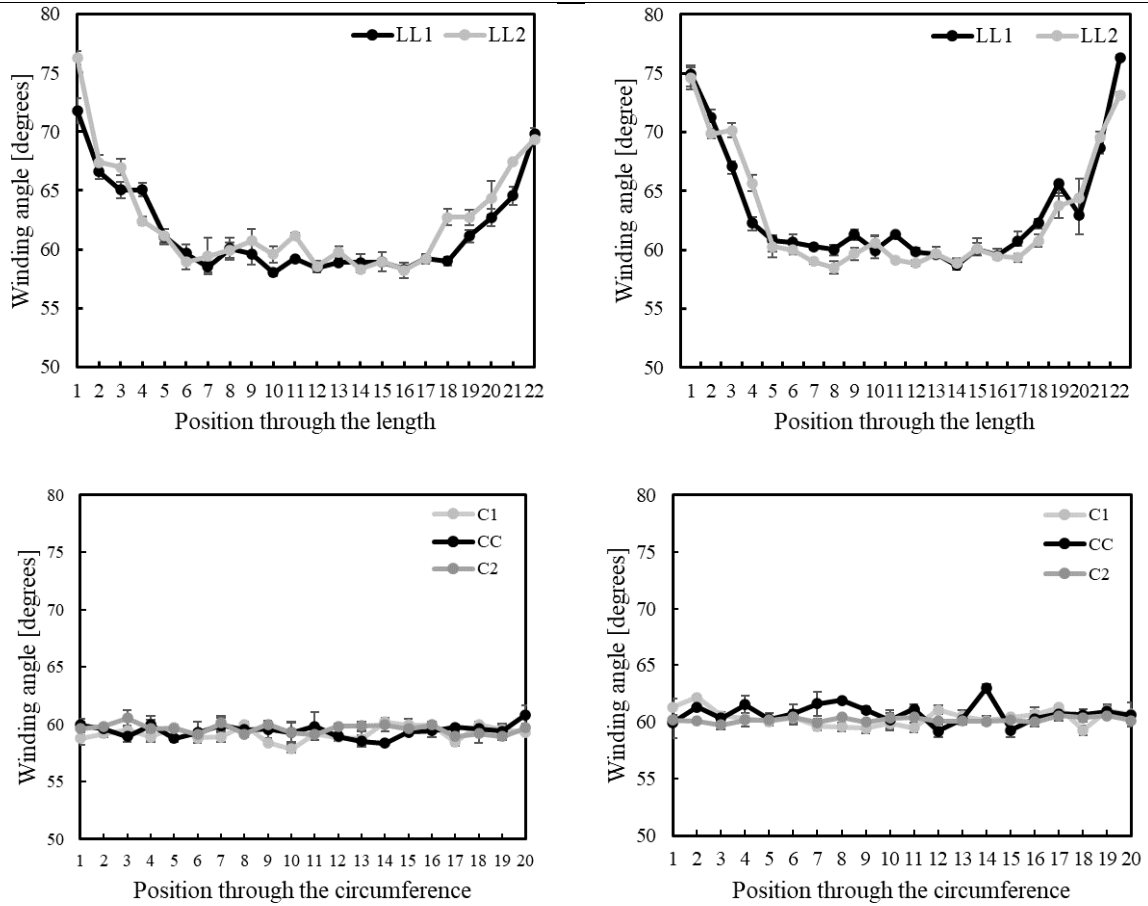
An interesting aspect of the winding angle concerns its variation through the length of the hollow cylinders in different zones as well as through the central circumferences. As seen in Fig.12, the winding angle follows similar trends through the length of both cylinders regardless of the location of the point lines. On the contrary, the optically measured winding angle is almost invariant in the 3 circumferences.

Fig. 14: Distribution of the winding angle through the length and through the circumferences of the 2 composite cylinders,

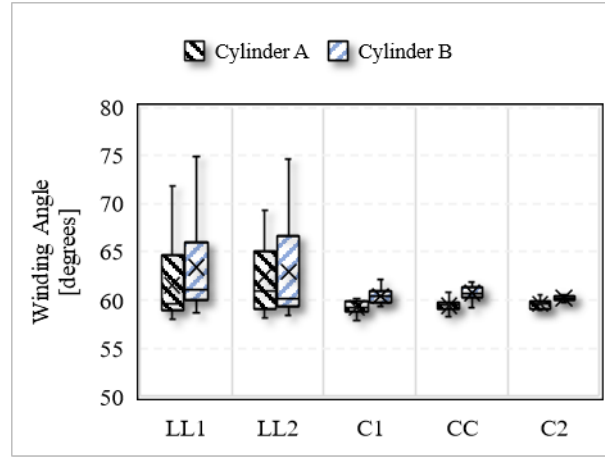
Similar observations may be extracted from the average values of the box plot of Fig. 13 where the average winding angle and the corresponding standard deviations are reported. The 3 circumferences are demonstrating average values close to the nominal one ( $60^\circ$ ) with a low standard deviation. On the contrary, the tows' winding angle appears to be variable through the length achieving average values of  $62^\circ$  and  $64^\circ$  for the Cylinder A and B respectively, accompanied also by an extensive standard deviation. Therefore, the actual filament winding angle may be considered variable only through the length of the hollow composite cylinders and not through the circumference of a certain point through the length of them.

Fig. 15: The average values of the tows winding angle as measured by the vision-based system through the length (LL1, LL2) and the circumferences of the 2 cylinders.
