Assessment of landslide damage to buildings at the urban scale

Assessment of landslide damage to buildings at the urban scale / Palmisano, Fabrizio; Vitone, Claudia; Cotecchia, Federica. - In: JOURNAL OF PERFORMANCE OF CONSTRUCTED FACILITIES. - ISSN 0887-3828. - STAMPA. - 32:4(2018). [10.1061/(ASCE)CF.1943-5509.0001201]

1 **ASSESSMENT OF LANDSLIDE DAMAGE TO BUILDINGS AT THE URBAN**  
2 **SCALE**

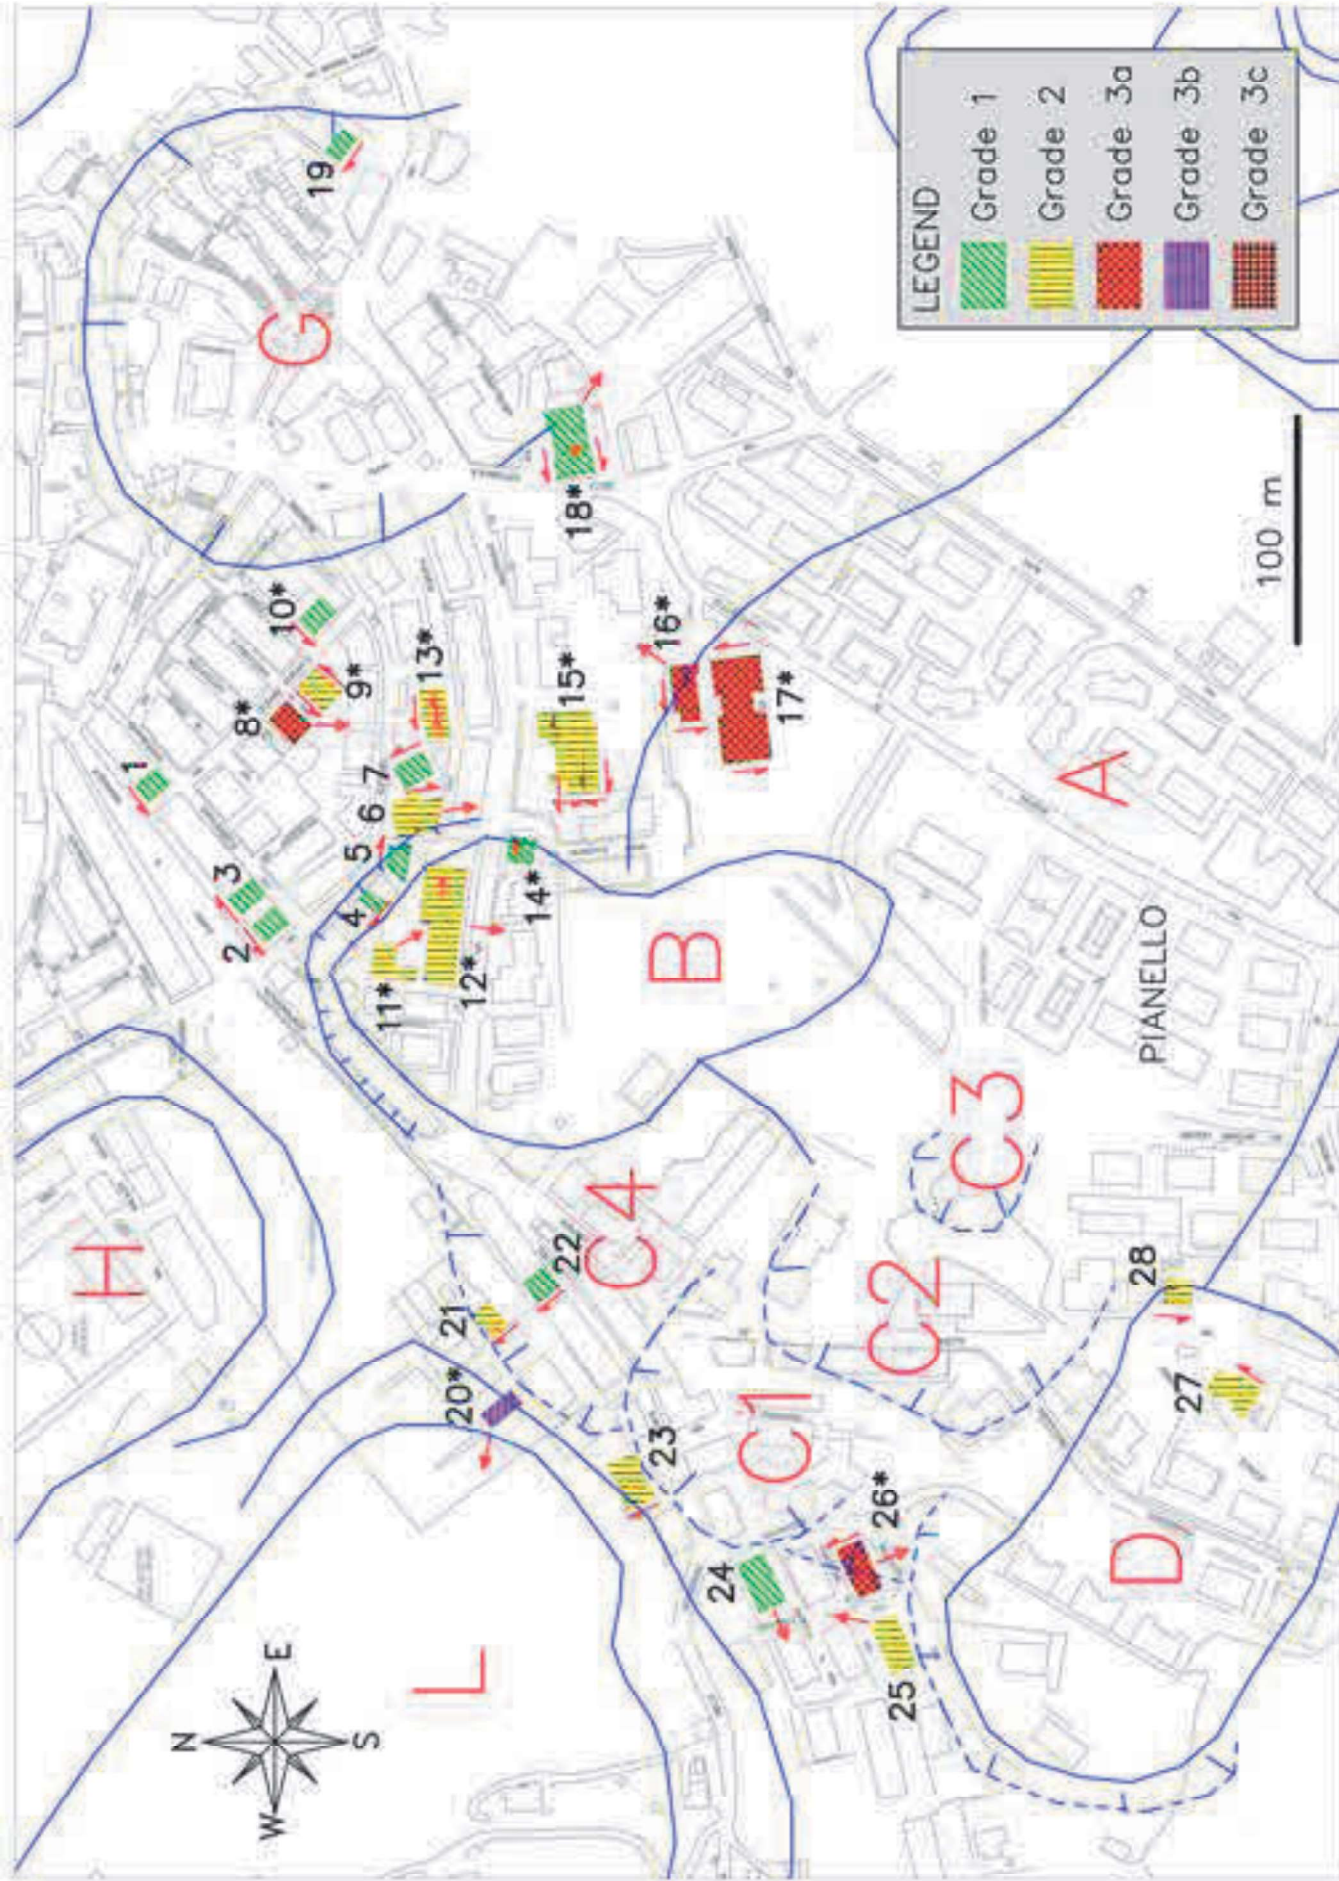
744 Figure 6. Landslide damage geotechnical chart of Bovino.

510 The results of the *Level 1* analyses of both Steps 1 and 2 for Bovino are mapped in the  
511 landslide damage geotechnical chart shown in Fig. 6. As result of the application of the  
512 methodology, this chart reports not only the damage grade of the buildings, but also the  
513 information concerning the direction of the settlements (arrows in the chart) reconstructed to  
514 have caused the damage through the diagnosis of the crack patterns carried out by means of  
515 the Load Path Method. The chart in Fig. 6 includes the damage grade only for those building  
516 that, according to Section 8 of the forms, resulted to be damaged by foundation settlements. In  
517 Fig. 7 some typical damage observed in Bovino are shown (the building numbers refer to  
518 those indicated in Fig. 6).

411 implementation will be defined as the ‘landslide damage geotechnical chart’, i.e, the end-  
412 product of both Steps 1 and 2 of the *Level I* assessment (Fig. 1).

413 This chart should include the geomorphological map of the urban area under study,  
414 indications about the kinematics of the landsliding, the damage grade of all the buildings for  
415 which damage appears to depend on foundation settlements, as well as the direction of the  
416 settlements causing the damage (according to Section 8 of the damage forms).

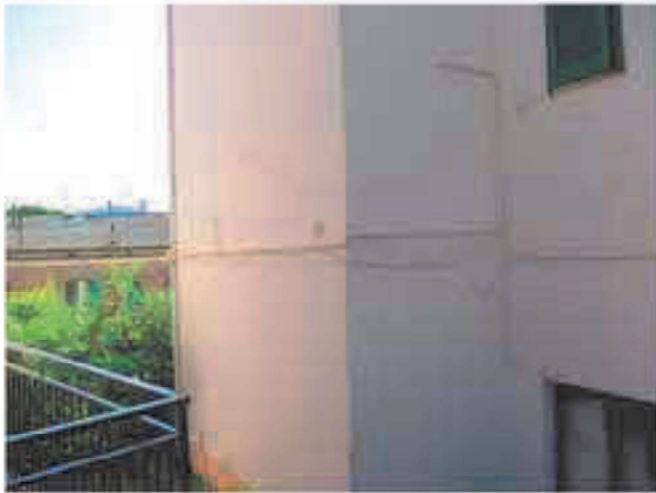
745 Figure 7. Some typical damages due to foundation settlements observed in Bovino (for the  
746 building numbers refer to Fig. 6).

building (6): masonry structure

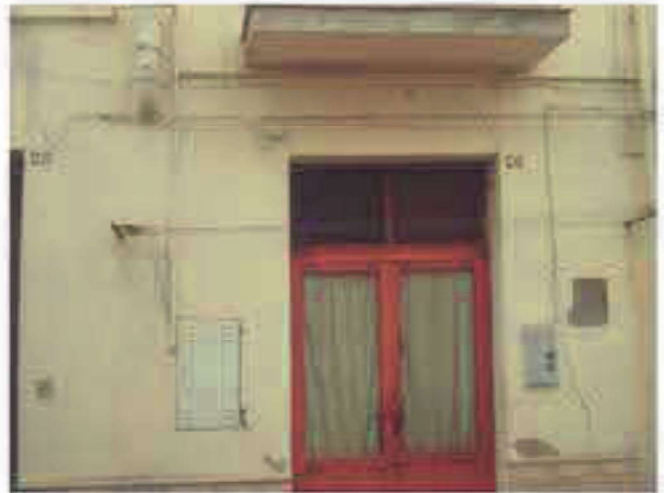
building (8): masonry structure

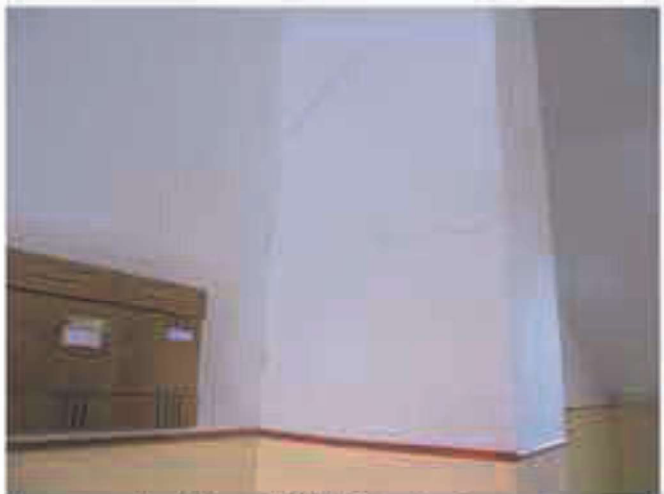
building (13): R.C. structure

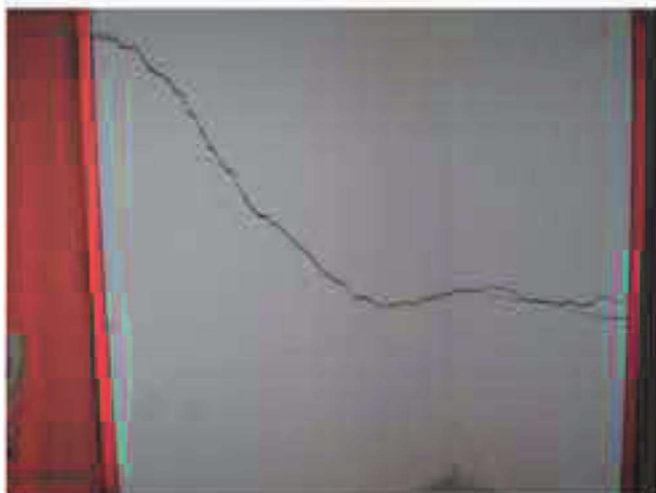
building (17): R.C. structure

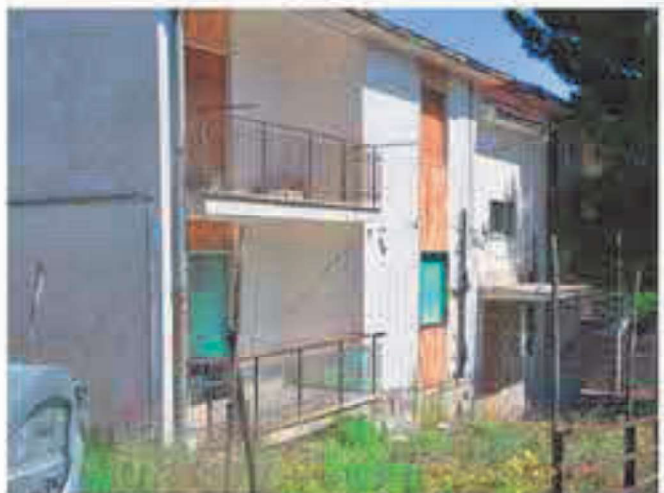
building (26): masonry structure
