ANTAEUS Project for the Regional Vulnerability Assessment of the Current Building Stock in Historical Centers

ANTAEUS Project for the Regional Vulnerability Assessment of the Current Building Stock in Historical Centers / Uva, Giuseppina; Casolo, S; Sanjust, C. A.; Mezzina, M.. - In: INTERNATIONAL JOURNAL OF ARCHITECTURAL HERITAGE. - ISSN 1558-3058. - STAMPA. - 10:1(2016), pp. 20-43. [10.1080/15583058.2014.935983]

The ANTAEUS Project for the regional vulnerability assessment of the current building stock in historical centres

Abstract This paper presents a methodology for the seismic vulnerability assessment of current buildings, suitable for the study of historical centres at the regional scale. The applicability is demonstrated with reference to four case studies: the historical centre of the city of Foggia (Italy) and three other small towns of this province, for a total of 4519 housing units. Field data were collected by several teams of technicians by means of a survey form, provided in electronic format. The subsequent data processing and drawing of vulnerability maps was performed using GIS. The collected data were used also for the validation of the algorithm, by compari

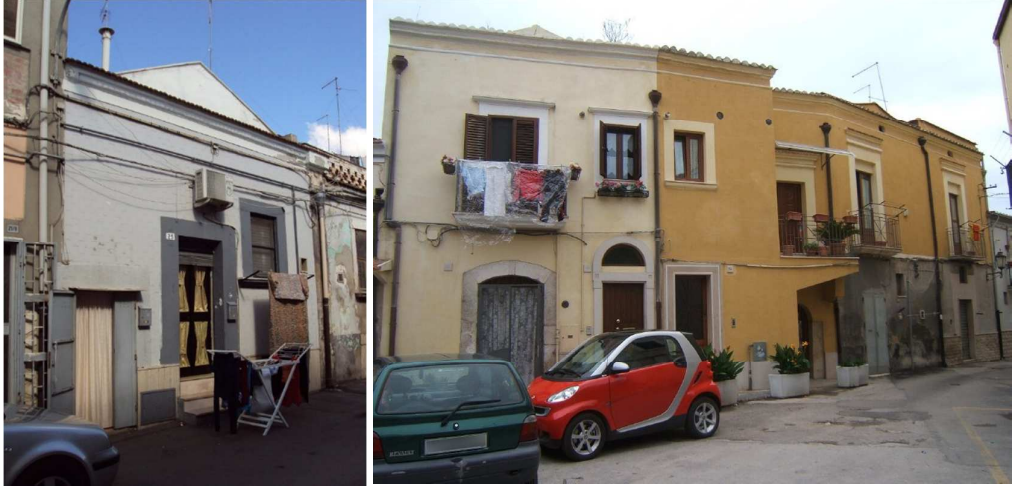
Figure 4: On the left, an example of the original configuration of the houses built after the 1731 earthquake. On the right, the same typology of houses after the addition of a storey and an enlargement.

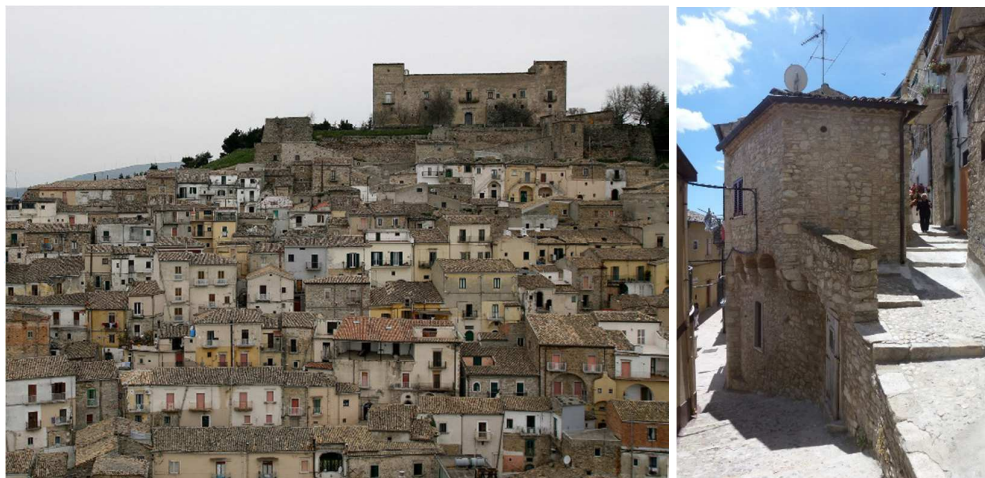
Figure 6: A view of Sant'Agata historical centre (left), and an example of the typical structural aggregate, built on a slope with two level elevations (right).

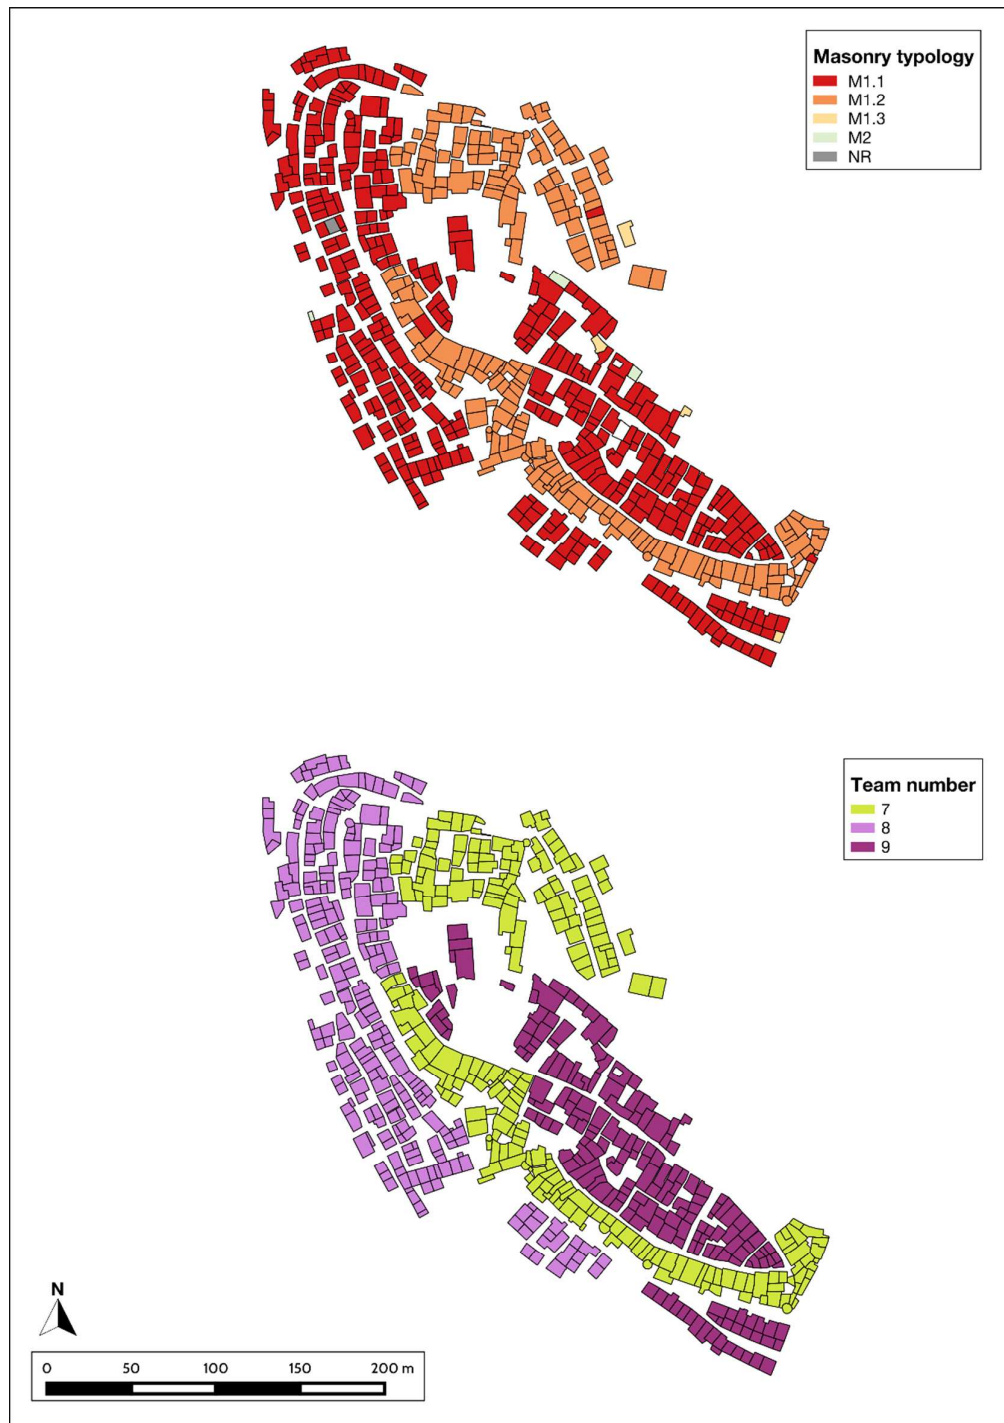
Figure 11: Vico del Gargano: comparison between the spatial distribution of masonry types and survey teams.
