The ANTAEUS Project for the regional vulnerability assessment of the current building stock in historical centres

Abstract This paper presents a methodology for the seismic vulnerability assessment of current buildings, suitable for the study of historical centres at the regional scale. The applicability is demonstrated with reference to four case studies: the historical centre of the city of Foggia (Italy) and three other small towns of this province, for a total of 4519 housing units. Field data were collected by several teams of technicians by means of a survey form, provided in electronic format. The subsequent data processing and drawing of vulnerability maps was performed using GIS. The collected data were used also for the validation of the algorithm, by comparing the results with those of the GNDT methodology, which is widely adopted in Italy. The results of the research study and the application showed some critical points, related to the poor nature of the information collected and to the reliability of the final results. These issues are analysed and discussed, proposing a strategy for improving the methodology.

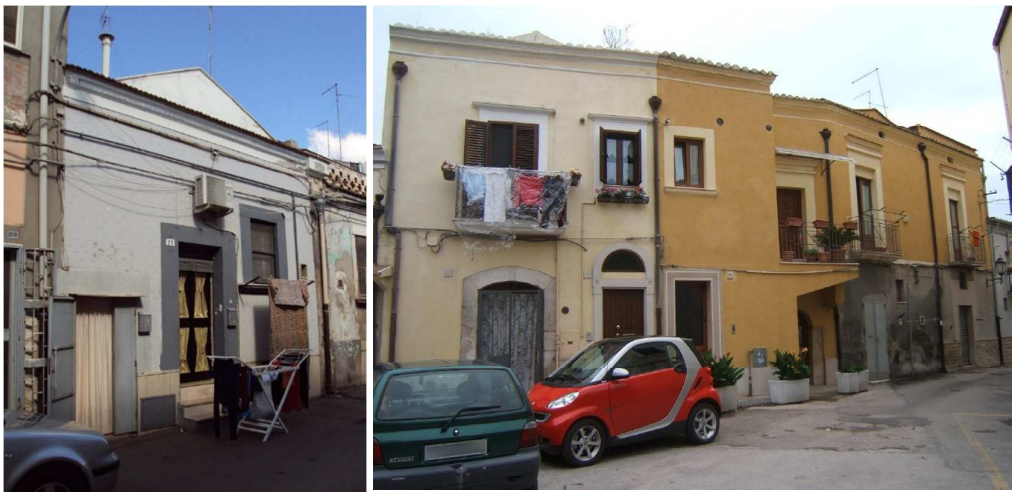
Figure 4: On the left, an example of the original configuration of the houses built after the 1731 earthquake. On the right, the same typology of houses after the addition of a storey and an enlargement.

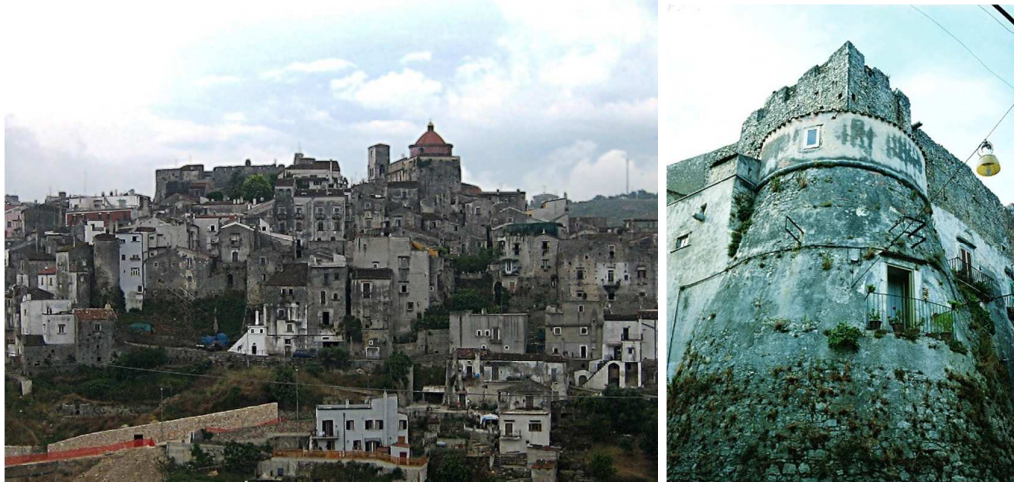
Figure 5: A view of the historical centre of Vico del Gargano (left), and an example of the reuse of the city walls (right).

Vico del Gargano is located in the Northern part of the Gargano Promontory, on a hill made up of limestone of dolomitic type. The historical centre grew around the core of the old castle, which is still visible (Fig. 5). Over the years, residential buildings have replaced the ancient city walls, whose path still defines the perimeter of the old town. The geometry of the buildings, mostly built of stone, is strongly unhomogeneous in plan and elevation, also because of alterations made at different times. Masonry is generally very regular, consisting of roughly cut stones, in some cases in weak condition because of the state of abandonment.

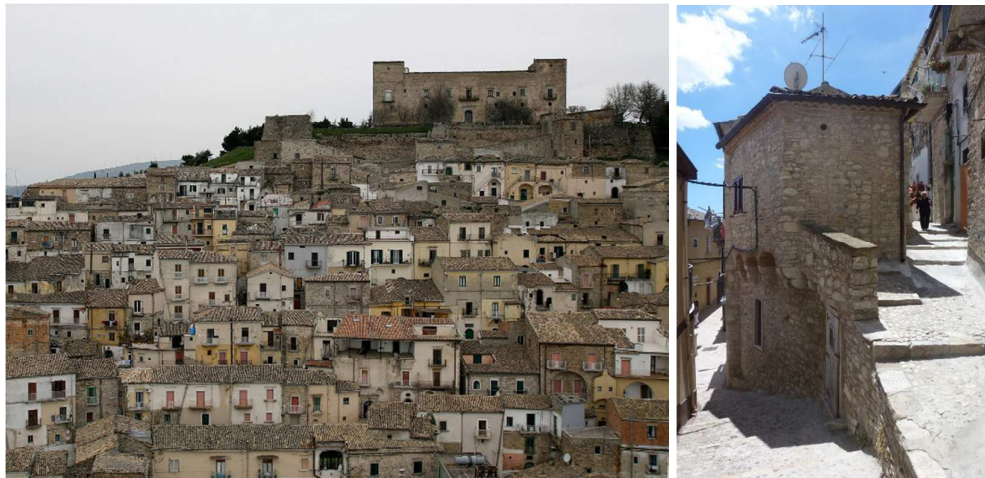
Figure 6: A view of Sant'Agata historical centre (left), and an example of the typical structural aggregate, built on a slope with two level elevations (right).

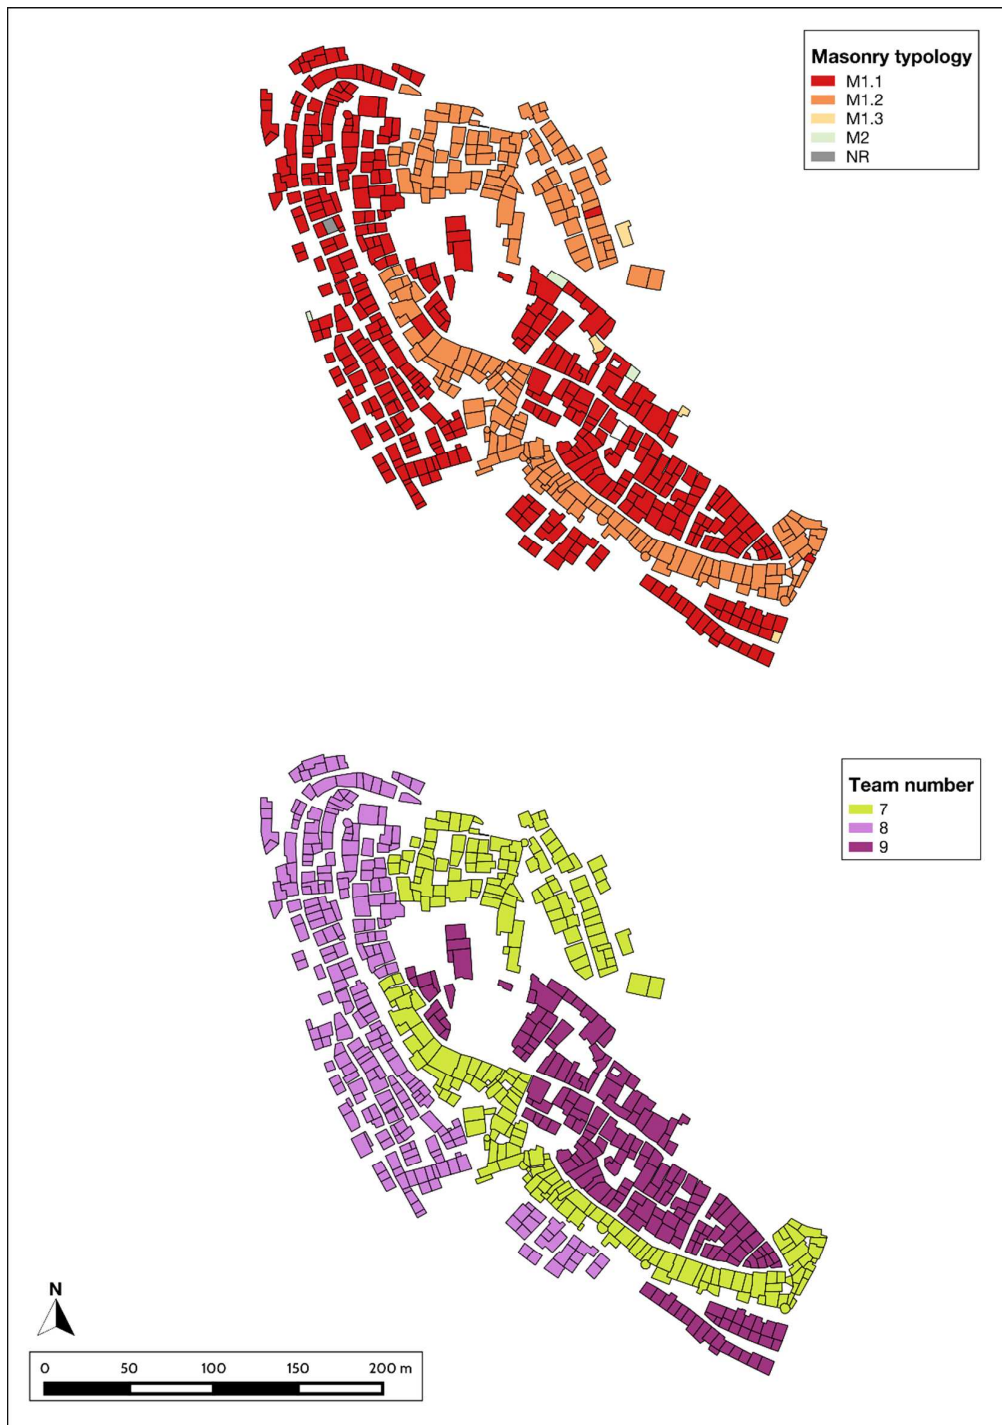
Figure 11: Vico del Gargano: comparison between the spatial distribution of masonry types and survey teams.
