International High- Performance Built Environment Conference – A Sustainable Built Environment Conference 2016 Series (SBE16), iHBE 2016

On the static and dynamic behavior of a prehistoric structure typical of Apulia in Italy

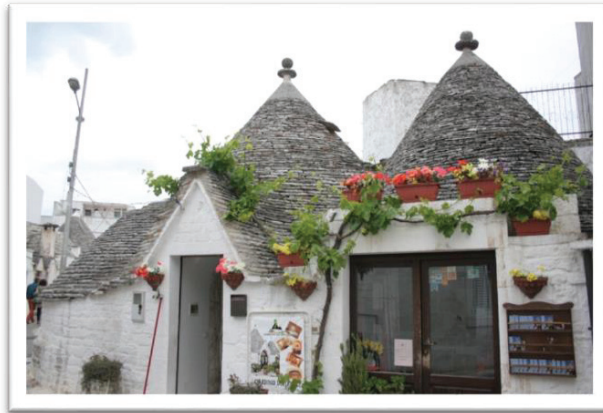
Fig. 2. Typical construction of a *Trullo*.

The vault of a *trullo* is realized with a method of construction, which provides for the implementation of a series of overlapped concentric rings of increasingly smaller diameter, up to a minimum opening, which is closed by a last stone. In this way and without any rib the vault of the *trullo* is realized, a simple stone structure that stands by gravity and by side contrasts, without the aid of any binder.

The cone is then covered with "*chiancarelle*" (slim layers of limestone), which are arranged with a slope towards the outside in order to facilitate the drainage of water.

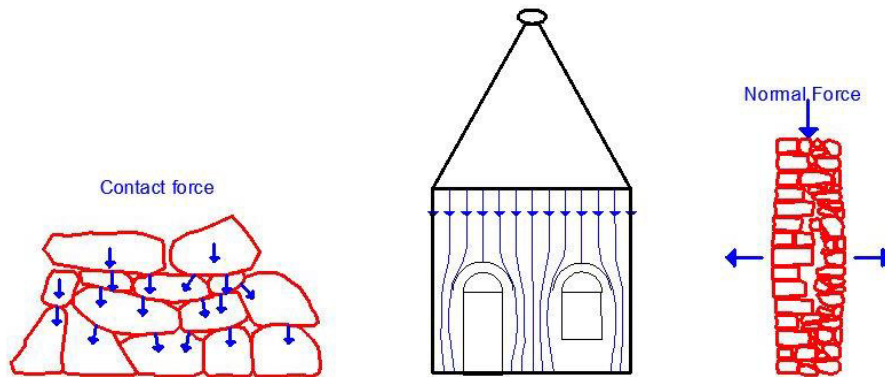
Fig. 3. Transmission of the forces; deviation of the stresses; inflection phenomenon of a sack masonry.

In the masonry without binder like in a *trullo*, the transmission of forces occurs between the points of contact among the stones [7] (Fig. 3).

Since the masonry is subjected to forces in its plane, it behaves like a plate spreading forces inside and diverting them in correspondence of the openings to find paths where the material provides to the wall enough resistance (Fig. 3).

In the specific case of a sack masonry like in a *trullo*, the forces do not spread throughout the entire thickness of the wall but deviate where the material offers greater resistance. This can lead to instability effects and the masonry is deflected in the direction of lower stiffness (Fig. 3).

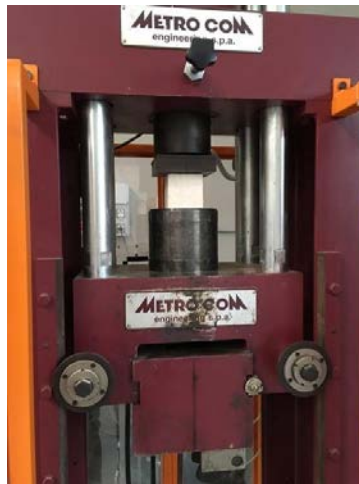
Fig. 8. Evaluation of compression strength of an ashlar.

- Evaluation of the compressive strength of a block taken from the masonry (Fig. 8): the natural and artificial stone materials reach the compression failure due to the transversal expansions. This kind of failure is related to the deformation mode.

A single ashlar (brick or stone) can be considered as a rigid element between two less rigid elements, i.e. the mortar joints. The strength of the masonry is intermediate between the stone and the mortar.

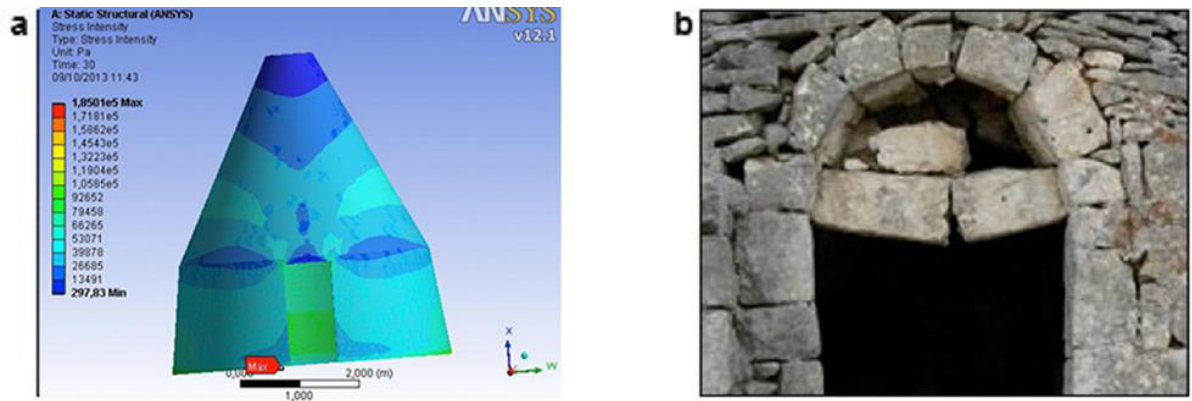
Fig. 10. (a) Plot of the tensile stress; (b) Crack in a lintel.

In Figure 10a it is possible to notice that there are not very high values of stress on the external surface of the structure, while the highest values are obtained on the internal surface and in correspondence of the lower part of the basement. Moreover, the behavior in correspondence of the zone of connection between the cone and the base is not linear; in fact there are areas where the stresses are higher and areas where they are lower. In particular, the areas that undergo high stresses are those in correspondence of the stone lintel of the entrance opening. For this reason,

the presence of a crack in correspondence of that area is not rare; in fact, it is one of the main causes of collapse (Fig. 10b).

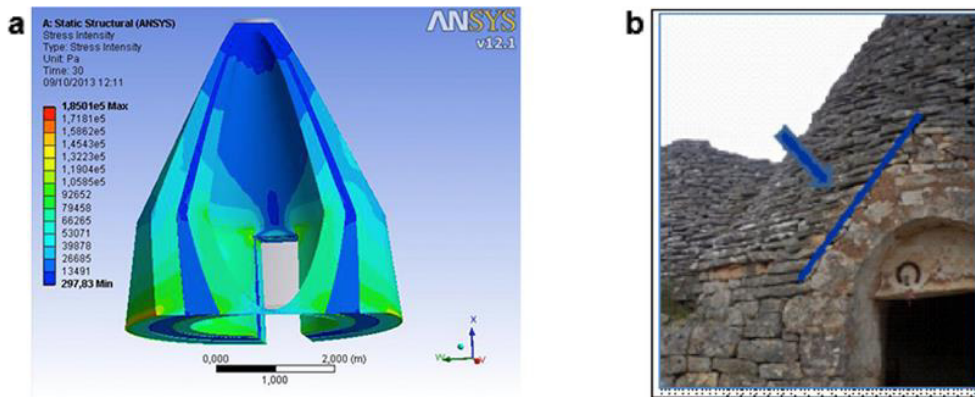
Fig. 11. (a) Distribution of the stresses; (b) Crack in correspondence of the lintel.

As regards to the stress intensity trend (Fig. 11a) it is possible to notice that the most loaded areas are those provided in the numerical analysis, namely the basement and the lower part of the cone. In particular, the stresses are very high in correspondence of the lower part of the basement and decrease upward. In fact, the weight force, which is very high, decreases upward. This result is often confirmed also for other *trulli*. In fact, taking as an example another *trullo* of Itria Valley, which presents the same mechanical characteristics of the examined one, it is possible to notice a crack that appears just at the lintel (Fig. 11b), where the stresses are higher.

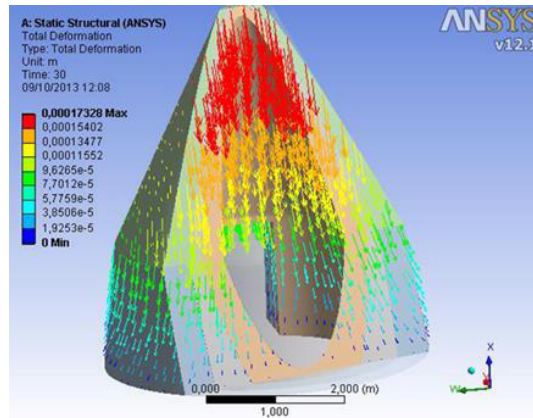
Fig. 14. Direction of the deformations.

Figure 14 shows the direction of the stresses; it is interesting to observe that there are tense areas and compressed areas.
