13th CIRP Conference on Intelligent Computation in Manufacturing Engineering, CIRP ICME '19

# Standard quantification and measurement of damages through features characterization of surface imperfections on 3D models: an application on Architectural Heritages

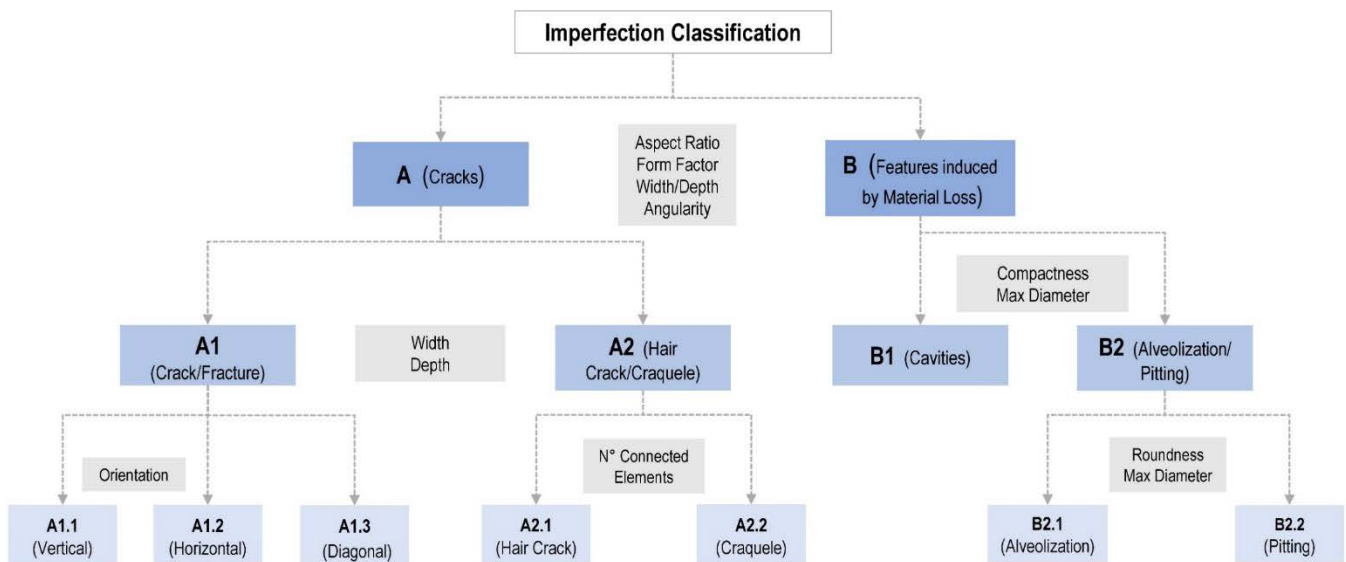
Fig. 1. Methodological workflow for a proposal of Classification of Imperfections.

In this paper, the geometrical characterization of surface defects, through selected features and thresholds, is proposed, see Fig.1. The main goal is to find some characteristic parameters able to distinguish from defects belonging to different categories, e.g. to distinguish between a crack (group A) or a defect induced by material loss (group B), and then, to differentiate defects within the same general category (A or B), such as, for example, fractures from hair cracks, or cavities from alveolization. This would serve a subsequent phase of evaluating the risk connected to that surface, in order to understand if the damage compromises its integrity or functionality.

Afterwards, other parameters will enter the analysis, according to the selected category, in order to deepen the classification into various sub-categories (Fig. 1). Regarding the first category, A, a significant parameter is the *Depth*, which provide a check on the first classification, i.e. if a grain is classified as a crack (class A), the quantitative information about the depth of the grain is useful to verify if the grain is actually a crack. Going further, the *Width* can be considered as a discriminant factor for the classification between crack (A1) and hair-cracks or craquele (A2). In fact, for example in the Architectural Heritage, the standard ICOMOS 2008 defines a hair-crack as a crack characterized by a *Width* < 0,1 mm. Then other features/parameters like the *Orientation* (A1.1, A1.2, A1.3) or the *Number of Connected Elements* (A2.1, A2.2), are relevant for finalizing the analysis. The same procedure is followed for the category B, with different parameters such as the *Compactness* and the *Roundness*, (Table 2), as well as, the *Max Diameter*.

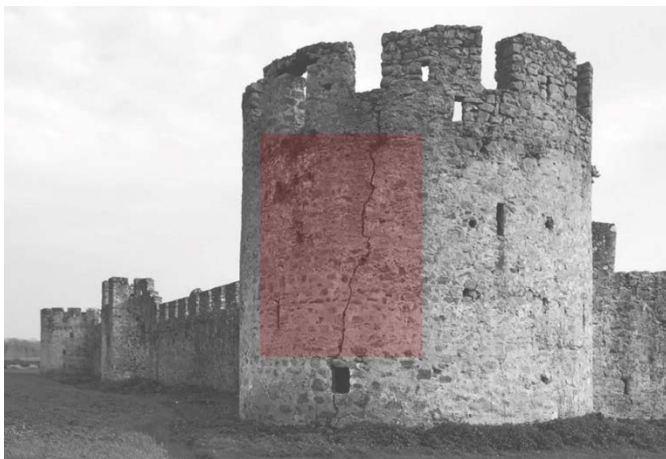
Fig. 2. North tower of the Fortress of Bashtovë. The red portion identifies the analysed area.

A particular attention was dedicated to the north tower which is affected, on one hand, by phenomena of structural deficiency, visible from a huge vertical crack covering almost the whole height of the tower (8 m), and, on the other hand, by widespread alterations (cavities, holes, alveolization), ascribable to stone deterioration.

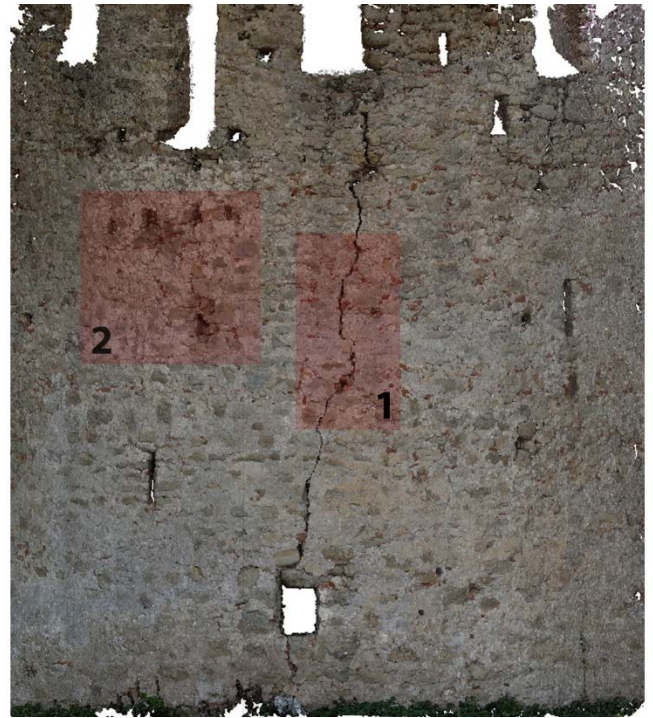
Fig. 3. Point cloud of an extended portion of the north tower (covered area of about 60 m<sup>2</sup>), with the indication of the two samples (1, 2) used for the application of the methodology.

The 3D models were retrieved through a photogrammetric reconstruction [14], carried out with a compact mirrorless camera (Samsung NX 2000 - 20 MPx) with fixed wide-angle lenses (16 mm). The scanning strategy established a shooting distance of 3 m, for a covered area of about 60 m<sup>2</sup> (corresponding to the external area of the north tower), with 58 total images (Fig. 3).

The outcoming model is composed by 192'000'000 points, with a resolution of 0,55 mm/pixel in a direction parallel to the object. This is quite appropriate for the purpose of detection and classification, but, as a consequence, it requires great computational costs. For this reason, the following analyses were performed on polygonal meshes, deriving from limited portions of the dense clouds, with an order of magnitude of 5'000'000 of faces (corresponding to about 25'000'000 of points), for each portion analyzed, (samples 1, 2, see Fig. 3).

The approach proposed in the previous section was then implemented to the selected areas (1, 2) of the processed polygon mesh, see Fig.3. Due to the typical curvature of the tower, first it was necessary to apply to both regions the form removal operator, which consists in approximating the general form of a surface using a mathematical function and subtracting this function from the measured surface. In the specific case polynomial functions of degree 8 were removed from the analysed polygon meshes. The surfaces were then segmented through the setting of a depth threshold value, isolating the defects from the background, see Fig.4,7,8. The following step consisted in a binary segmentation of the surface, which divides the surface in a series of grains and retrieves a set of parameters, such as *Form Factor*, *Aspect Ratio*, *Compactness*, see Table 2.

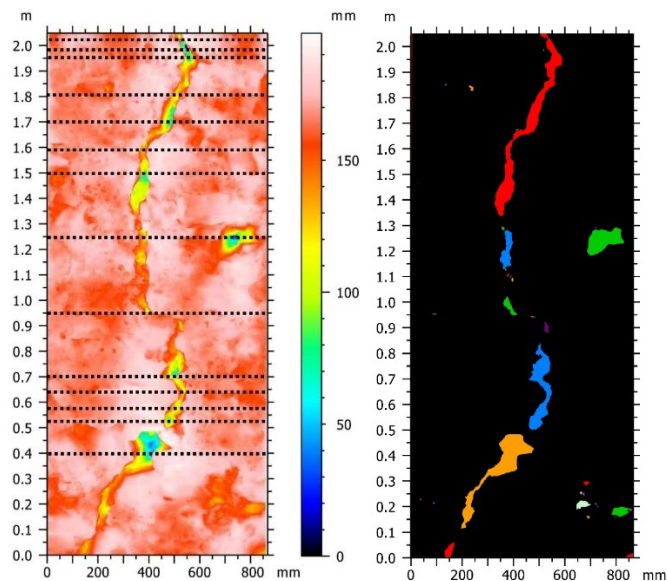
Fig. 4 Left: Pseudo-colour view of the surface (region 1), after the application of a form removing filter (polynomial of degree 8). Indication of the fifteen transversal profiles extracted from the surface. Right: Binarized surface after the application of a depth-threshold, where the segmented regions correspond to the surface imperfections.

A step forward was the extraction of fifteen transversal profiles on each area 1 and 2, see Fig. 4,5. The profile contour analysis allows the measurement of certain parameters like the *Width*, the *Maximum Depth* and *Angularity* between the vertical sides.

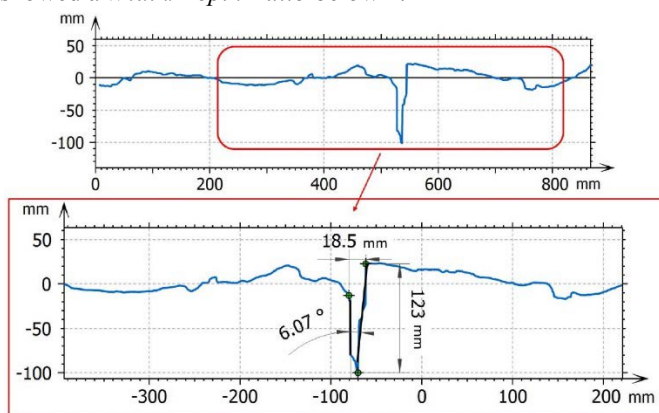
Fig. 5. Transversal profile extracted from the surface.

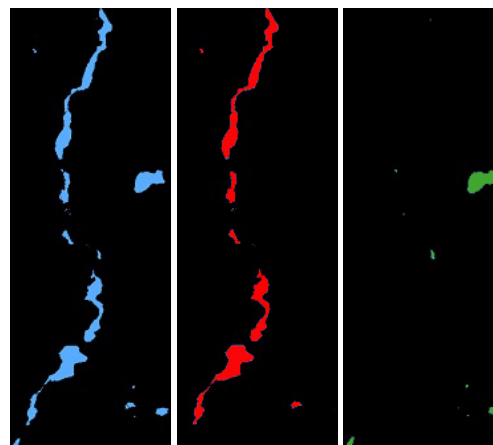
Fig. 6. Application of a threshold value for the Form Factor (0,38), to the binarized image of Fig. 4: from left to right, original image (light blue), grains below the threshold (red), grains above the threshold (green).

Therefore, in correspondence of the *Aspect Ratio* = 4, the *Form Factor* is 0,38, and this value can be used as the threshold to isolate grains pertaining to the two main classes (A, B).

These features were used to classify the detected grains into the different categories, according to the threshold values identified in Section 2.3, whose application to the two surfaces of the case study confirm their validity, see Fig. 6.

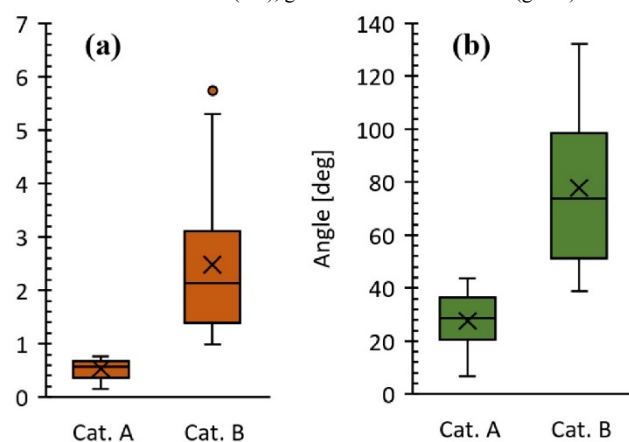
Fig. 7. Boxplot of the Width/Depth ratio (a) and the Angularity (b) with respect to the two categories, A and B. The X represents the mean value, while the line at the centre of the box is the median.

Results obtained highlighted that also the *Width/Depth Ratio* is a discriminant factor between defects belonging to group A and group B, see Fig.7, and, through the analysed set of data, it was possible to obtain a threshold value. It was observed that all the cavities belonging to the category B and considered in this case study, presented a *Width/Depth Ratio* above or equal to 1, while all the profiles retrieved on the crack, showed a *Width/Depth Ratio* below 1.

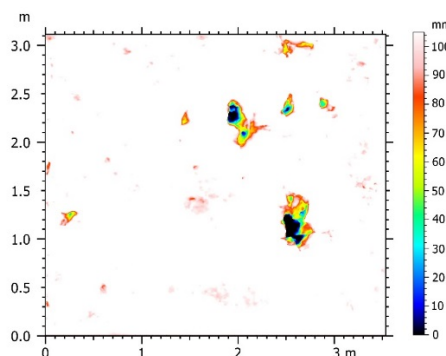
Fig. 8. Application of a depth-threshold to the surface (region 2).

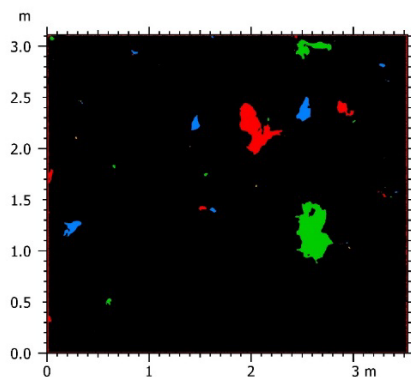
Fig. 9 Binarized surface (region 2), after the application of a depth-threshold, where the segmented regions correspond to the surface imperfections.
