REMOTE DIAGNOSIS AND CONTROL OF HERITAGE ARCHITECTURE BY PHOTOREALISTIC DIGITAL ENVIRONMENTS AND MODELS

Abstract

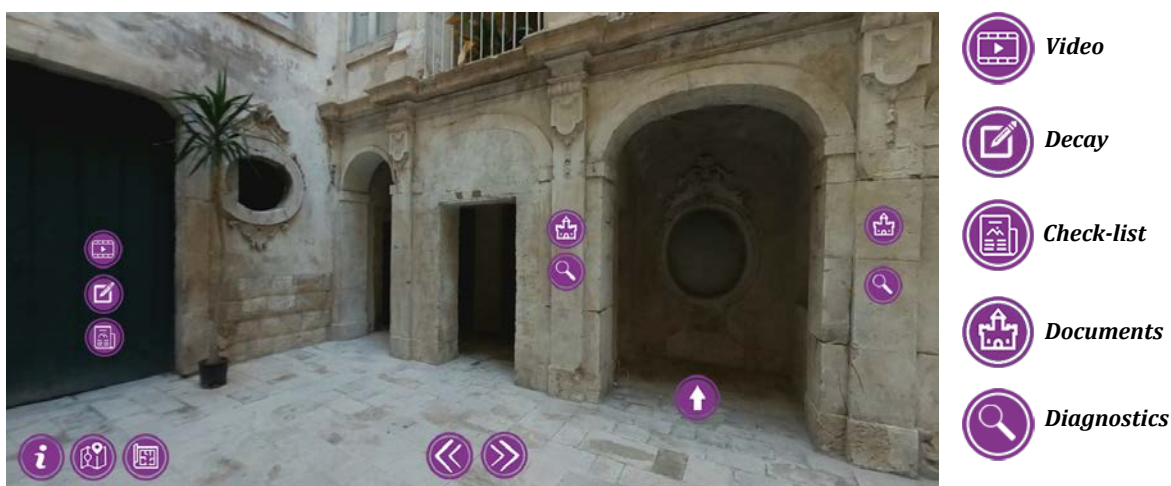
Fig. 3: Panorama of the internal courtyard on the ground floor

Further links (Fig. 3) are specifically related to the entire current scene, such as:

The first situation (Fig. 3) concerns the pillars at the ground floor of the internal courtyard, which has been documented, not only by a series of panoramas at increasing heights, but also by video survey by drone-link "Videos". For this situation, the coordinated and integrated assessment of historic data (hot spot "Documents"), damage patterns (link "Decay") and ultrasonic tests (hot spot "Diagnostics") has enabled the diagnosis of the nature and magnitude of the occurring buckling. In fact, the pillars, whose structural deficiency was already observed at the beginning of the last century, is still causing some typical deterioration phenomena, including vertical and hyperboloid cracks with missing parts at the corners of the stone blocks and poor compactness of the mortar joints, as classified by the related thematic panoramas (Fig. 4).

With reference to the two situations presented in section 4.1, the experimentation was implemented on different samples of the right pillar of the internal courtyard (Fig. 3) and the main façade (Fig. 4). In this connection it is worth restating that, in the first case, a structural deficiency (vertical and hyperboloid cracks, poor mortar joints and missing parts at the corner of the stone blocks, etc.) was diagnosed, whereas, in the second case, a widespread surface degradation was connected to rising dampness (cavities, erosion and lacks). Scans were carried out with an increasing level of detail, in order to investigate these phenomena.

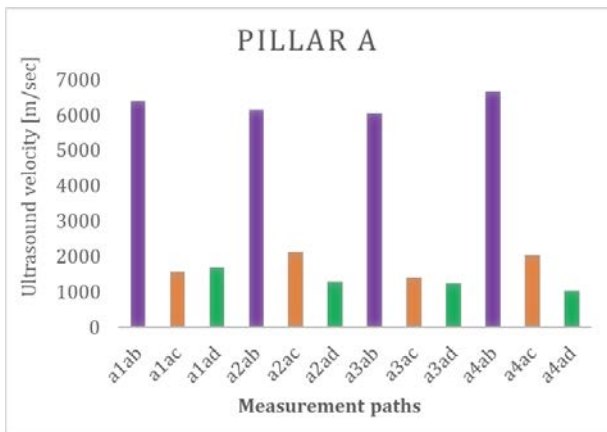
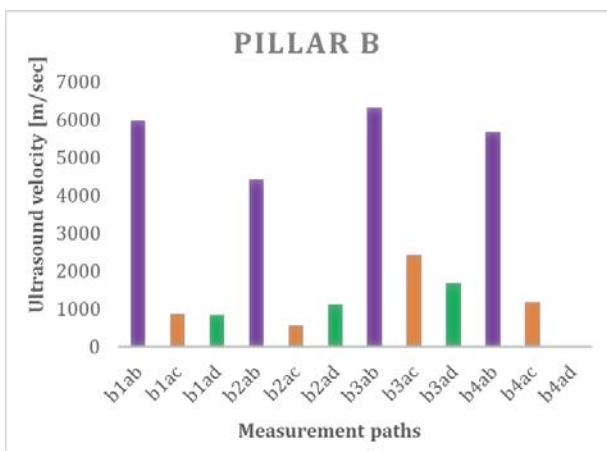
Fig. 6: Extract of the ultrasonic test report, which is accessible by hot spot “Diagnostics” – average travel velocities for each measurement path

The displayed results, which were analysed for groups of measurements from similar paths, have enabled the identification of a great variability of the ultrasound travel velocity in the component (Fig. 6).

- For the paths with receiver probe in "d" intercepting two mortar planes, the average velocity is 1100 m/sec, with some values that could not be recorded because the signal failed to reach the receiver due to high attenuation.

Such a global response reasonably indicates that several cracks, which are visible on the external surface, correspond to internal fracture planes, with significant propagation even for the whole thickness of the component.

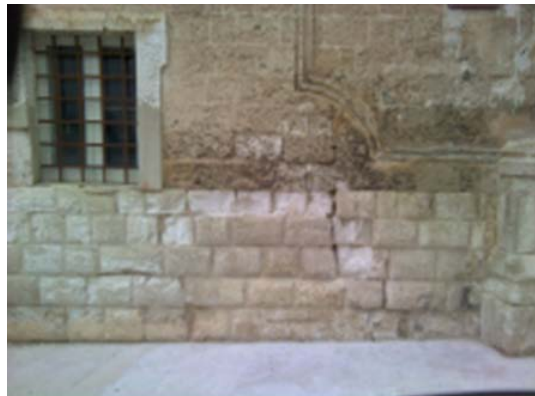
Fig. 8: Visible and infrared picture of the basement which is accessible by hot spot “Diagnostics” – front view

The second situation concerns the base of the main façade, where the thematic mapping of the stone decay – link "Decay" -, with great incidence of cavities, erosion and lacks, is compared against the thermographic survey, carried out by equipment FLIR T430s – hot spot "Diagnostics" (Fig. 7 and Fig. 8).

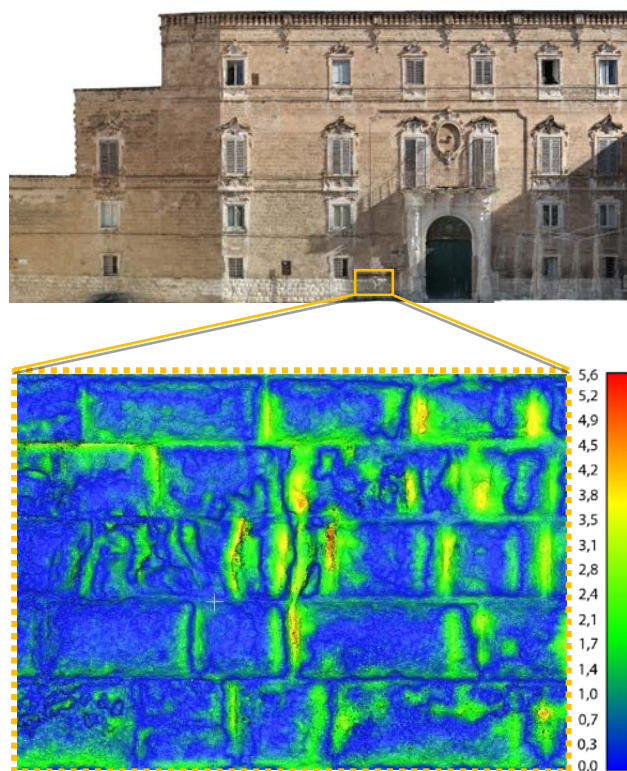
Fig. 10: Restricted area of the masonry, in the basement of the external façade (red rectangle); false colour map with absolute distances (cm) between the two point clouds (06/11/2015 - 09/06/2017).

As far as the external façade is concerned, at a first observation, the areas are characterized by widespread degradation. It emerged that in a time interval of eighteen months (from 06/11/2015 to 09/06/2017), there occurred a progression of the detected alterations (Fig.10). The evolution of this situation is quite compatible with a phenomenon of rising dampness, which is also visible through

other diagnostic analysis such as thermography. As an example, the greater distances (3,5-4,5 cm) are located near extended cracks, cavities, erosions and lacks, visible on the external surface, as demonstrated in 4.1 by a thermographic survey.
