DIAGNOSTICS OF HISTORICAL STEEL BRIDGES: THE CASE OF THE VALENCIAN RAILROAD NETWORK

The proposed procedure is applied to a riveted steel bridges located in the Valencian railroad networks (Valencia region, Spain).

The proposed methodology to derive an analytical failure tree from a FEM model is applied to the “Quisi” riveted steel bridge located in the Valencian railroad networks (Valencia region, Spain). The “Quisi” bridge is a multi-span truss deck bridge connecting the towns of Alicante and Denia, built between 1913 and 1915, which currently is still in-service within the Spanish railway network.

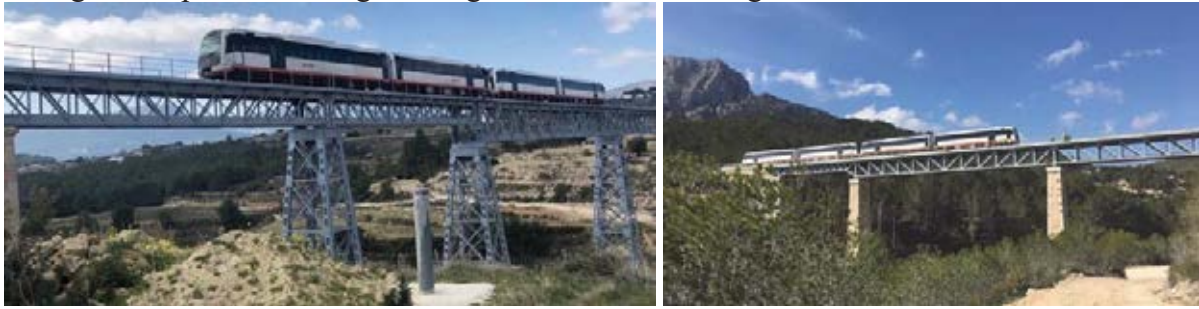
Figure 1. Two examples of old steel bridges in the Valencian railroad network: “Quisi” (left) and “Ferrandet” (right) bridges.

In *Valencian region* a large number of *riveted steel bridges* were built to create the railroad network from the middle of the 19th century to the first decades of the 20th century when the use of steel in bridge construction was widespread. After more than 100 years of existence of this railroad network, many bridges need repairing or strengthening interventions due to changes in service requirements or pathologies. In addition, since the steel bridges have been subjected over the years to an increasing number of train passages (which means a large number of load cycles from the beginning to nowadays), the *fatigue* phenomena could affect their remaining life. In particular, fatigue often leads to a brittle fracture that, joined with a typical low level of redundancy of these types of structures, produces a high risk of collapse. Figure 1 shows two examples of old steel bridges in the Valencian railroad network.

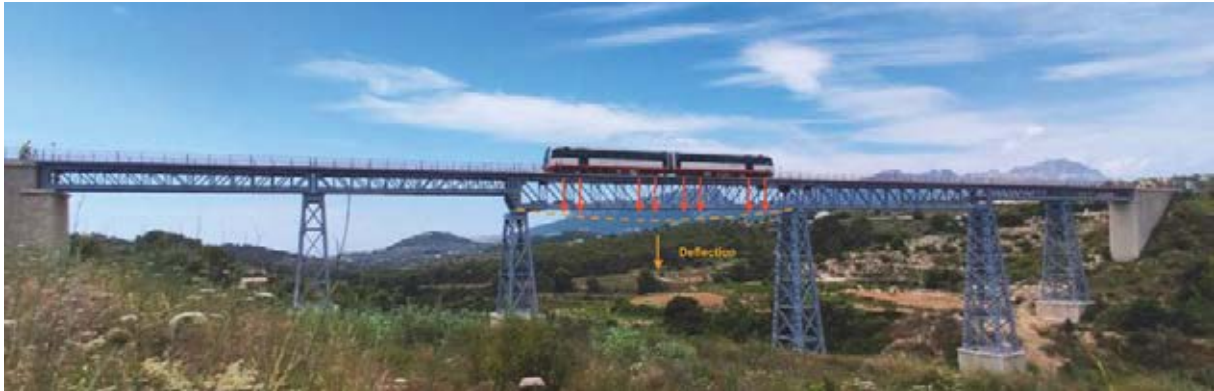
Figure 4: Static and load test on the bridge.

A *static load* test is performed: a train composed of two wagons, representative of the real service loads, is placed at the middle of each span and the stabilized *maximum deflection* of the truss is measured. Furthermore, the deformations in some significant truss components are registered thanks to the numerous strain and displacement sensors (Figure 4). In addition, a dynamic test is performed, in which a moving train travels on the bridge (speed of 30 km/h) and the strains and stresses of significant members are evaluated. This latter test allows for measuring bridge dynamic parameters such as the *modes of vibration* and *natural frequencies* by using a set of accelerometers during the same test.

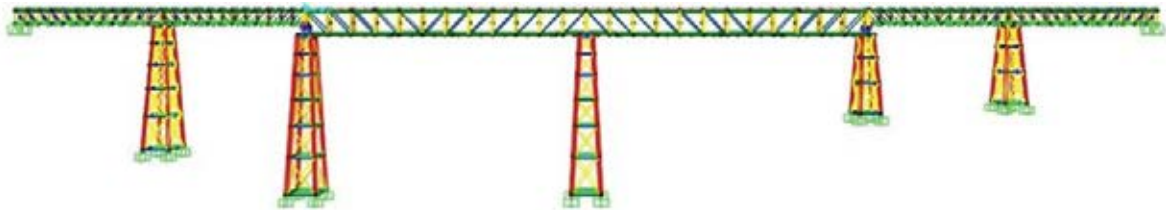
Figure 5: Structural Model of the investigated Bridge realised with SAP2000.

The FEM model is realized with the software SAP2000 (Computer and Structures INC (CSI). SAP2000 - Structural Analysis Program 2018) by exploiting the results of the described investigation plan. Figure 5 shows the structural model of the investigated Bridge. All the built-up members are modelled by single frame elements. The bearing devices connecting the trusses to the top beams of the towers are represented by linear *two-nodes links*. The elastic modulus of the steel is fixed at 210000 MPa and fully fixed foundations are considered. Rigid end zones are placed to model connection zones between the frame elements.

Some geometrical modelling assumption are necessary in order to reflect correctly the acquired information in the numerical model. In particular, the riveted connection beam-diagonal is modelled by using a fixed connection with rigid end offsets. Moreover, the isostatic span is assumed with the following external restraints: i) the fixed bearing modeled through pinned (i.e. fixed displacement) connection, ii) the movable bearing allowing a free longitudinal translation.

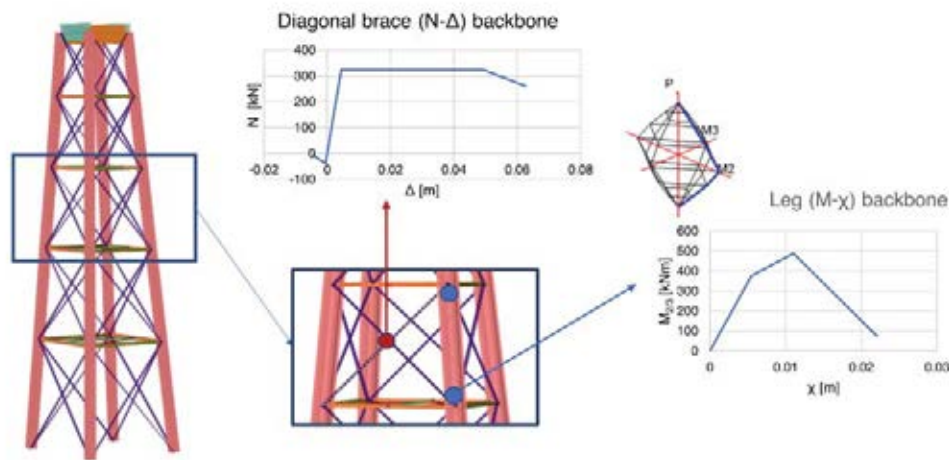
Figure 10: Modelling strategy (lumped-plasticity) for seismic response of supporting steel towers.

To this aim, a nonlinear numerical model should be adopted to predict the inelastic demand for each member during the seismic excitation. An appropriate modelling strategy should particularly consider the inelastic response of the substructure members which exhibit the highest probability to reach selected damage states, as proved in the large literature about the seismic response of multi-span bridges types [23,24]. To this aim, distributed- or lumped-plasticity strategies can be adopted. In the latter, plastic hinges should be used to predict the nonlinear axial response of bracing members (subjected to buckling or tensile yielding) and nonlinear axial-flexure response in the legs of the steel towers (Figure 10). Also, failures of the riveted connections or for shear should be considered. Appropriate recommendations about modelling and seismic analysis of truss bridges are reported in [25].

Nonlinear dynamic analyses are widely recognised as the most accurate strategies to predict the response of the case-study bridge under a given ground-motion shaking. However, such analysis approaches are very demanding in terms of computational efforts, particularly for complex structures such as steel truss bridges. Moreover, these analyses require models about the cyclic response of built-up steel members which are rarely available in the literature [26,27]. Conversely, nonlinear static procedures are less demanding with respect to nonlinear dynamic approaches. The accuracy of these simplified methods strongly depends on various assumptions (e.g. regular dynamic response) which can be not valid for typical steel truss bridges. However, according to [25], this simplified methodologies are effective for local analysis of substructure
