# CMMoST 2019

5th INTERNATIONAL CONFERENCE ON

## Mechanical Models in Structural Engineering

## HEALTH MONITORING THROUGH A TUNED FE MODEL OF A MEDIEVAL TOWER PLACED IN A LANDSLIDE AREA

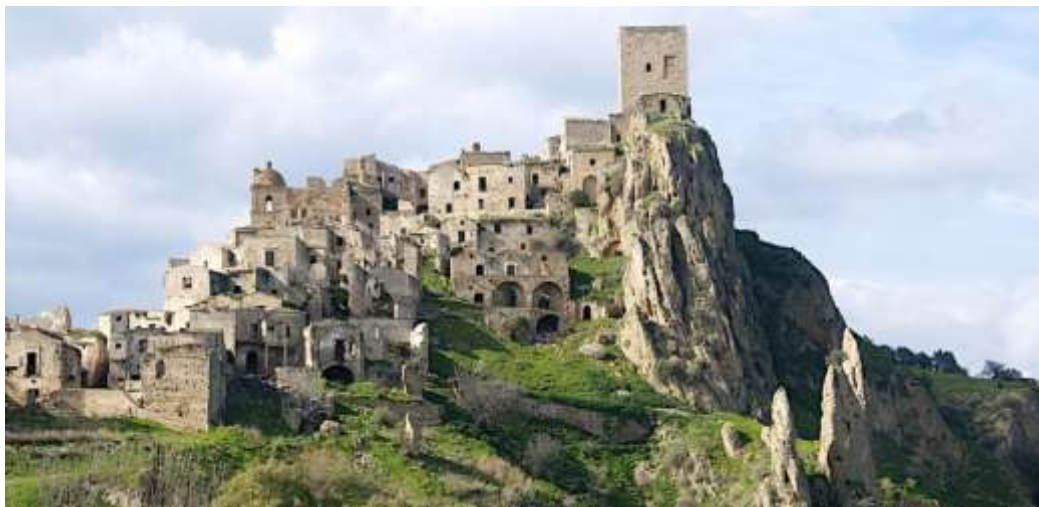
**Figure 1.** Medieval tower at the upper area of Craco (Matera, Italy).

The Norman tower of Craco, instead, suffered minor damages caused by the landslide (Fig. 1). It was realised by masonry walls without any floors, the roof can be considered as rigid. Inside the tower during the 1949, a reinforced concrete tank was realised.

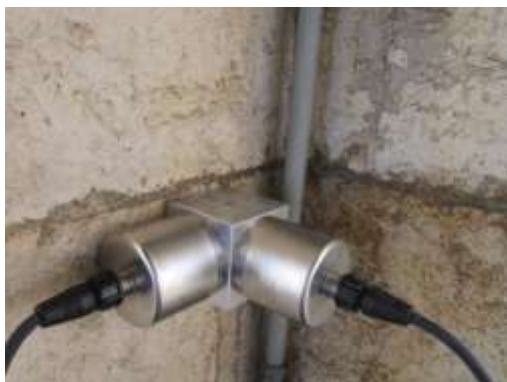
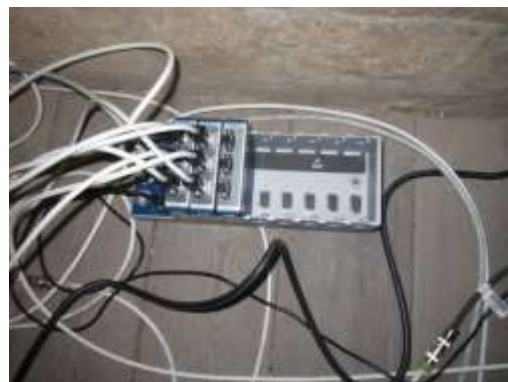
**Figure 4.** a) connection of piezoelectric accelerometers; b) acquisition modules (DAQ).

- 1) acquisitions units: piezoelectric accelerometers, PCB 393B31 with a sensitivity of 1000 mV/g and frequency range [0.1-200] Hz. Appropriate rectangular blocks were designed and realized in order to ensure the perfect orthogonality of the accelerometers in each point of application, directly applied to the masonry: the accelerometers were inserted with screws on the threads realized on the perpendicular faces of the blocks (Fig. 4a),
- 2) data acquisition system (DAQ): The control units consist in acquisitions modules, each one is divided into 3 channels; for each DAQ two modules were used, so overall there are 6 channels (Fig. 4b)
- 3) co-axial cables with low impedance and with a length variable from 4.0 m to 15.0 m;
- 4) a laptop where an oportune code based on Labview software is installed.

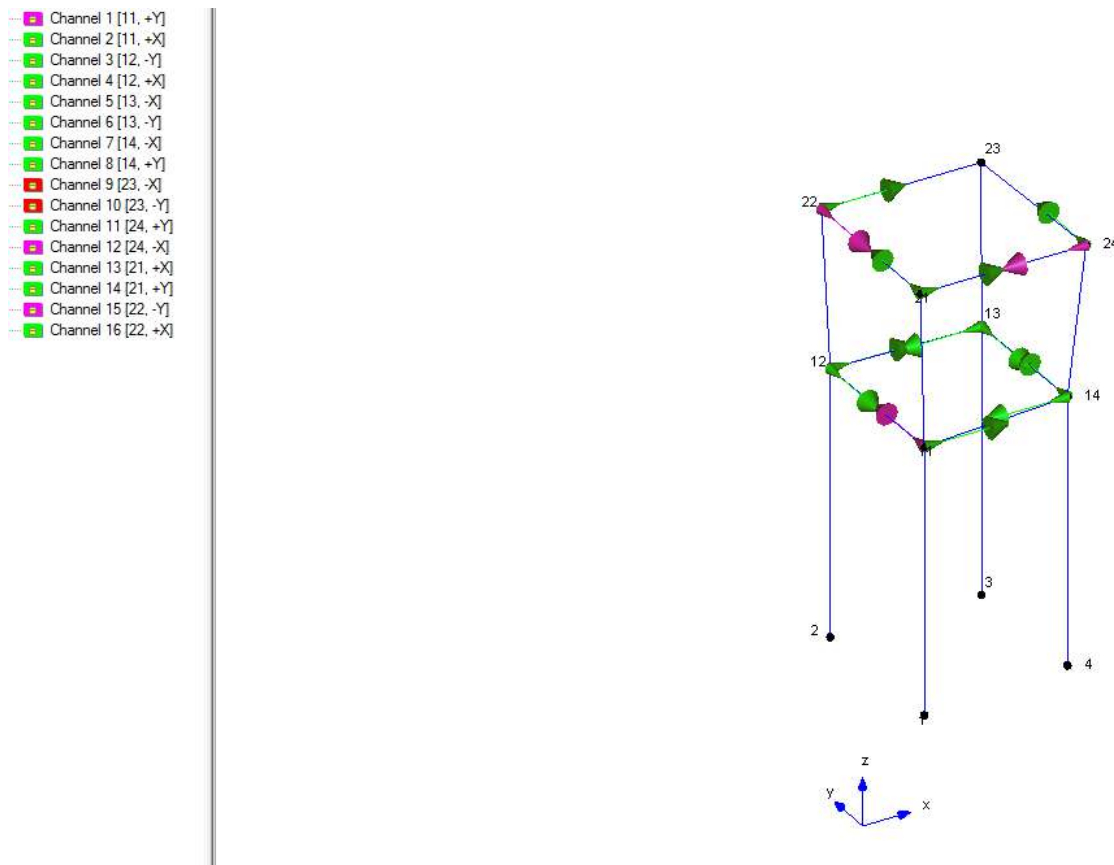
**Figure 8.** Artemis model of the tower

In Fig. 8 the Artemis model with the considered 14 accelerometers, noting that channel 9 and 10, corresponding to the accelerometers indicated with 35211 and 35208 not properly working, have been removed from the analysis. In Fig. 8 is also reported the reference system xyz previously introduced. In Fig. 9 the SSI identification for the Test 3, where more frequencies appear but that have not been considered for the specific type of the mode (local) also considering the results of the model introduced in the following paragraph.

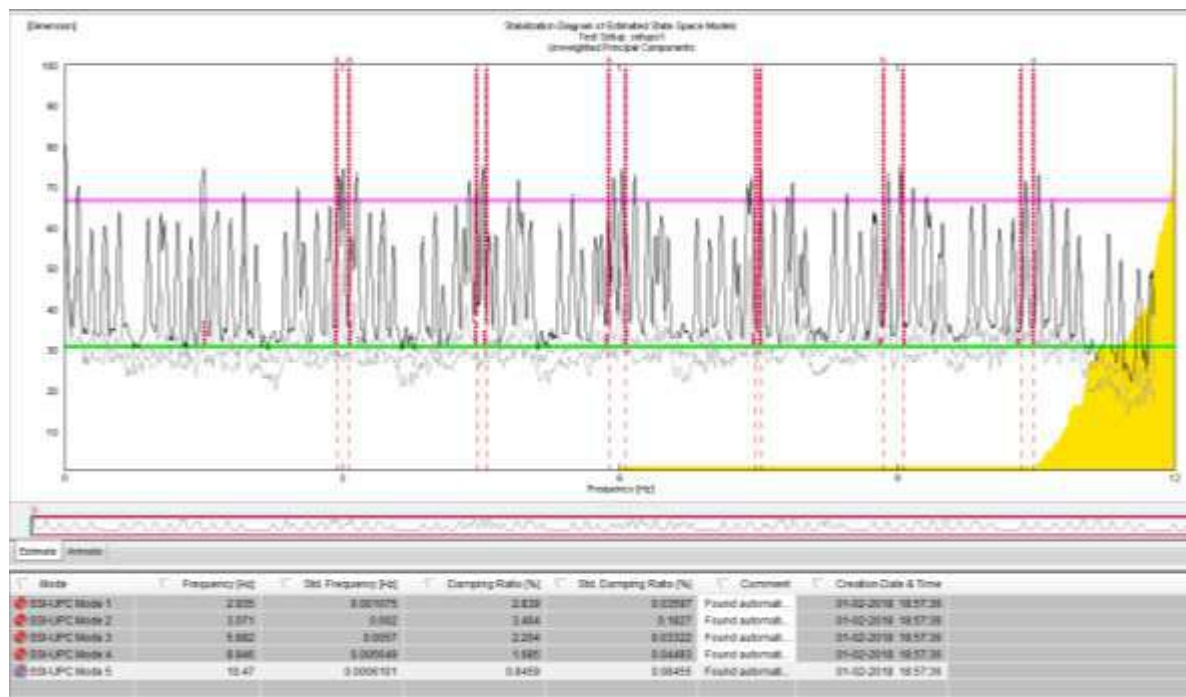
Figure 9. SSI identification results for Test 3

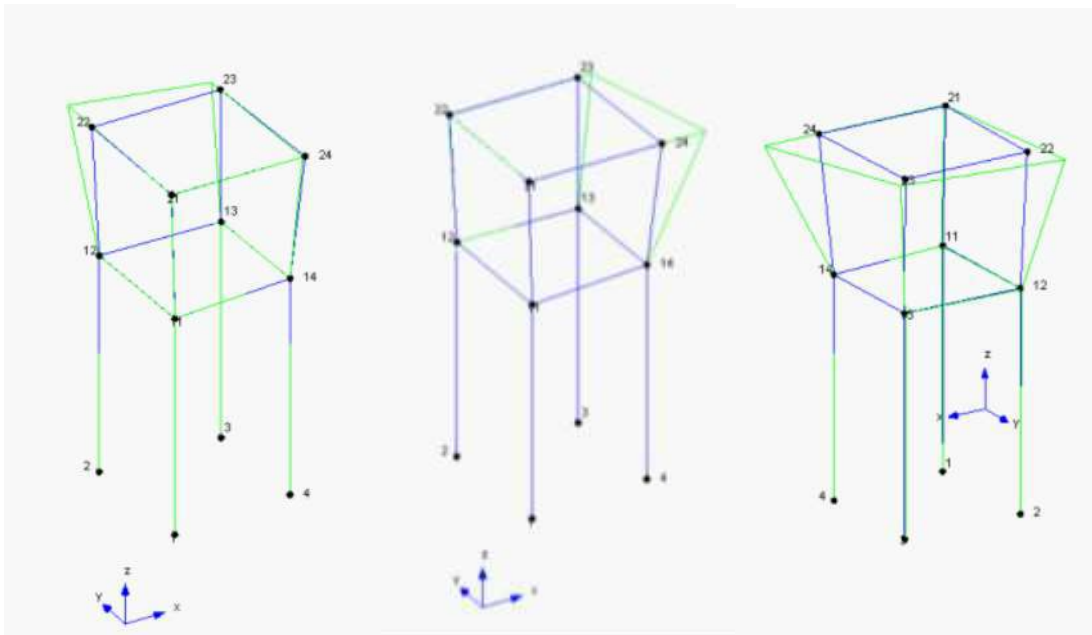
**Figure 10.** Modes related to the first 3 identified frequencies.

x axis; the third mode is a torsional one. In Fig.10, the modes are represented and it is evident that the main oscillation is referred to the structure part included between the height of 12.5 and 21 meters, the two levels monitored with the accelerometers; the different oscillations of the two levels had been also noted and underlined in analysis of the time histories (Figs 6 and 7).
