## Tensile and fatigue testing of impacted smart CFRP composites with embedded PZT transducers for nonlinear ultrasonic monitoring of damage evolution

To cite this article: Christos Andreades *et al* 2020 *Smart Mater. Struct.* **29** 055034

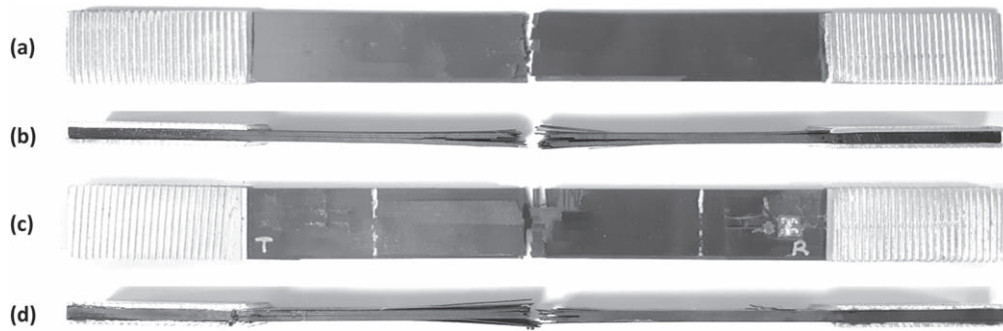
**Figure 6.** Tensile failure of specimens without BVID. Top view (a) and side view (b) of P-specimen, and top view (c) and side view (d) of G-specimen.

In tensile tests, the P- and G-specimens (both intact and impacted) failed by lateral through-thickness shear at the centre of their un-tabbed length (impact location), as shown in figures 6 and 7. Considering that the tabbed sections of the samples were free of damage, this type of failure was acceptable according to the ASTM D 3039/D 3039M standard. This indicated that in each case of initial sample state (undamaged or impacted), the failure behaviour under static tensile loading was the same between the P-specimens the G-specimens, using the proposed layout of embedded sensors.

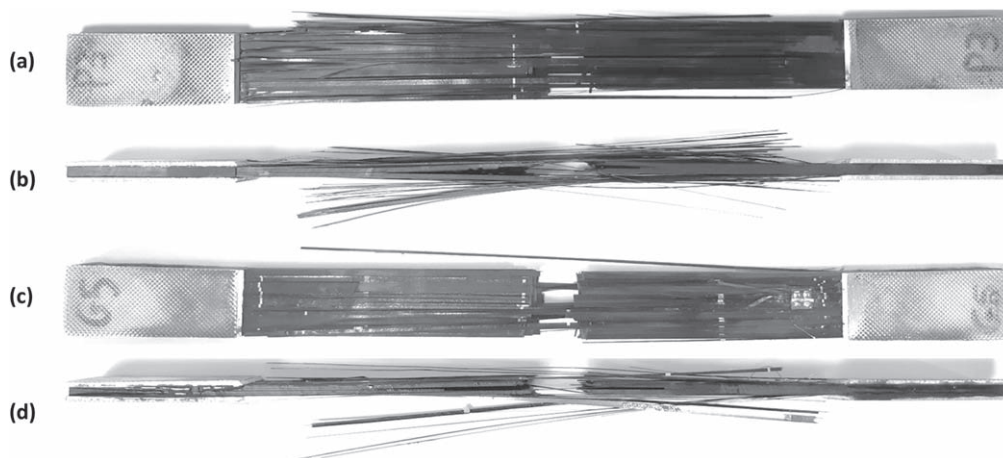
**Figure 8.** Tension–tension fatigue failure of specimens without BVID. Top view (a) and side view (b) of P-specimen, and top view (c) and side view (d) of G-specimen.

without any damage in the end-tabs of the specimen. With reference to the ASTM D3479/D 3479M standard, this failure mode was valid. As it is shown in figures 8 and 9, there was not any noticeable difference between the two specimen groups (P- and G-specimens). This proved that the evolution of material damage in the G-samples was not affected by the presence of the internal transducers, and it was true for both cases of initial sample condition: pristine and impacted.
