CASE REPORT

ENGINEERING SCIENCES

Three-Dimensional Integrated Survey for Building Investigations

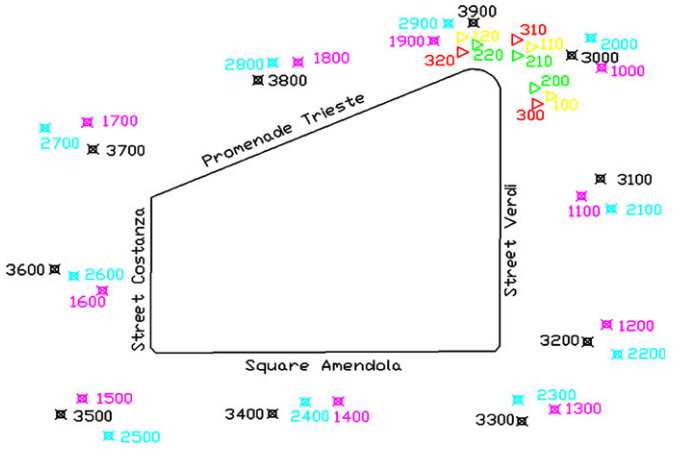
FIG. 4—*Laser stations locations.*

Scans were taken from 36 standpoints, placed at a distance ranging from 20 to 100 m from the building. The map in Fig. 4 shows the locations of the laser stations carried out during the survey. Specifically these locations are marked with a label specified by the numbers 1000, 2000, and 3000, respectively, for the first level (on the road corresponding to approximately zero quota), the second one (about 8 m from the ground), and the third level (about 15 m from the ground). With the same criteria

labels specified by the numbers 100, 200, and 300 show the locations from which the laser survey of the collapsed corner was carried out.

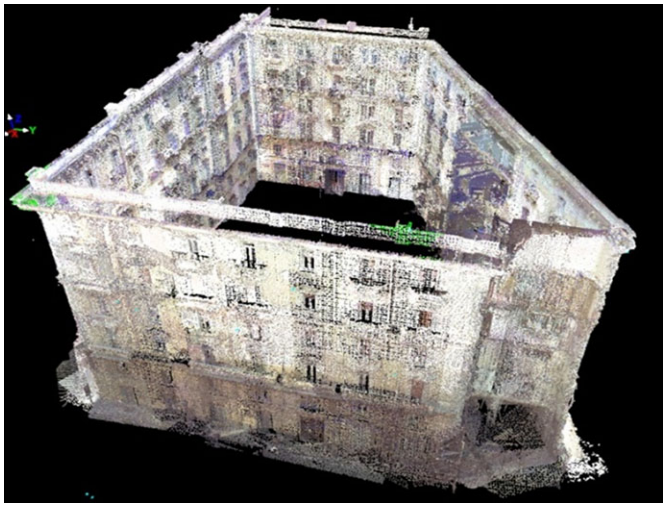
FIG. 5—*Point cloud image to Verdi street front.*

Data processing was performed by several softwares, and specifically by Cyclone, Geomagic, and others. After the phase of data filtering followed by noise removal, a process of alignment for each front of the building was realized; this alignment was based on the recognition of the control points corresponding to the reflecting targets and natural GCPs (11). The georeferencing was cornered because it was unable to locate these targets; an automatic georeferencing was hence carried out by using the retro-reflecting targets of the TLS instrument which were automatically detected and identified by the supplied software. For each front an average of 20 targets appropriately distributed was recognized. On the collapsed area, a data registration procedure, based on the spin-images algorithm, was improved by means of the use of a multi-resolution method that was be able to generate a pyramid of spin-images in order to speed up the matching phase between the adjacent scans (12). An rms included in a range from 0.001 to 0.008 m for almost all the tie points was obtained. Figure 5 shows the point cloud image carried out to Verdi Street situated in front of Palazzo Edilizia.

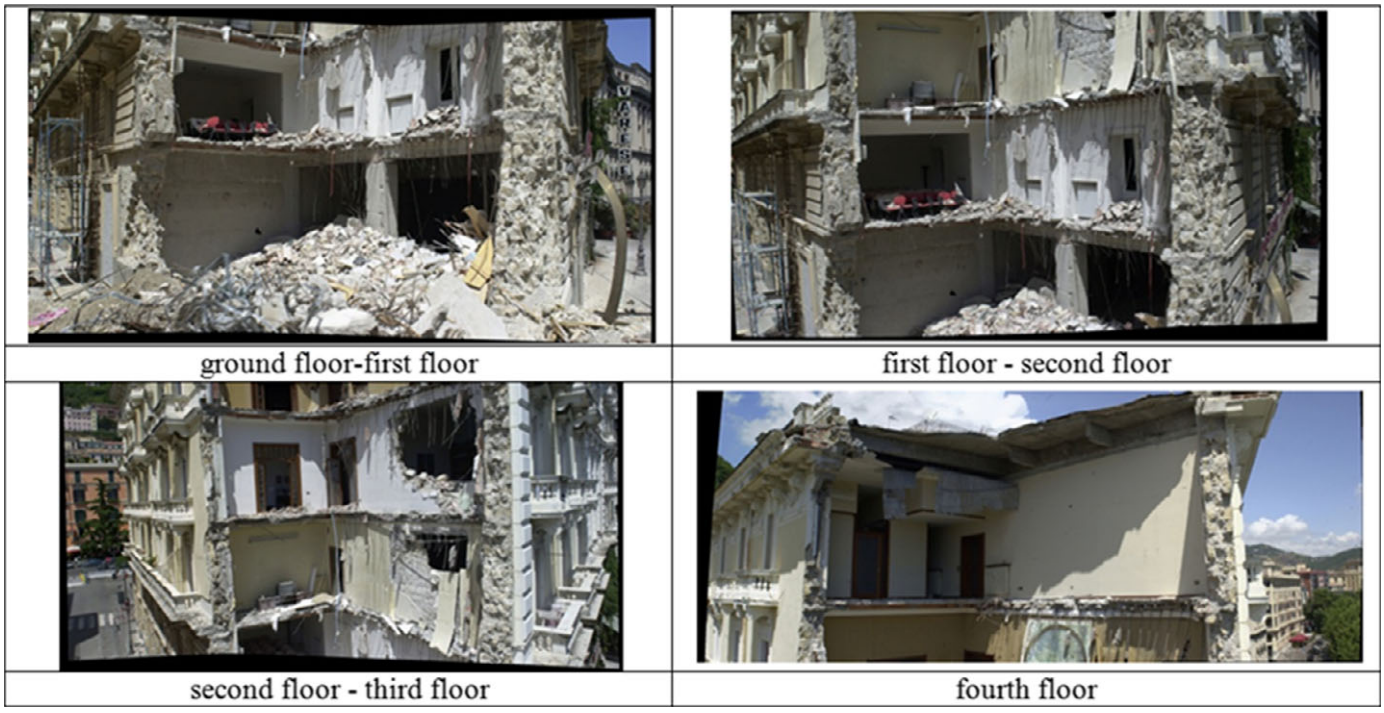
FIG. 6—*Ortho-photos of collapsed corner.*

Simultaneously, a photogrammetric survey of the collapsed corner was performed both for production of ortho-photos (Fig. 6) and for the integration of more complex elements of the collapsed area that, in connection to the considerable morphological variability had shown significant gaps in the laser scanning data processing (13,14).

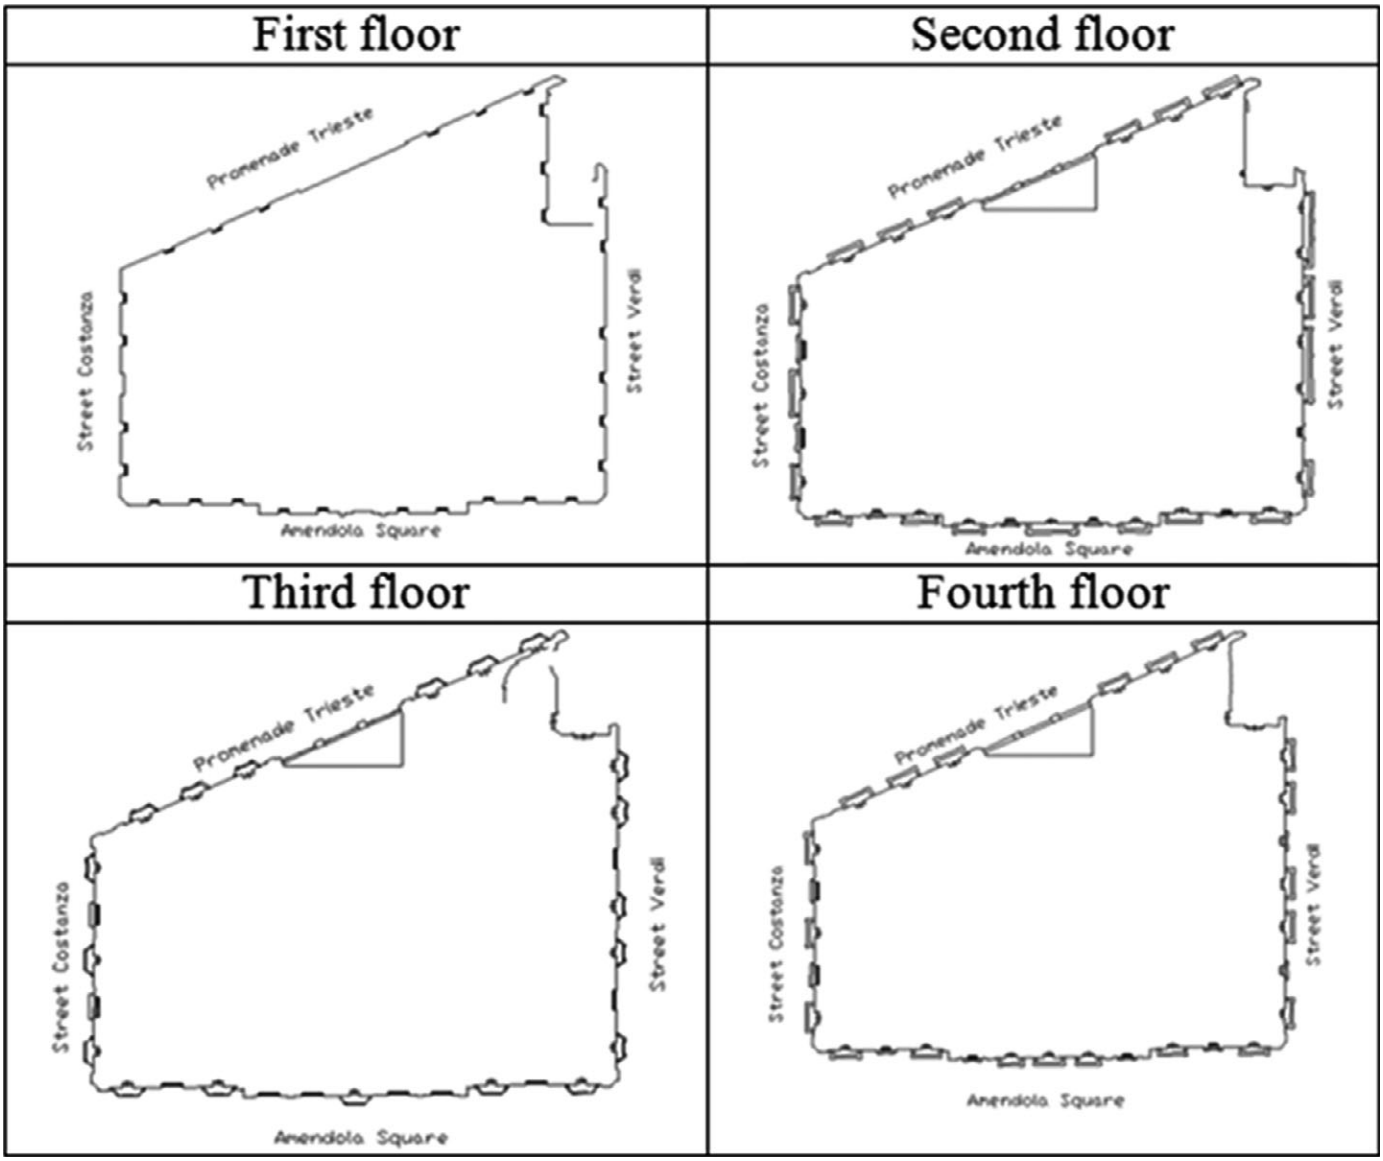
FIG. 8—*Planes for various tiers.*

The interpolation error was proportional to the distance between data points, raised to the n^{th} power. In order to manage all the digital information defined by the algorithm in a CAD environment, a further proceeding to save the results in the dxf format was carried out. For each file related to a 3D polyline in which each element of the line is identified by X, Y, and Z coordinates, the proceeding, by means of the corresponding polyline and N vertices, was able to create a dxf file. The continuous 2D information worked out from the data that had been acquired by means of the laser scanner surveying of the building were used to identify a suitable methodology for a correct 3D modeling. Starting from the vector data corresponding to the planes placed at various levels and some sections planes and integrating them with appropriate information the authors were able to produce a set of drawings suitable as reference in the technical consultation, as aforementioned. Specifically these are the planes of various tiers (Fig. 8), meant as horizontal sections planes of the building, made at some significant levels, and then projected at right angles to a horizontal reference plane which corresponded to the floor.

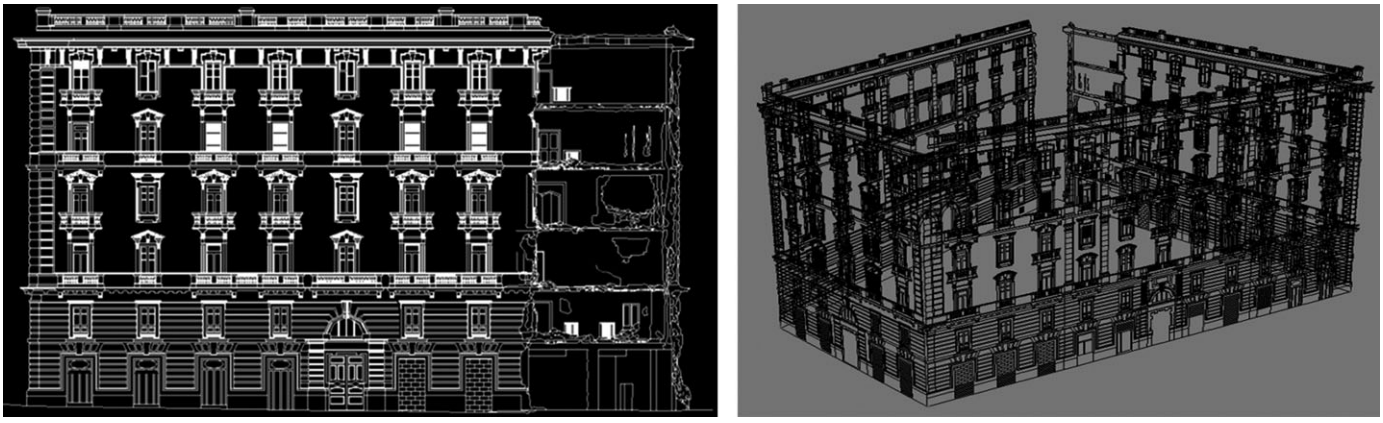
FIG. 9—*Prospect to Verdi Street (left) and Reconstruction vector (right).*

Furthermore, for each front of the building, the related prospect was carried out, and a reconstruction vector was simulated (Fig. 9).
