Morphological analysis of as-manufactured filament wound composite cylinders using contact and non-contact inspection methods

Morphological Analysis of As-Manufactured Filament Wound Composite Cylinders Using Contact and Non-Contact Inspection Methods

Emanuela Natale¹, Antonella Gaspari², Luciano Chiominto^{1*}, Giulio D'Emilia¹, Antonios G. Stamopoulos¹

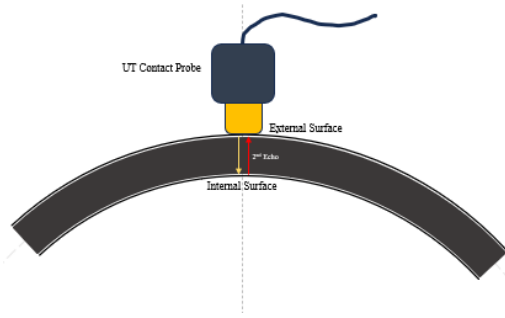
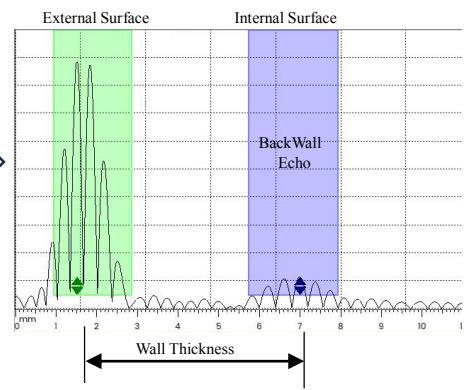
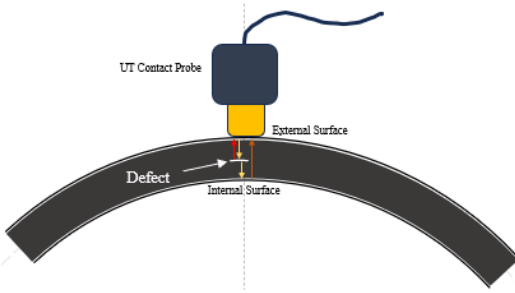
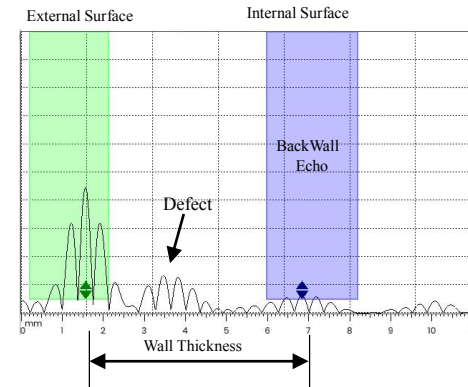
Fig. 7: Schematic description and the corresponding A-scan for the case of a cylindrical, filament wound, composite structure without (a) and with a discontinuity (b).

The 2 typical cases of the signal received are presented in Fig.7 for the case of a filament wound structure with and without defect, stating a typical pulse-echo analysis. The first peak of the A-scan corresponds to the external surface while, in the case of the presence of a defect such as a delamination or a gap, there can be observed 3 peaks where the 2nd one corresponds to the discontinuity.

As seen in Fig.7, the time of flight (ToF), that is the time required for the ultrasound to travel throughout the composite structure, is utilized for the calculation of the thickness. The thickness values may be obtained by the distance between the first peak and the backwall echo. Also considering the complexity of the filament wound structure, multiple defects in more than 1 level through the thickness may be present. This fact may affect the calculation of the overall wall thickness of the composite cylinder due to the presence of multiple peaks that make almost the back wall echo almost undetectable. In this case, the value of the backwall echo was taken by linear extrapolation using the values of the previous and the next point of measurement. The distribution of the wall thickness across the 2 longitudinal lines of the 2 cylinders are presented in Fig.8. As seen in all the cases, there is an oscillation of the first echo caused by the roughness of the external surface of the interlaced tows. On the other hand, the backwall echo appears to be stable mostly between the 5th and 22nd points of the measuring lines that correspond to the central part of the cylinder, also considering the presence of hoop wound tows that are highly compacted to the mandrel compared to the external helical ones.
