Three dimensional integrated survey for building investigations

CASE REPORT**ENGINEERING SCIENCES***J Forensic Sci*, 2015

*Domenica Costantino,¹ Ph.D.; and Maria Giuseppa Angelini,¹ Ph.D.***Three-Dimensional Integrated Survey for Building Investigations**

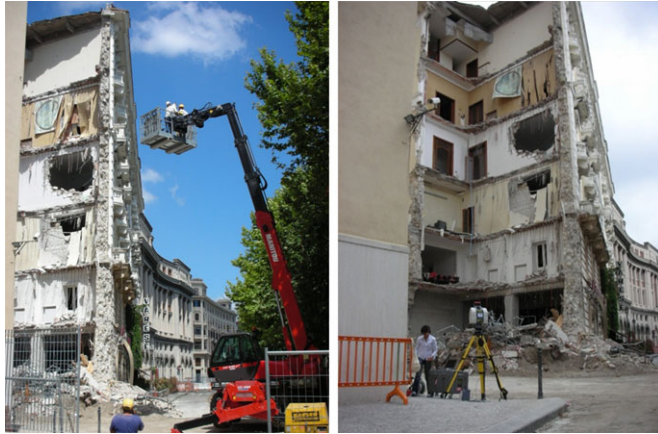
FIG. 3—Photogrammetric and laser survey with telescopic handler and station on the ground.

TOU (Fig. 3- left side) was used. This machine is able to safely operate in work configuration of off-road tires or stabilizers and reaches heights of up to 27 m in a complete safety; for the specific survey it was equipped with an aerial work platform. The MRT Easy has a stabilizer designed in order to ensure a perfect stability on any kind of terrain thanks to the support surface (4 × 4 m) which allows an excellent adaptation to any ground surface, and moreover the stability control is carried out by the measurement of the pressure exerted by the pads on the ground.

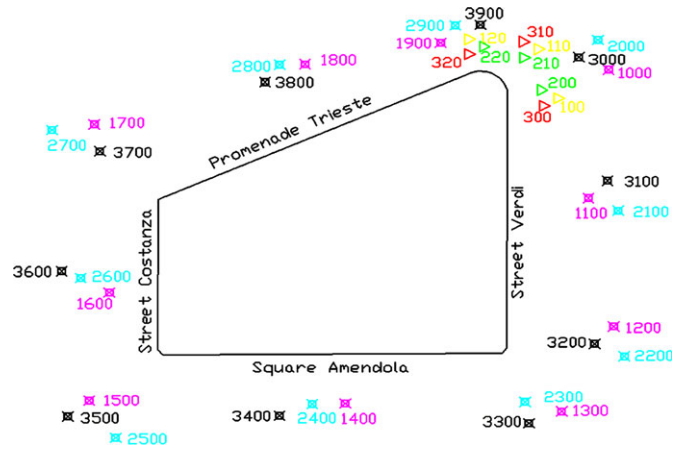
Scans were taken from 36 standpoints, placed at a distance ranging from 20 to 100 m from the building. The map in Fig. 4 shows the locations of the laser stations carried out during the survey. Specifically these locations are marked with a label specified by the numbers 1000, 2000, and 3000, respectively, for the first level (on the road corresponding to approximately zero quota), the second one (about 8 m from the ground), and the third level (about 15 m from the ground). With the same criteria

FIG. 4—Laser stations locations.

labels specified by the numbers 100, 200, and 300 show the locations from which the laser survey of the collapsed corner was carried out.

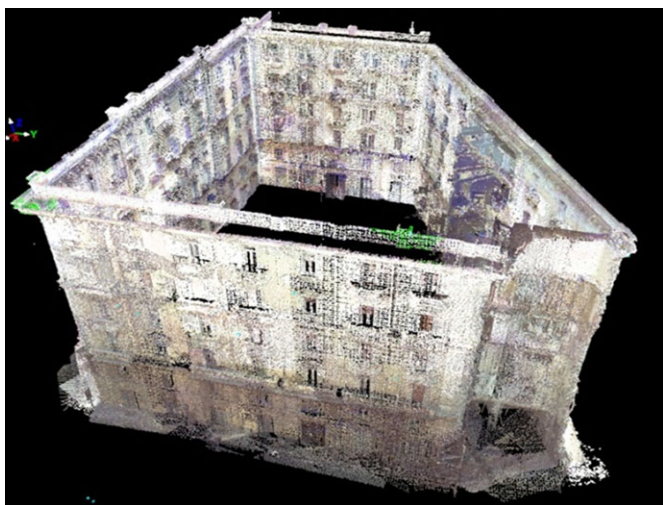
Data processing was performed by several softwares, and specifically by Cyclone, Geomagic, and others. After the phase of data filtering followed by noise removal, a process of alignment was performed for each front of the building was realized; this alignment was based on the recognition of the control points corresponding to the reflecting targets and natural GCPs (11). The georeferencing was cornered because it was unable to locate these targets; an automatic georeferencing was hence carried out by using the retro-reflecting targets of the TLS instrument which were automatically detected and identified by the supplied software. For each front an average of 20 targets appropriately distributed was recognized. On the collapsed area, a data registration procedure, based on the spin-images algorithm, was improved by means of the use of a multi-resolution method that was able to generate a pyramid of spin-images in order to speed up the matching phase between the adjacent scans (12). An rms included in a range from 0.001 to 0.008 m for almost all the tie points was obtained. Figure 5 shows the point cloud image carried out to Verdi Street situated in front of Palazzo Edilizia.

FIG. 5—Point cloud image to Verdi street front.

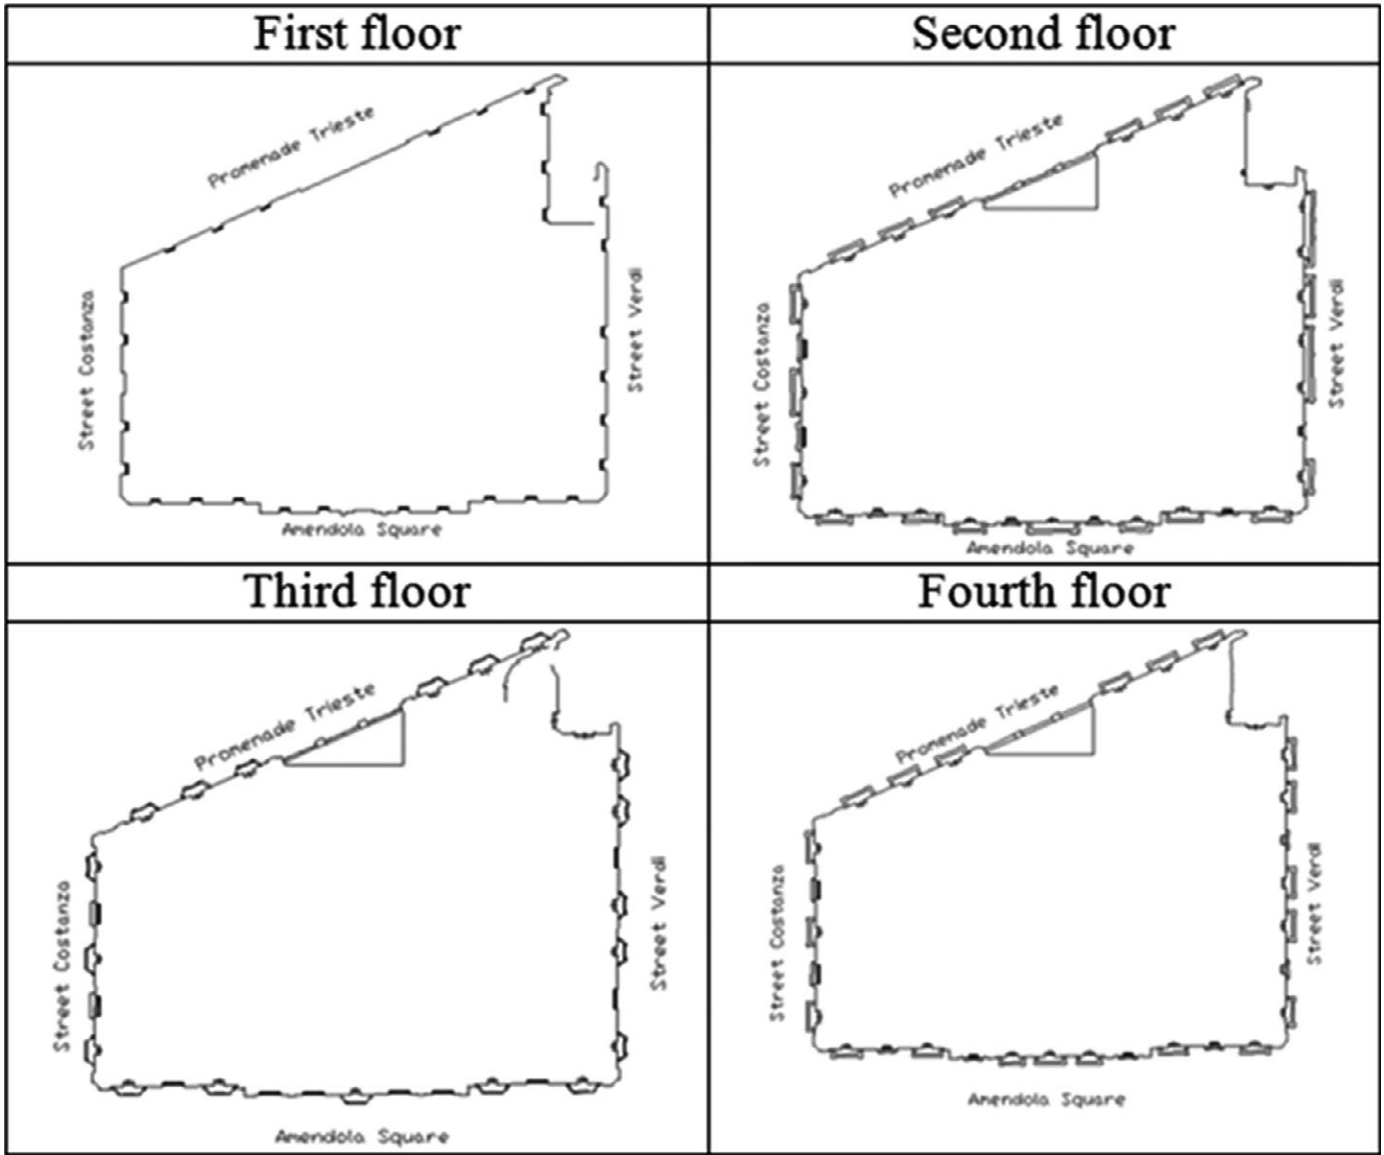
FIG. 8—Planes for various tiers.

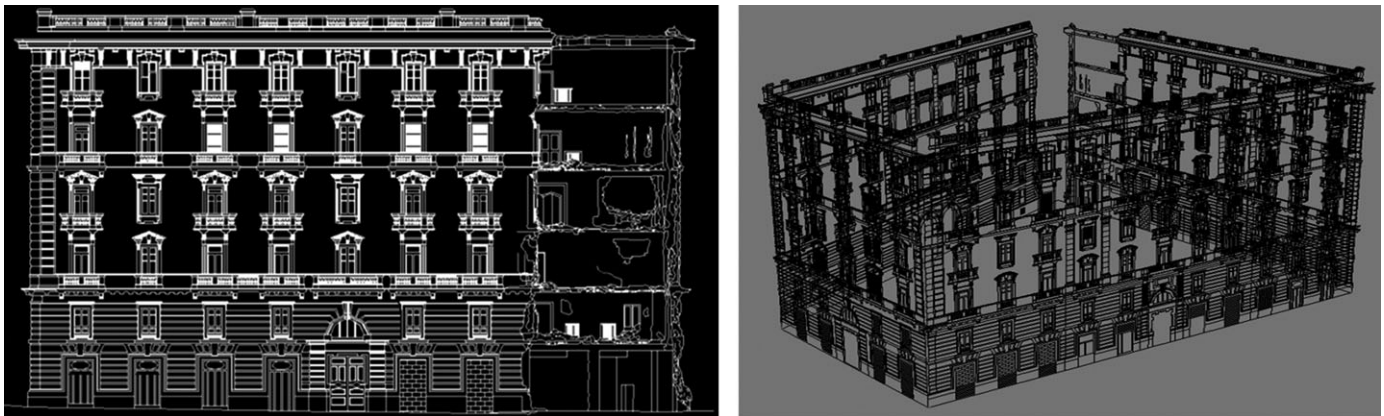
Furthermore, for each front of the building, the related prospect was carried out, and a reconstruction vector was simulated (Fig. 9).

FIG. 9—Prospect to Verdi Street (left) and Reconstruction vector (right).

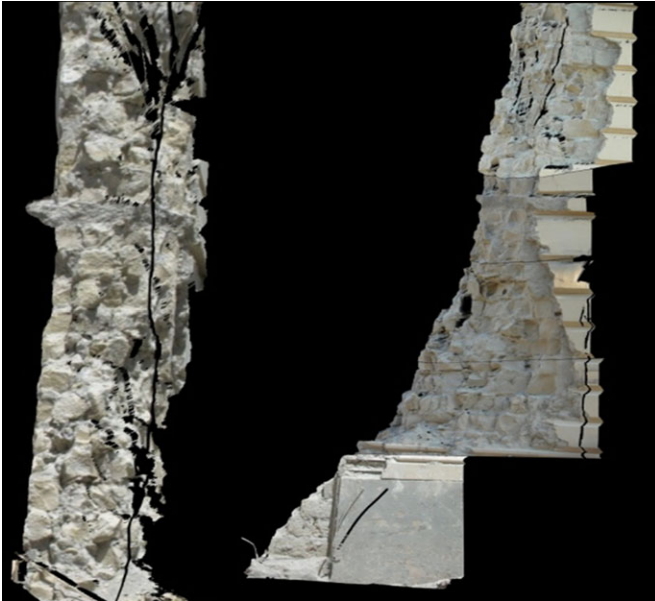
on the other hand, as a production of orthophotos using aligned and triangulated point clouds as a DEM. In the present case the melting of data is aimed to create a single 3D representation in which photogrammetric and laser scanning data are merged together so that the final product can be seamlessly explored. This kind of utilization of a 3D modeling can benefit from the use of both of the surveying techniques. For example, in the case of historical buildings, such as Palazzo Edilizia, 3D information about pretty regular parts of the structure can be deduced by photogrammetry, while more interesting architectural details and areas with higher surface curvature can be reconstructed by means of laser scanning data. In this case the texture processing was used to provide a detailed 3D structure of the most significant areas for the investigations. Specifically, a survey was carried out for all the areas of the masonry where the detachment had occurred. Some rectification work were also necessary in order to put together several images in only one photo, playing also with brightness and contrast of the images, to define an homogeneous texture (19). The results of the texture process are showed in Fig. 10.

FIG. 10—Rectified texture.
