Observations from the 26th November 2019 Albania earthquake: the earthquake engineering field investigation team (EEFIT) mission

Fabio Freddi¹ · Viviana Novelli² · Roberto Gentile^{1,3} · Enes Veliu⁴ · Stoyan Andreev⁵ · Anton Andonov⁵ · Federica Greco⁶ · Emiljano Zhuleku⁷

Abstract

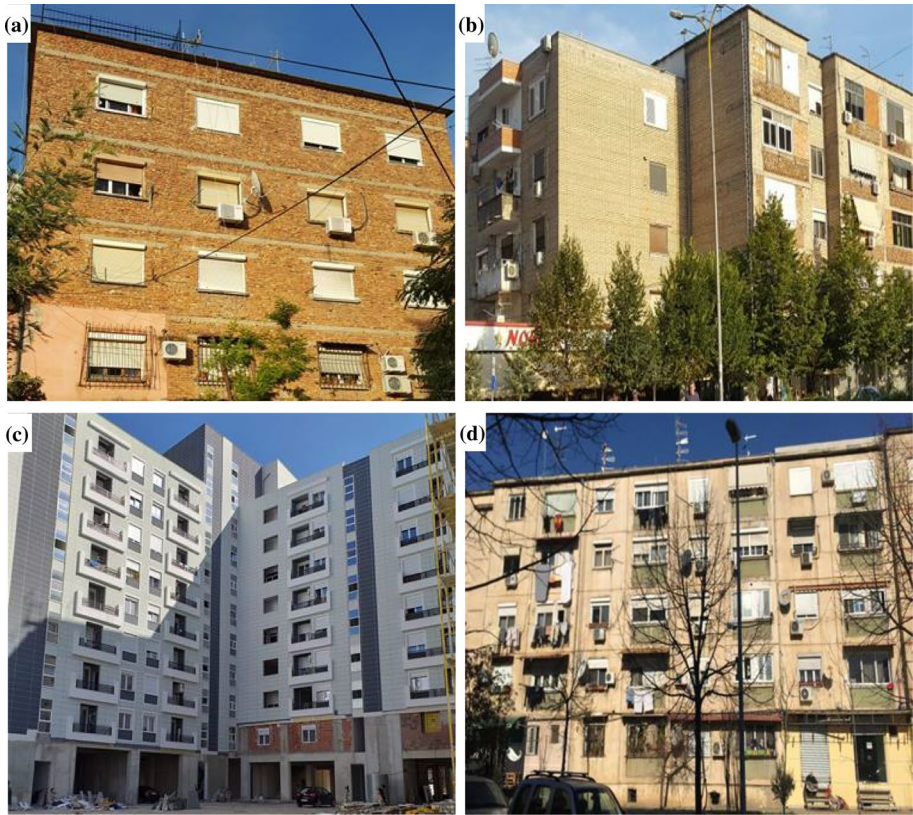
Fig. 5 Representative typologies of the multi-storey Albanian building stock: **a** unreinforced masonry building (URM) in clay bricks; **b** confined masonry (CM) building in silicate bricks; **c** new reinforced concrete (RC) building (under construction); **d** prefabricated large-panel building

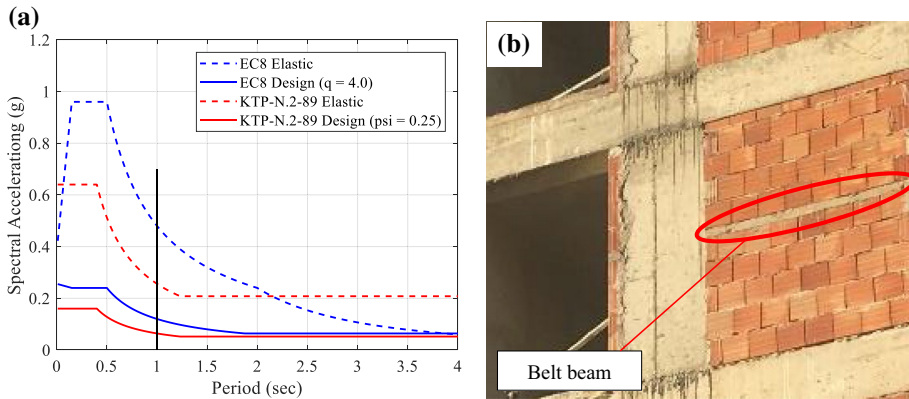
Fig. 11 **a** Comparison of the elastic and design spectra for one representative site according to the KTP-N.2-89 and the Eurocode 8; **b** belt beam for infill panels in Typical 2010+ multi-storey RC buildings

3. Absence of stiffness requirements i.e., no considerations regarding Damage Limit State (DLS) checks. This aspect could be considered the most evident difference between the KTP-N.2-89 and the Eurocode 8 and is the main one that, in this occasion, affected the seismic response of multi-storey RC buildings. This aspect shows that insufficient consideration is made to the damage of the building under low-intensity (i.e., frequent) earthquakes, which is generally concentrated in the infill panels (for the considered building typology). However, attention is paid to the out-of-plane behaviour of the infills by the introduction of belt beams as shown in Fig. 11b.

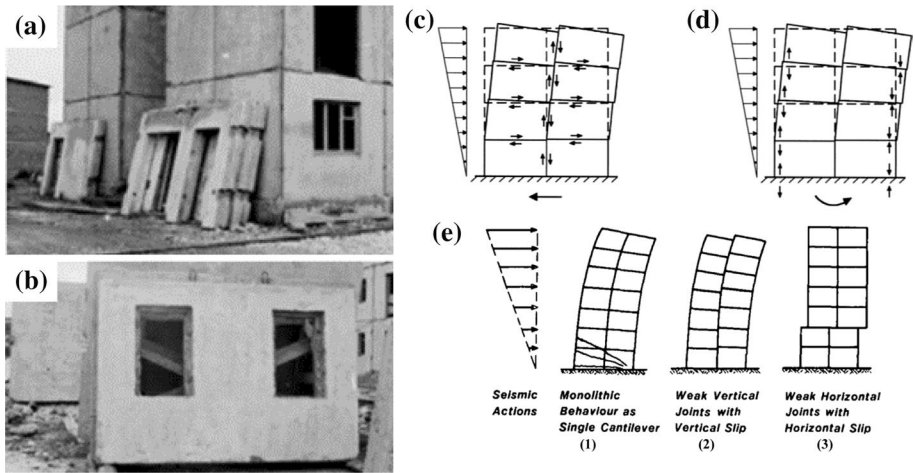
Fig. 16 **a** and **b** Large-panel buildings in Albania; **c** in-plane shear forces of prefabricated wall; **d** in-plane tensile and compressive forces of prefabricated wall. **e** Different behaviours and possible failure modalities. Based on Abazaj (2019), fib Bulletin 43 2008 and UNDP/UNIDO 1985

have monolithic behaviour under lateral load as shown in Fig. 16e, and the structural damage will be concentrated in the form of diagonal cracks in the panels. However, in prefabricated concrete wall systems there may be significant slip (shear displacements) along the vertical and horizontal joints. Figure 16e also shows horizontal actions applied to a large-panel cantilever wall in which slip has occurred along both vertical and horizontal joints due to shear forces transferred along these joints. The effect of slip along the horizontal and vertical joints is to reduce the stiffness of the system. It is difficult to say which will be the prevailing seismic response and failure mode of large-panel walls under earthquake loads. The observations in past earthquakes in Romania, Armenia and Bulgaria suggest that slippage between panels is likely to occur since most of the reported damage was in the form of horizontal and vertical cracks in the interfaces between panels. This situation with ‘strong panels—weak joints’ is also related to the high-quality control of the prefabricated elements which provides the prefabricated panels with a high concrete resistance. However, the situation with ‘strong joints—weak panels’ cannot be excluded and should be checked during the assessment procedures. In addition, in the most common situations with ‘strong panels—weak joints’, the slippage and rocking between panels, is likely to provide a significant friction damping which is beneficial for the seismic performance of these structures and could be one of the reasons for the good seismic performance of large-panel buildings observed in past earthquakes.

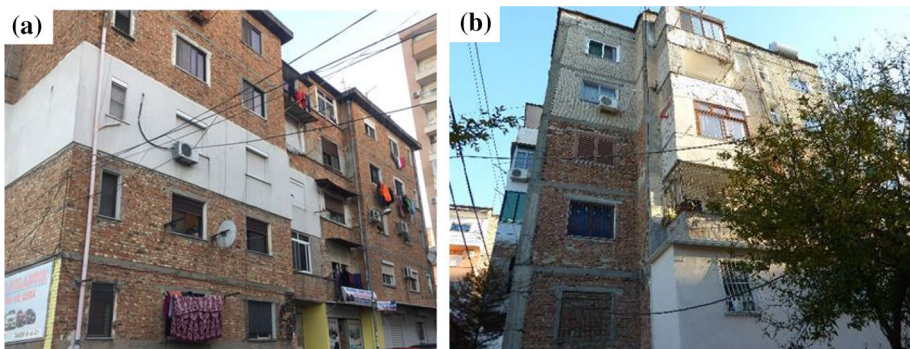
Fig. 17 Typical 5-storey **a** unreinforced masonry (URM); **b** concrete-masonry (CM) buildings in Durrës

The major deficiencies observed for these buildings are related to irregularities in elevations due to unauthorised interventions such as the closure and creation of new openings, use of different masonry for reparation, and introduction of additional floors carried out by the owners of the single dwellings as showed respectively in Fig. 19a–c. These alterations, together with the lack of maintenance, degradation of the mechanical properties of the material, and change of the load paths, can become the origin of damage and deteriorations, which may increase the seismic vulnerability of the structure over its lifetime.

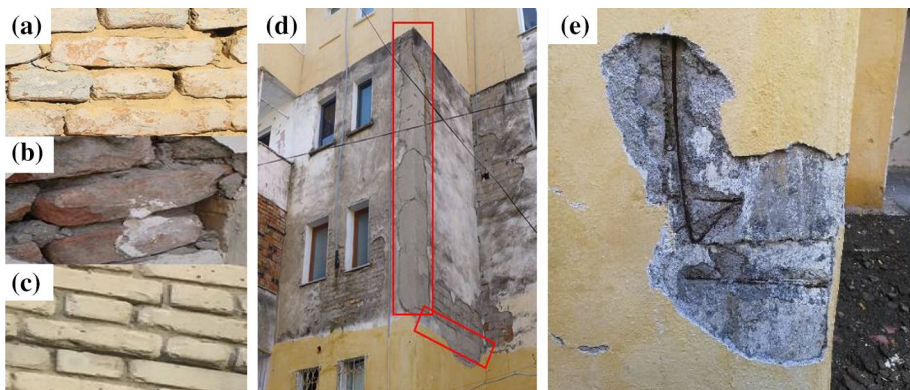
Fig. 18 Typical bricks for load bearing walls. Solid clay bricks with **a** silicate mortar, **b** cement mortar, and **c** silicate bricks with silicate mortar. Details of concrete-masonry (CM) buildings, **d** reinforced concrete columns and beams, **e** reinforcements
