## Morphological analysis of as-manufactured filament wound composite cylinders using contact and non-contact inspection methods

Morphological analysis of as-manufactured filament wound composite cylinders using contact and non-contact inspection methods / Natale, E., Gaspari, A., Chiominto, L., D'Emilia, G., Stamopoulos, A.G.. - In: ENGINEERING FAILURE ANALYSIS. - ISSN 1350-6307. - STAMPA. - 158:(2024). [10.1016/j.engfailanal.2024.108011]

# Morphological Analysis of As-Manufactured Filament Wound Composite Cylinders Using Contact and Non-Contact Inspection Methods

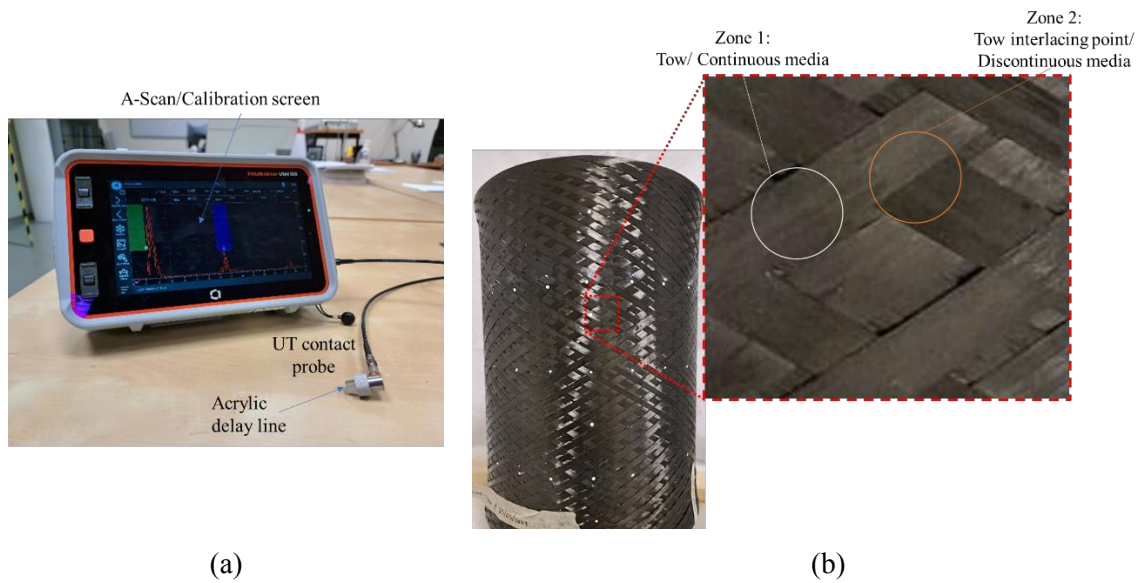
Fig. 2: The Waygate USM 100 ultrasound inspection system utilized in the present work(a) and the details of the scanned zones of the interlaced tows (b).

MHz. For the damping resistance, the only available options were 50  $\Omega$  and 400  $\Omega$ . Also considering the complexity of the filament wound structure, the interlaced tows are introducing a complex surface that is composed of rhomboidal units that are repeated. This outer surface may introduce further difficulties on the applicability of the contact ultrasound system. Therefore, measurements were carried out on 2 different zones, namely on the distinct tow surface and on the gap between interlaced tows as seen in Fig.2(b). The interlaced zone was found to increase the noise of the measurement and altered the obtained A scan. Therefore, to eliminate any interference of the morphology of the interlaced tows, Zone 1 was selected for further assessment of the characteristics of the filament wound structure.

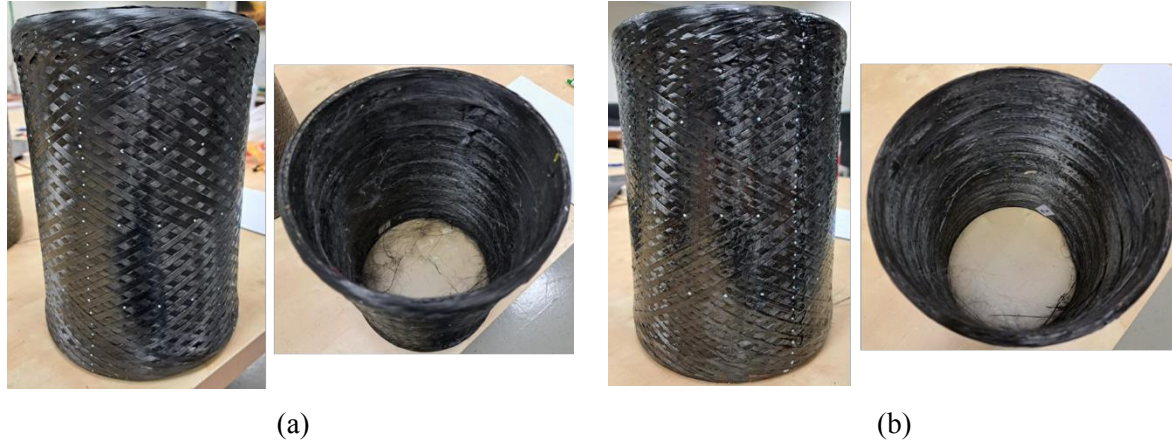
The 2 filament wound cylinders studied in the present work are reported in Fig.5. For excluding the influence of several fabrication parameters and for assessing the repeatability of the manufacturing method, they are both wound by the same carbon/epoxy system, same material quantity, nominal winding angle and deposition parameters. They both consist of 1 layer of hoop wound prepreg tows while the rest is helicoidally wound, as described in section 2 of the present work.

Fig. 5: The cylinder A (a) and B (b) studied in the present work.

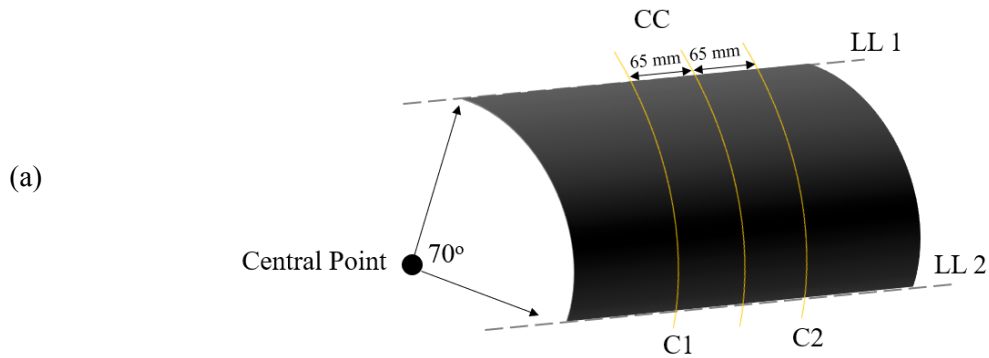
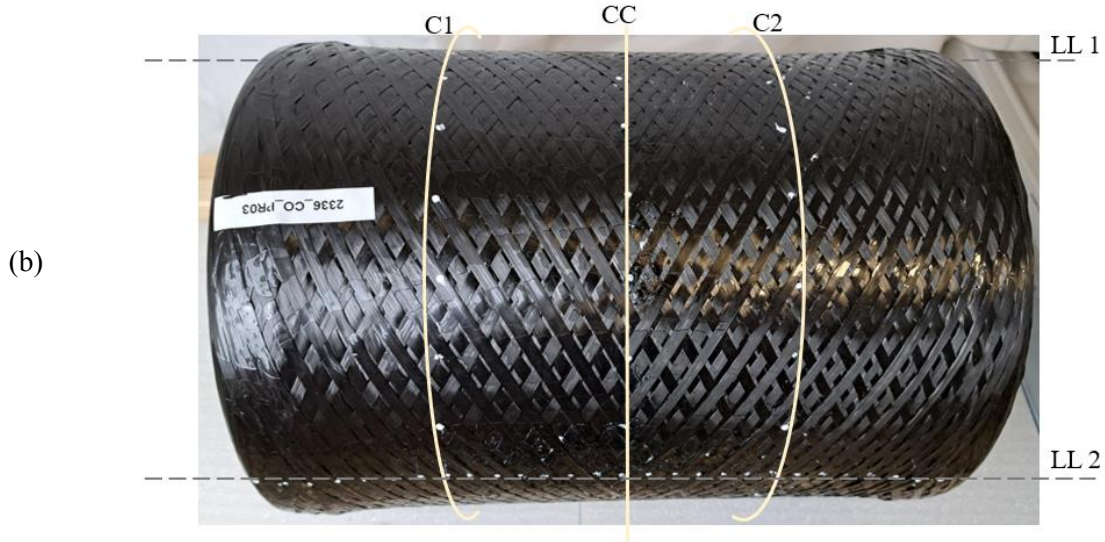
Both components are inspected using the ultrasound system and the vision system to study their thickness trend and the winding angle variation. For performing the thickness measurements, the 2 cylinders were divided into distinct zones, 2 lines (LL) parallel to the longitudinal axis and 3 circumferences, as seen in Fig.6 (a). Therefore, also considering the notable dimensions of the tubes, a grid was introduced through which the necessary measurements are conducted locally. The 2 longitudinal lines, namely LL1 and LL2, are considered at approximately  $70^\circ$  distance between them and are composed of 29 points, presented in Fig.6 (b) with the white spots, that cover the whole length of the tube, each of them 10 mm distant from the subsequent one.

*Fig. 6: The subdivision of the component into distinct zones of measurements*

For the circumferential measurements 3 slices were considered, namely the central circumference (CC), the top (C1) and bottom one (C2), as seen in Fig.6. The CC corresponds to the most central circumference of the cylinder since it is considered at half of the length of the cylinder. The C1 and C2 are placed 65 mm left and right respectively, as seen in Fig.6 (a). Each of the circumferences is composed of 22 points every  $16^\circ$  approximately, as seen in Fig.6 (b). As explained in Section 2.2.1 of the present work, the measurements were conducted in zones on the top of an external tow, avoiding discontinuities of the material that could potentially affect the quality of the ultrasound. For calibration purposes, the point where the front and backwall of the ultrasound are detected without any severe defects was considered as reference. In the present case, the nominal thickness value was 5.5 mm. The measurement was provided by a high-precision micrometer.
