Assessment of landslide damage to buildings at the urban scale

Assessment of landslide damage to buildings at the urban scale / Palmisano, Fabrizio; Vitone, Claudia; Cotecchia, Federica. - In: JOURNAL OF PERFORMANCE OF CONSTRUCTED FACILITIES. - ISSN 0887-3828. - STAMPA. - 32:4(2018). [10.1061/(ASCE)CF.1943-5509.0001201]

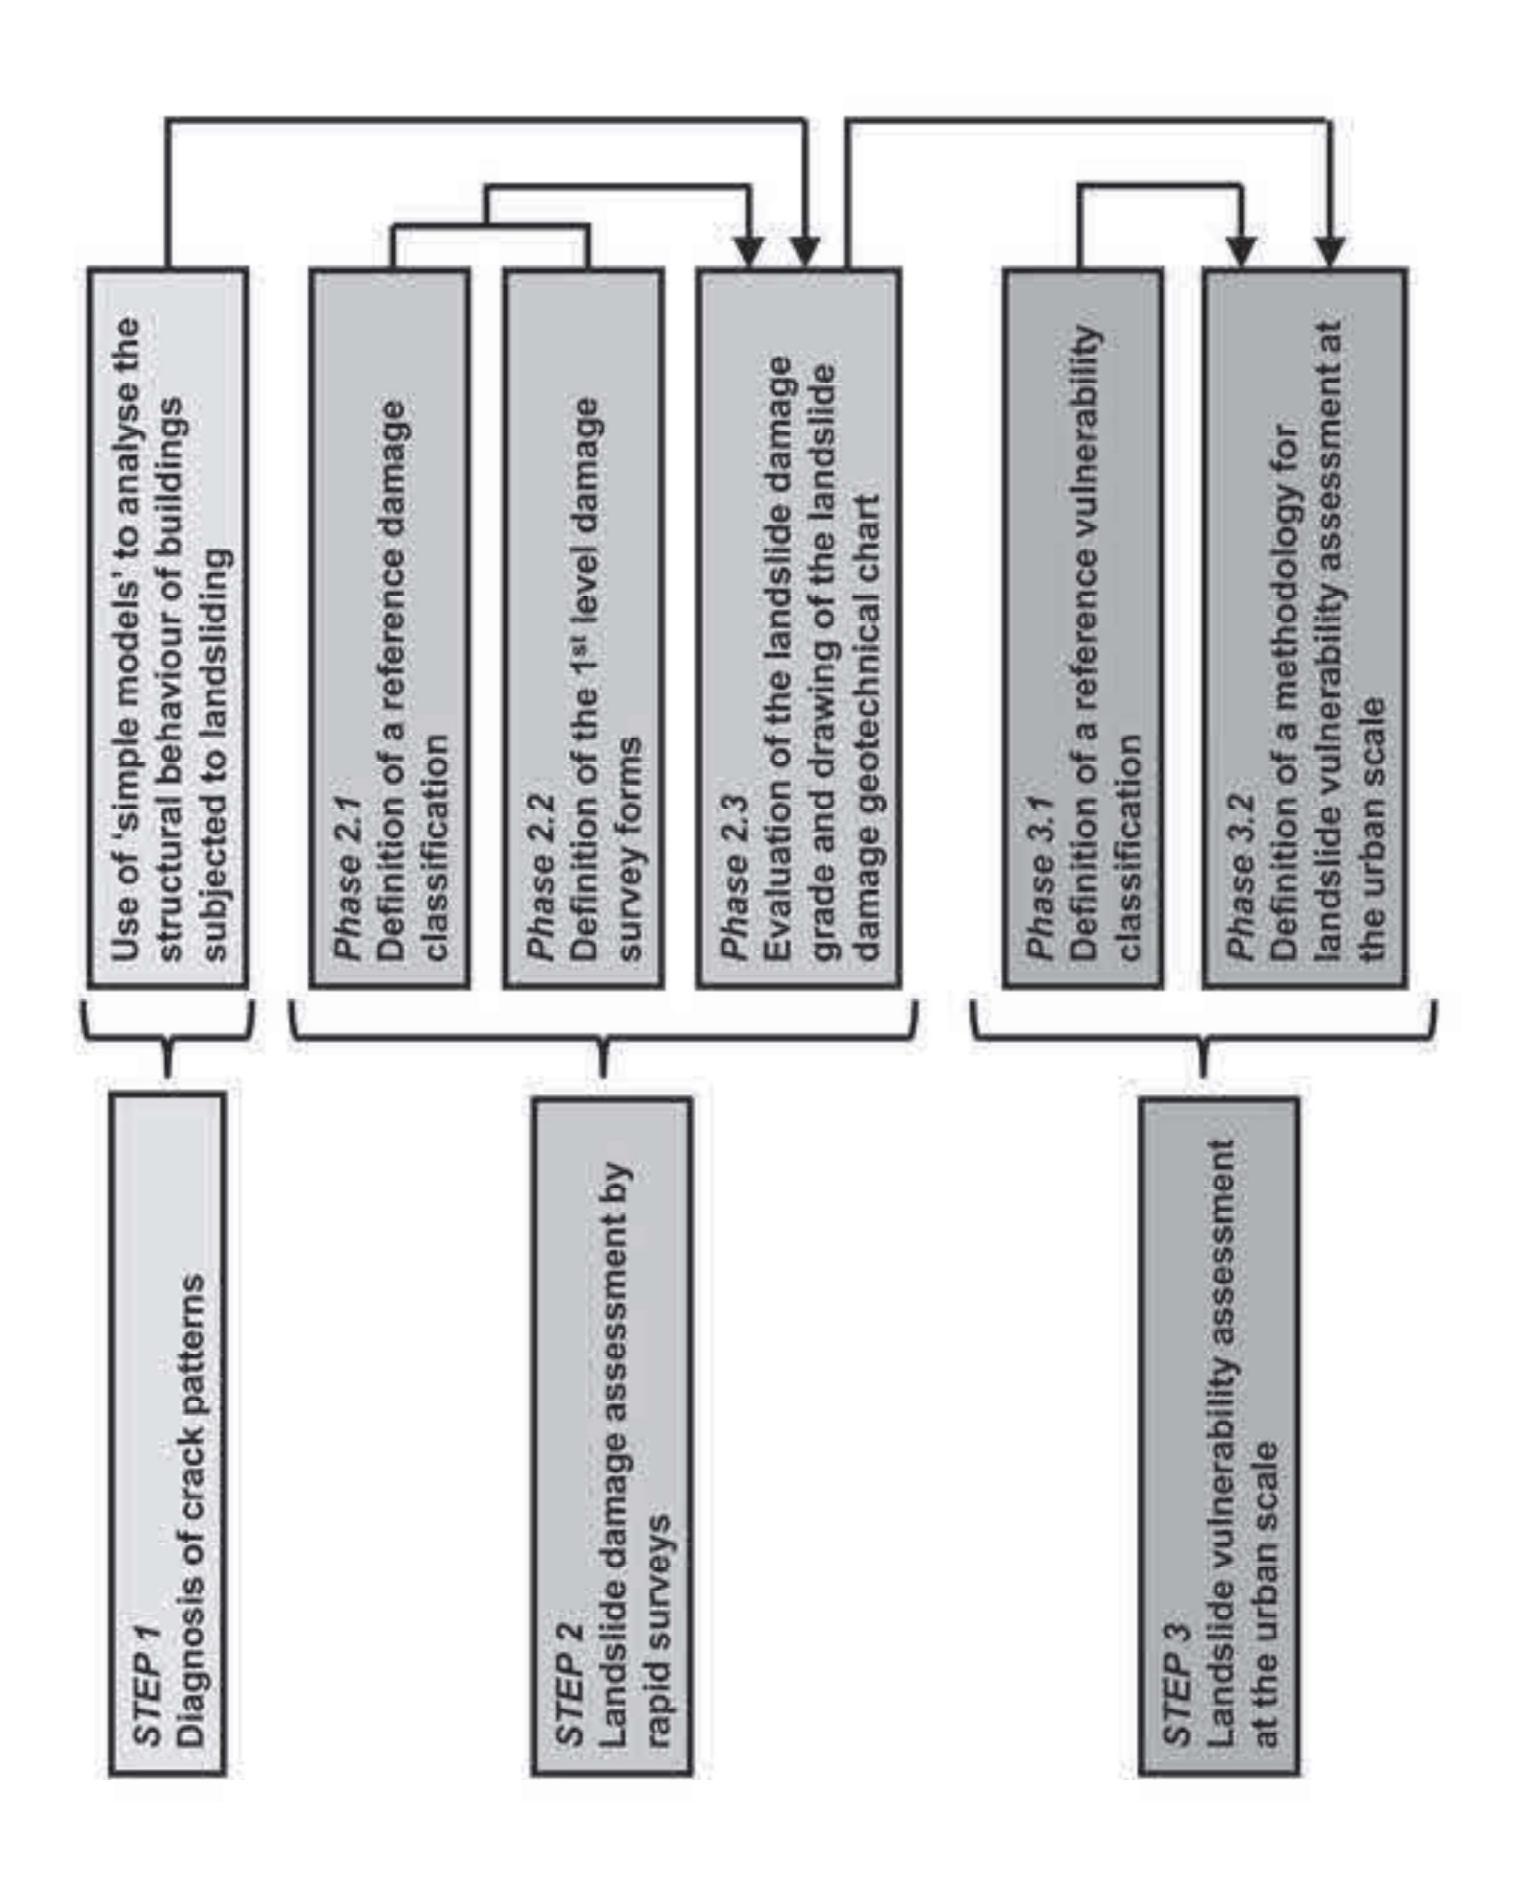
- 63 Level 1. The vulnerability assessment at this level can be developed through the work • 64 steps reported in Fig. 1 and it covers all the buildings across the area under study. 65 Given the scale of analysis, it should be based on information of easy acquisition, such 66 as general building data (e.g., construction year, structural typology, use), and on the 67 results of visual inspections of the building conditions. The accomplishment of Level 1 68 assessment results in: i) the assignment of both a damage grade and a first instance 69 vulnerability grade to each building; ii) the sorting out of the buildings at 'highest 70 vulnerability'.

78 This article focuses on Step 2 of the Level 1 approach (Fig. 1) through the outline of an 79 original methodology for landslide damage assessment of ordinary (masonry and reinforced 80 concrete) buildings that can be applied at the urban scale. In the framework in Fig. 1, this Step 81 is preceded by Step 1 that frames the application of 'simple models' (Palmisano 2014; Roca 82 et al. 2011) to interpret the response of buildings subjected to foundation settlements. The 83 simple models are used to back-analyze observed crack patterns and derive the foundation 84 settlement geometry that may have, eventually, caused them. They should be based on 85 fundamental principles of structural mechanics, such as the limit theorems of plasticity, that 86 are valuable at this level, since they afford the description of the essential phenomena 87 controlling the structural capacity (Roca et al. 2011), despite being of relatively simple use. 88 Among this category of models, the Strut-and-Tie Model (Ritter 1899) and the Load Path 89 Method (LPM hereafter; Schlaich et al. 1987) have been successfully used for long time to 90 analyze reinforced and pre-stressed structures. By using the LPM, it has been possible to 91 define the most recurrent typologies of crack patterns that affect ordinary buildings subjected 92 to foundation settlements (Palmisano 2016b; Palmisano and Elia 2013, 2015). In Fig. 2 some 93 examples of simple crack patterns and damages to masonry and R.C. buildings due to 94 foundation settlements are shown. For more complex cases of LPM applications see also 95 Palmisano (2016b).

96 The *Level 1* methodology (Fig. 1) makes use of the characterization of the crack patterns such 97 as those in Fig. 2 to discern if the damage is due to foundation settlements. Moreover, it 98 should be noted that the back analysis of the crack patterns through LPM makes it possible to 99 derive also the settlement direction (Fig. 2). This information, when collected for several 100 buildings in the urban area, can be of use to recognize the morphology of a landslide body, 101 even when landslide features are hidden by urbanization or are unclear.

The damage assessment at the urban scale (Step 2, *Level 1* in Fig. 1), that is the main object of the present article, aims to provide rapid and objective data that, together with the geomorphological and the geotechnical ones, are fundamental for both the diagnosis of the landslide damage distribution across the territory and the vulnerability assessment (i.e., Step 3). This Step may be very useful in urban areas also to acquire indirect evidence of landslide activity, otherwise of difficult detection solely on geomorphological basis.

The third part of the proposed methodology (Step 3 in Fig. 1) benefits from the results of the previous steps and aims to assess the *Level 1* structural landslide vulnerability at the urban scale. In particular, the geometry and the structural and historical data about the buildings, acquired in Step 2, are used as input data for the evaluation of structural vulnerability, whereas the damage data are useful at this step to further support the characterization of landslide-structure interaction. This part of the methodology will be covered in a forthcoming article.

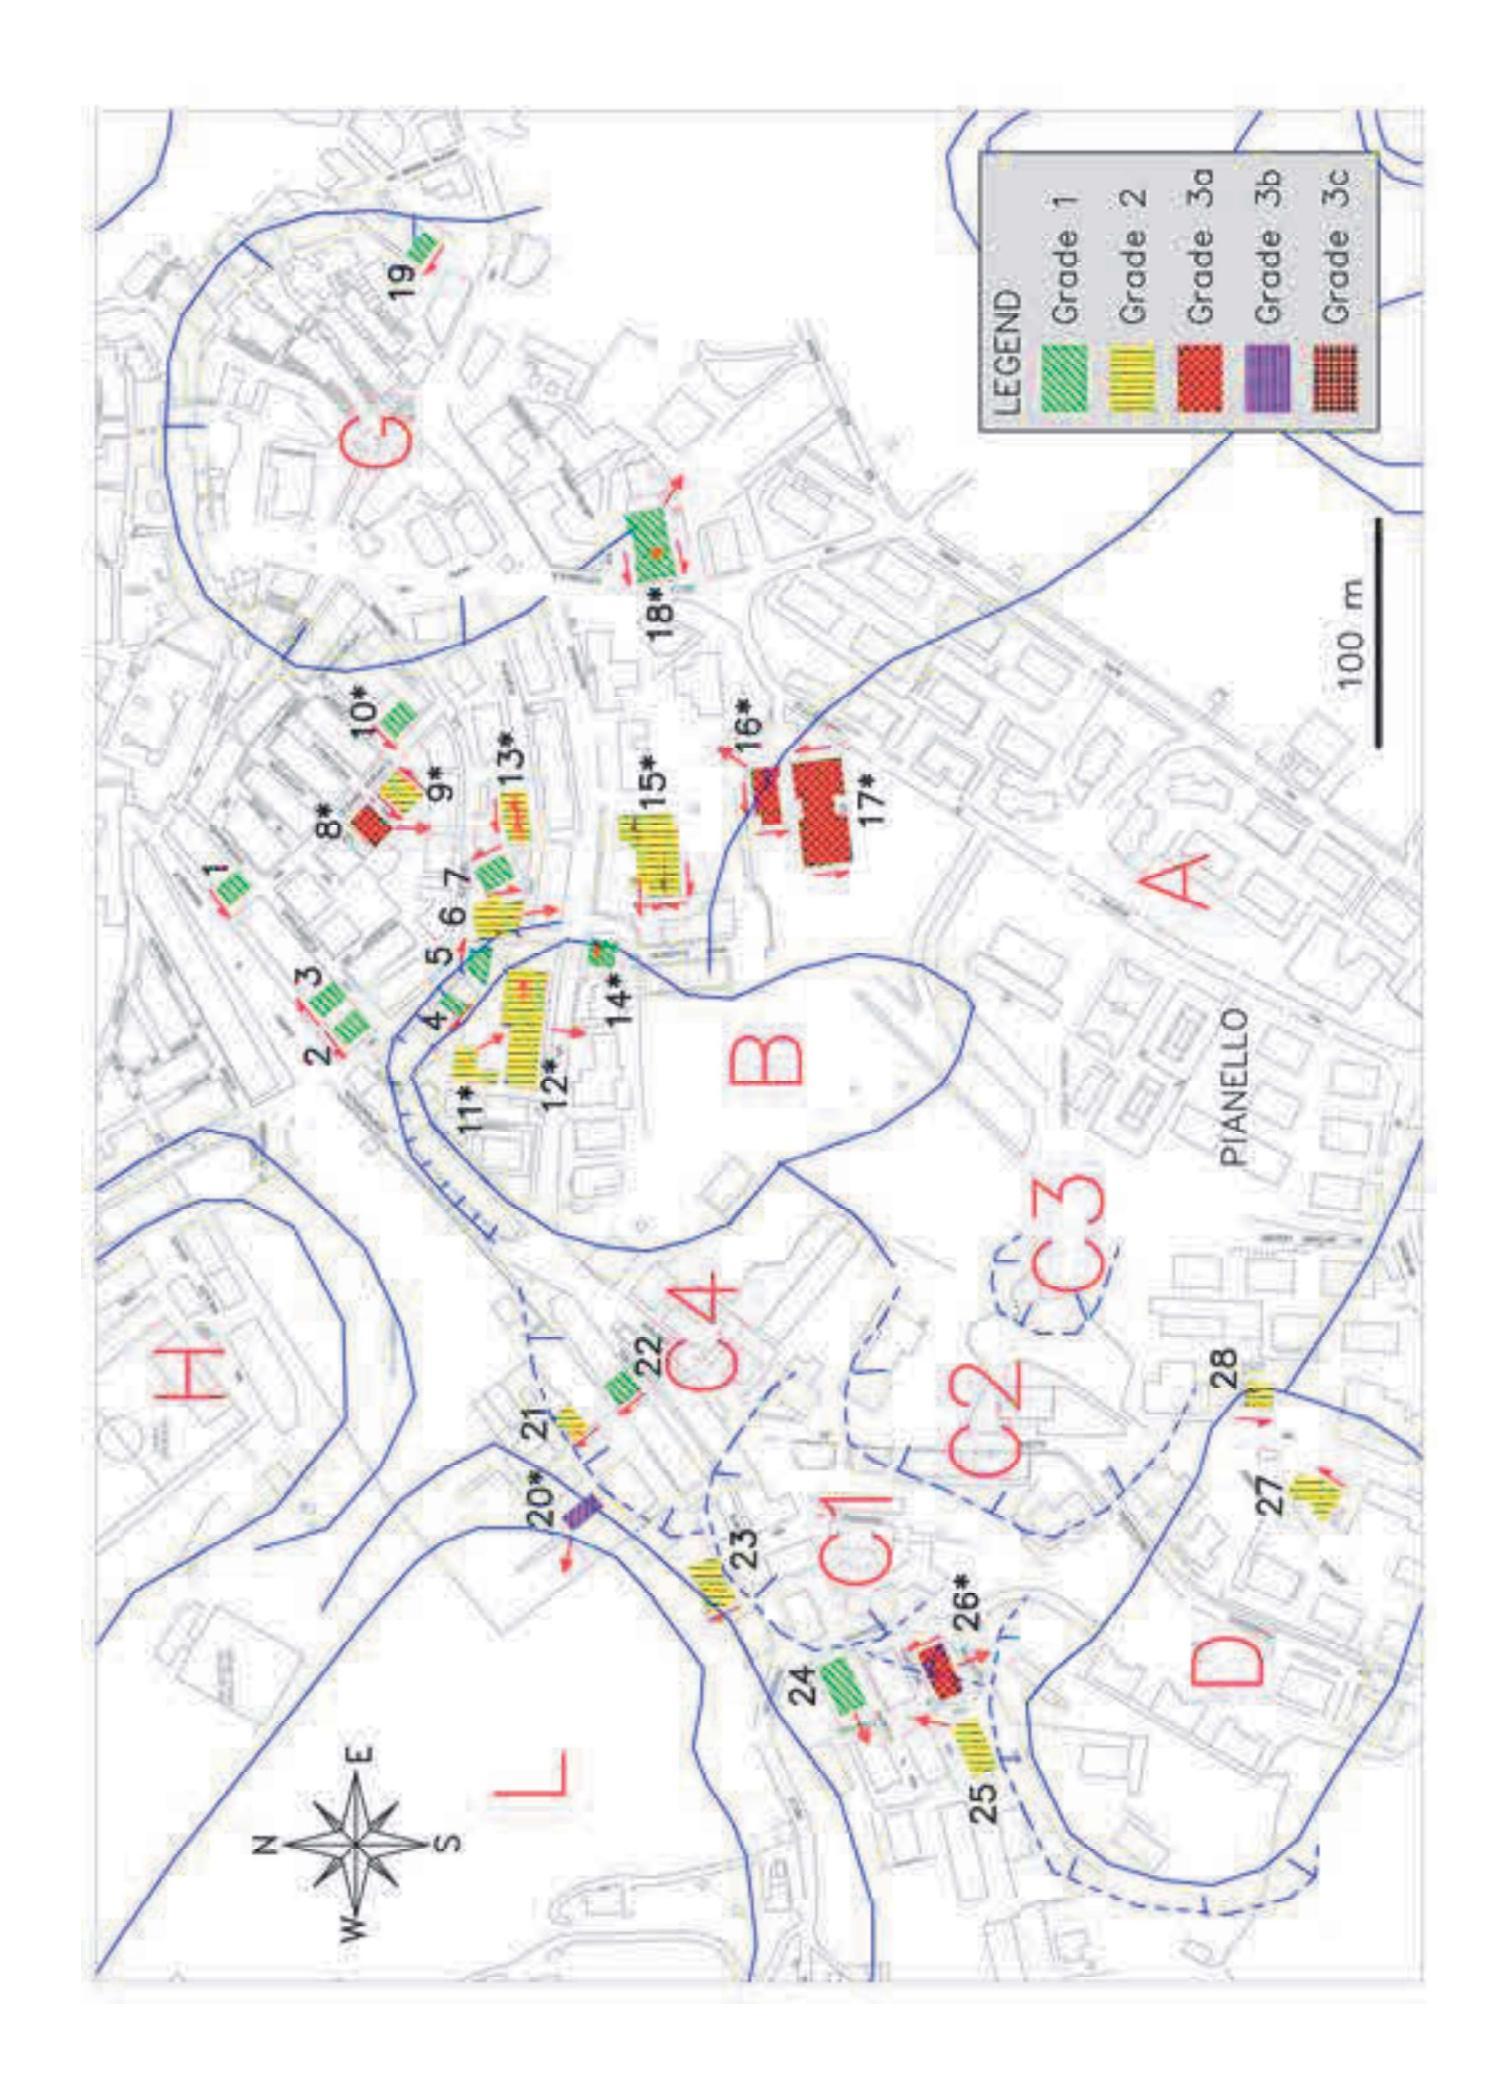
- boreholes (PS 119; a: inclinometers, b: piezometers); b) inclinometer readings along
- borehole I2.
- Figure 6. Landslide damage geotechnical chart of Bovino.

510 The results of the Level 1 analyses of both Steps 1 and 2 for Bovino are mapped in the 511 landslide damage geotechnical chart shown in Fig. 6. As result of the application of the 512 methodology, this chart reports not only the damage grade of the buildings, but also the 513 information concerning the direction of the settlements (arrows in the chart) reconstructed to 514 have caused the damage through the diagnosis of the crack patterns carried out by means of 515 the Load Path Method. The chart in Fig. 6 includes the damage grade only for those building 516 that, according to Section 8 of the forms, resulted to be damaged by foundation settlements. In 517 Fig. 7 some typical damage observed in Bovino are shown (the building numbers refer to 518 those indicated in Fig. 6).

The landslide damage geotechnical chart (Fig. 6) shows that most the damaged buildings is located either at the back or within the crown area, or on the lateral borders of the landslides. It follows that buildings located within the landslide body are likely to be mainly subjected to 'rigid-body' displacements, so that they do not exhibit any damage.

Among the damaged buildings in Fig. 6, those numbered as 10-13, 15-18, 23-24, 27 have R.C. structure while the others have masonry structure. Moreover, buildings 10-12, 15-17, 23 are public while the others are residential buildings. At the time of the surveys, buildings 16-17, 20, 26 were declared unusable by the municipality while in building 12 some retrofitting works were in progress.

556 The chart shows that, except for one case (i.e., the building 13 in Fig. 6), all the buildings 557 have shown crack patterns typical of lateral settlements. Even if this aspect requires further 558 investigation, a preliminary interpretation is proposed in the following. As mentioned above, 559 most of the damaged buildings are located either in the crown area or on the lateral borders of 560 the landslides. This means, firstly, that differential settlements within the landslide body are 561 not so large to produce structural damages. The main reason of this could be that building 562 dimensions are negligible with respect to the landslide settlement shape and, hence, 563 differential settlements are negligible. This consideration does not apply to the borders of 564 landslides where, in general, high values of differential settlement have been observed. 565 Moreover, on the borders a 'hogging' landslide settlement shape is activated, which could 566 justify why only crack patterns due to lateral settlements have been observed in Bovino (i.e., 567 typologies a-d and l of Fig. 2). The central settlement damages observed in the internal part of 568 building 13 (Fig. 6) can be, hence, suspected to be due to intrinsic structural defects of the 569 building (e.g., under-dimensioning of the foundations of the internal columns).

In some cases, the landslide damage geotechnical chart (Fig. 6) shows a strict correlation between the settlement direction and the main landslide movement (for instance see buildings 6, 11-12, 20, 23, 28 in Fig. 6). Moreover, when buildings are located on the lateral borders of the landslides some torsional movement is testified by the crack patterns (e.g., buildings 16-18, 26 in Fig. 6). As said before, landslide damage assessment at the urban scale may be very useful as indirect evidence of landslide activity in urban areas, since the assessment of landsliding in such urbanized contexts may result to be not easy if based solely on geomorphological studies.

At Bovino, the landslide contours in the chart in Fig. 6 result from geomorphological studies carried out up to 2010, whereas the structural damages are updated to 2013. This discrepancy in time clearly emerges from some discrepant results reported in the landslide damage geotechnical chart (Fig. 6). In particular:
