Advances damage detection techniques in historical buildings using digital photogrammetry and 3D surface analysis

Rosella Alessia Galantucci*, Fabio Fatiguso

Department of Civil, Environmental, Land, Building, and Chemical Engineering (DICATECH), Politecnico di Bari, Bari, Italy

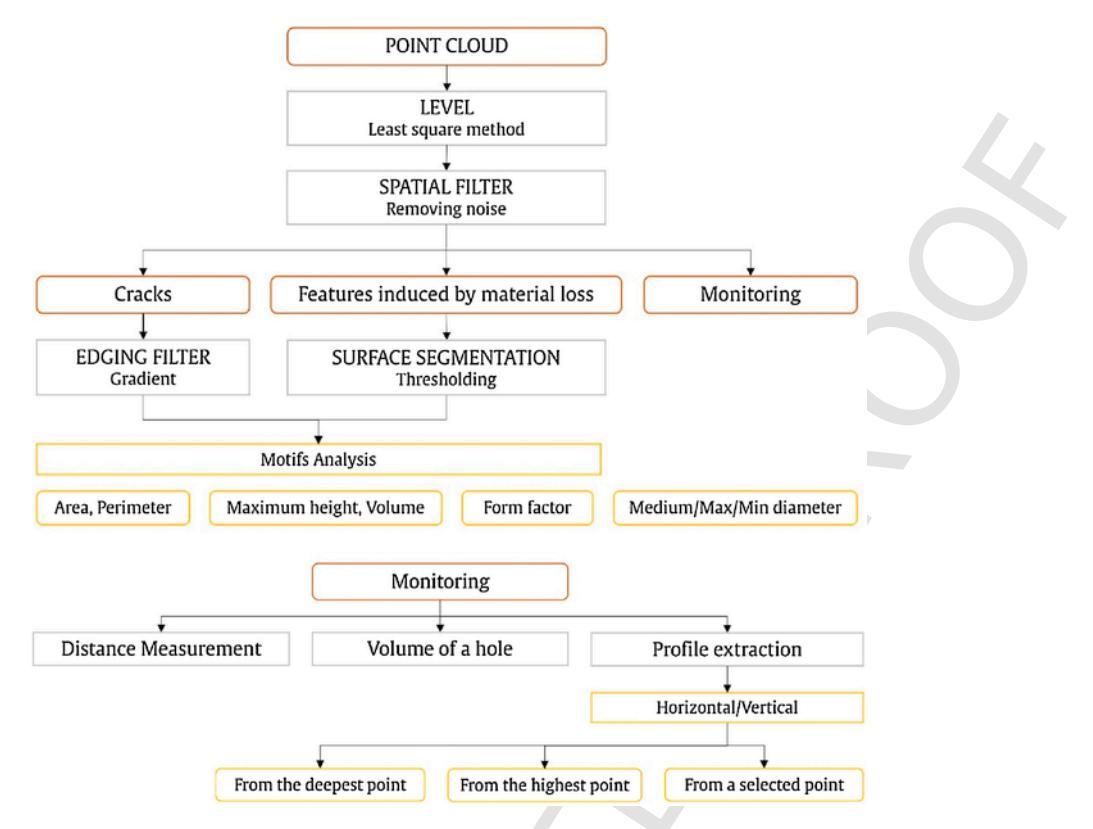
Fig. 1. Flow chart illustrating the sequence of operations composing the protocol, to obtain information on cracks or features induced by material loss; flowchart of the process proposed for monitoring the alterations.

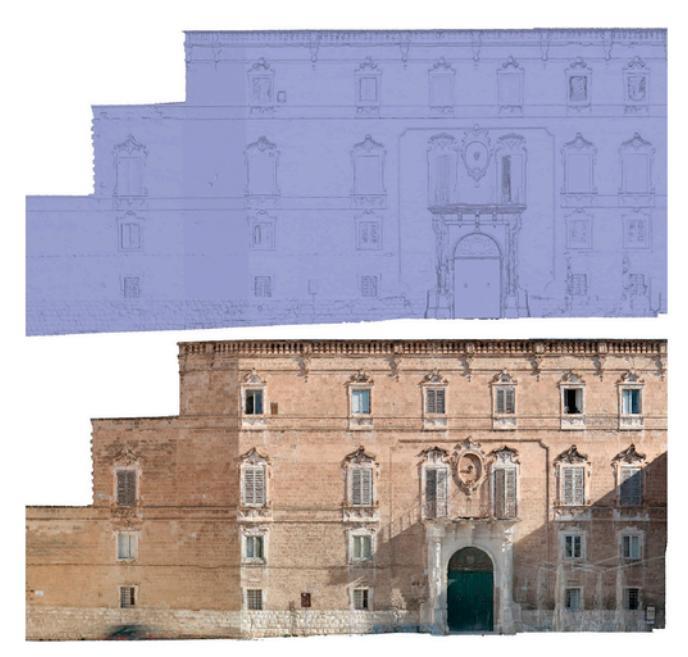
Fig. 2. Three-dimensional models: polygonal meshes with and without texture.

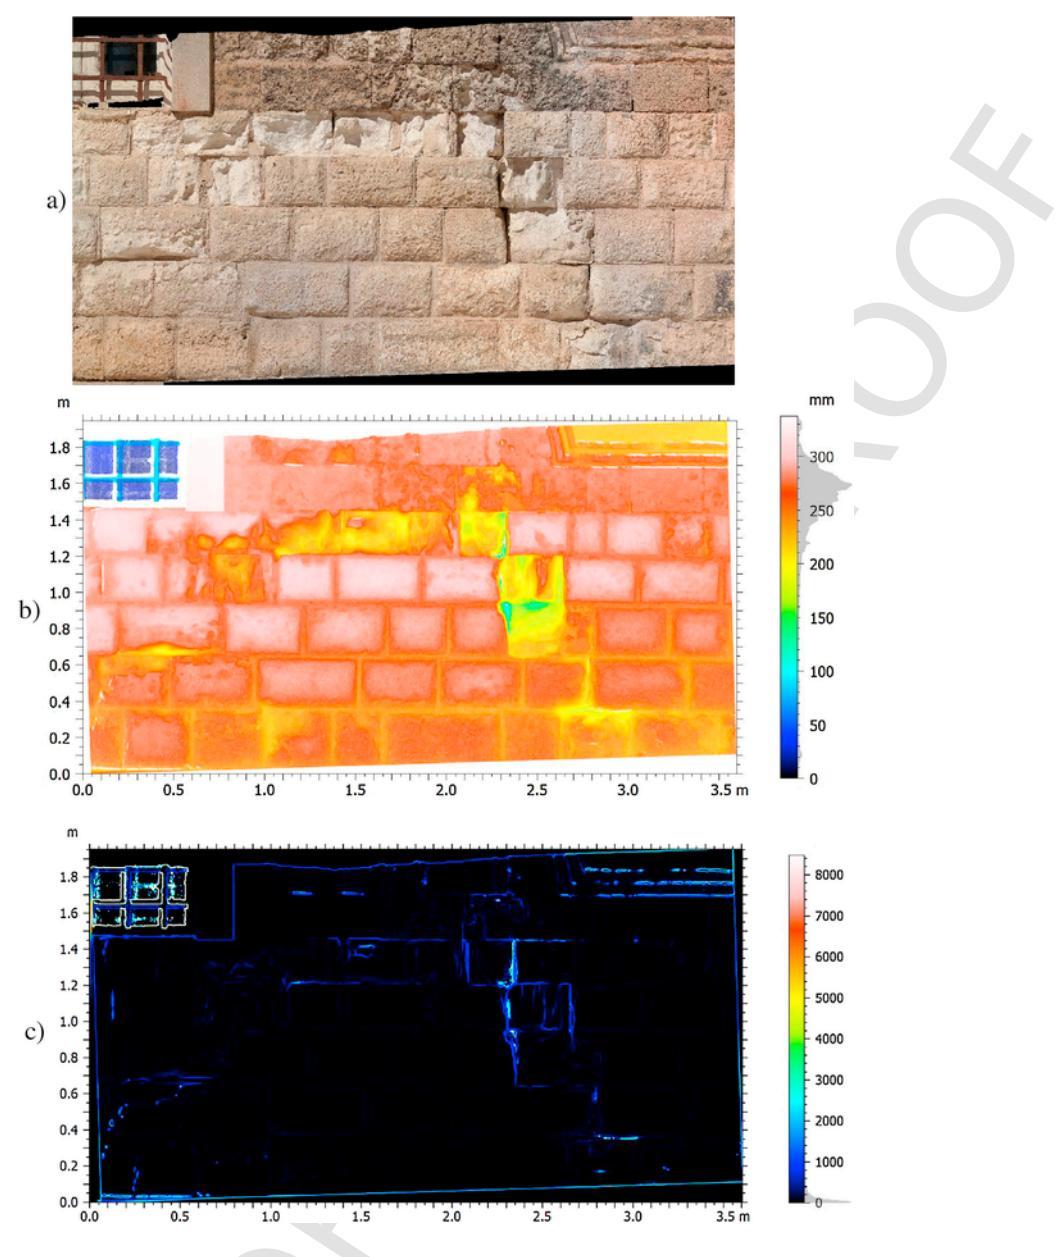
Fig. 3. a: small area $(3.5 \times 1.8 \text{ m}^2)$ extracted from the rusticated basement, on which the protocol was applied; b: three-dimensional model of a small area of the main façade transformed in a false-colour depth map by the software; c: studiable resulting from the application of the gradient filter (matrix 9×9).

The gradient filter allowed the edge extraction. The edges identified by the program are located in the deepest areas, which correspond to cracks. Several tests were carried out, choosing different sizes of the kernel matrix and obtaining different information:

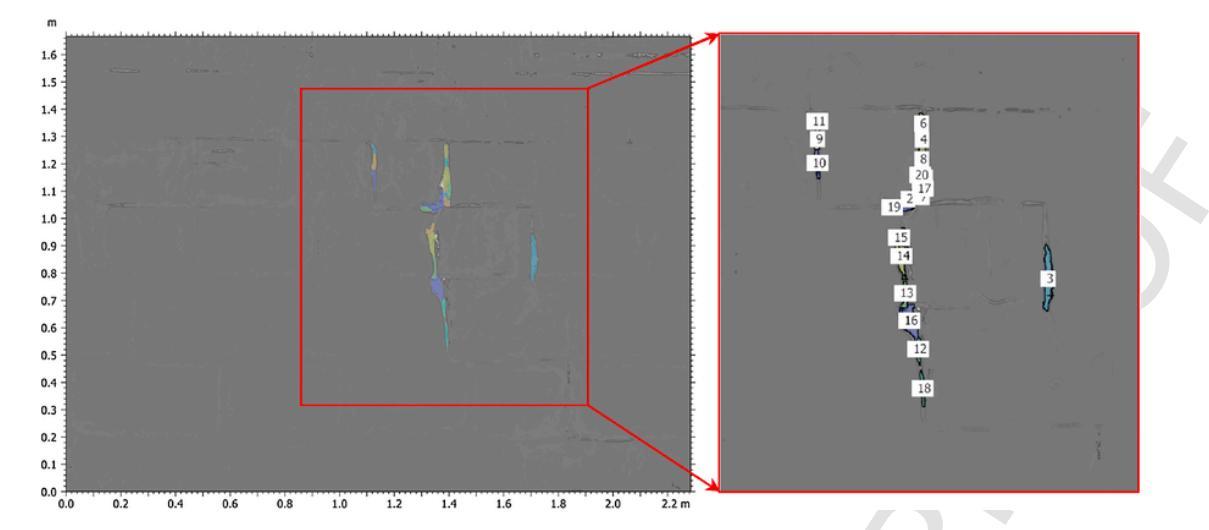
Fig. 4. Cracks detection by segmentation of areas deeper than a selected threshold (the window top-left visible in Fig. 3 has been excluded manually from the segmentation process, because if included in the segmentation, it would protract the processing time, without specific reason).

To perform the motifs, thresholds (area, depth) were chosen, according to the smallest dimension detectable and consequently the resolution of the analysed model. In Fig. 4 it can be observed that the software identified 19 patterns, corresponding to the cracked areas. For each of the detected regions, it was possible to obtain quantitative information (Table 4). Then all these data were exported as tables in Excel format.

For the damage detection, it was possible to recognise only alteration like cracks or features induced by material loss, through the illustrated protocol. But for each of these alterations, as it can be observed from Fig. 4 and Fig. 5, it was possible to locate them precisely, and calculate area, perimeter, average, maximum, minimum diameter, orientation, form factor, without the use of other more complex instruments (crack-meters, deformeters), normally used for the diagnosis of the damage. Anyway, it was important to choose the right thresholds for each case, in order to get an accurate detection.

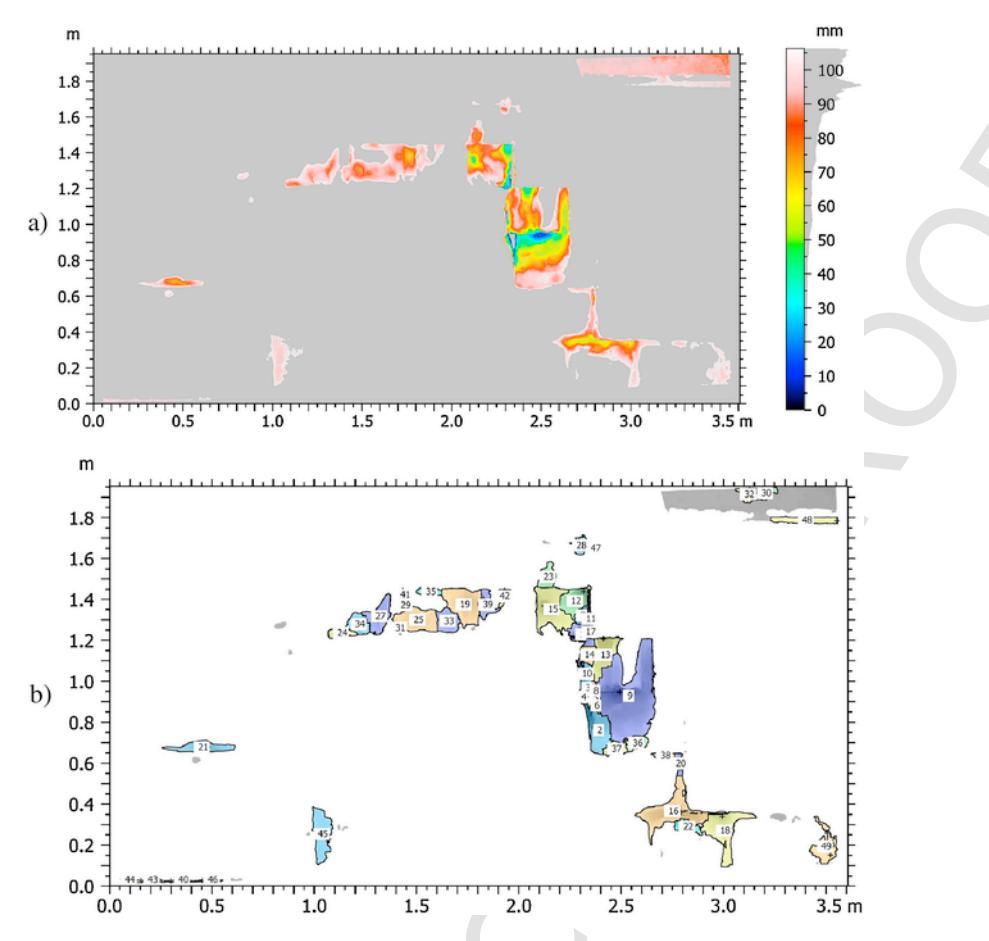
Fig. 5. a: application of the threshold, in order to include all the areas affected by alveolizations, differential erosions, mechanical damage, perforation, missing parts; b; motifs analysis obtained through the surface segmentation.

Alveolizations, differential erosions, mechanical damage, perforation, missing parts were detected through two chosen depth thresholds, which identify the study interval (Fig. 5a). The depth thresholds were chosen in accordance with preliminary on-site observations, performed with traditional instruments. Through the motifs analysis (Fig. 5b), the program created 48 motifs, corresponding to the areas identified by the threshold operator. Consequently, also in this case, it was possible to quantify the geometric characteristics of these motifs: area, perimeter, volume, minimum, maximum, average diameter, height, number of adjacent elements, form factor, coplanarity, orientation.

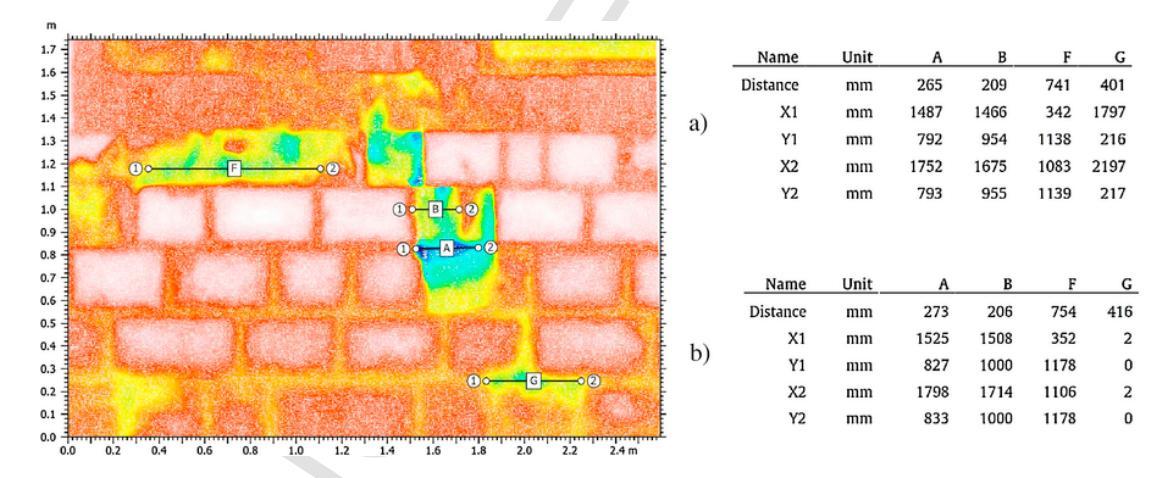
Fig. 6. Distance measurement (A, B, F, G); Table 5 Comparison between corresponding distances (A, B, F, G) in the two models: a: years 2015; b: year 2017.

For the monitoring, the analysis of the three-dimensional models (years 2015 and 2017) showed differences in the order of a few centimetres. In fact, the discrepancies found in the distance measurement are significant and ascribable to the evolution of the decay over time. In fact, in Fig. 6 and in Table 5 the detected differences (measured in a plane parallel to the façade) are: 8 mm (A), 13 mm (F), 15 mm (G). Therefore, these differences are above the Ground Resolution (2.3–2.4 mm/pixel). From the profile extraction (Fig. 7) it can be also observed that the lowest peaks are lowered of 1.5 cm, in the second model (2017) that is above the Height Resolution (4.6–4.8 mm/pixel).

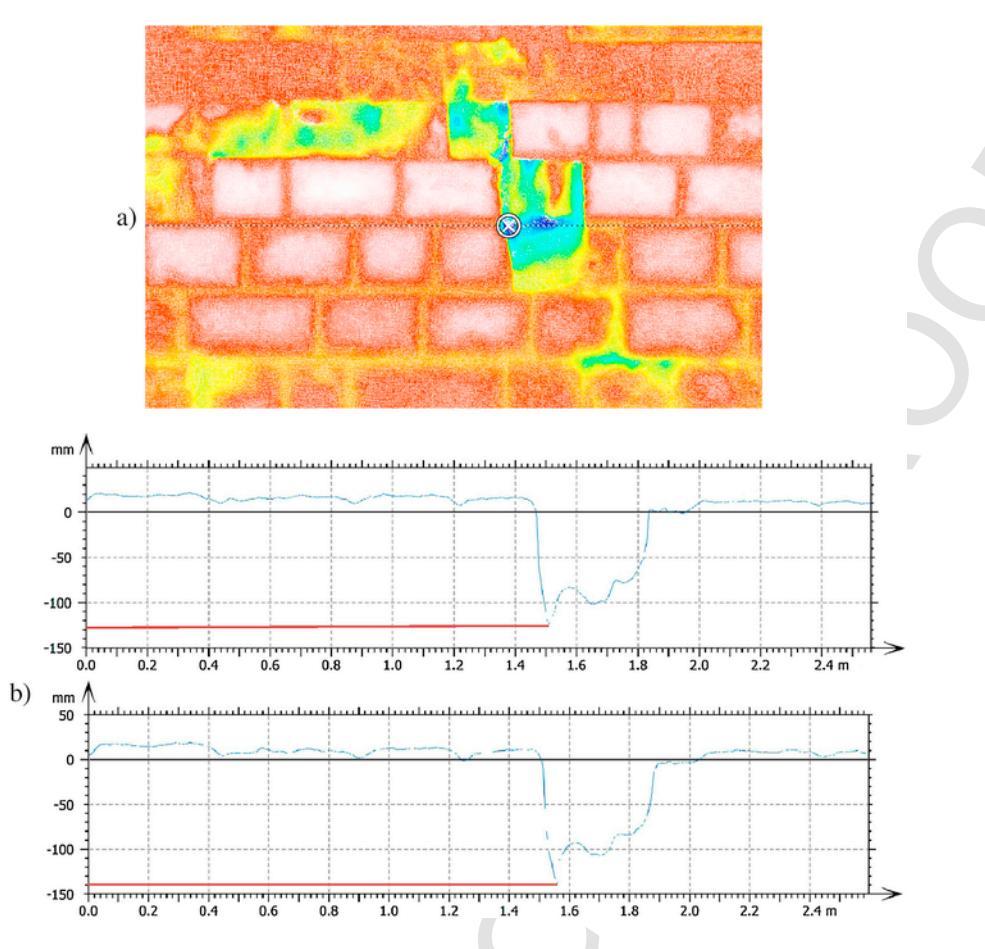
Fig. 7. Profile extraction: a: indication of where the deepest point is located on the analysed surface; b: horizontal profiles passing through the deepest point (up: years 2015 down: 2017).

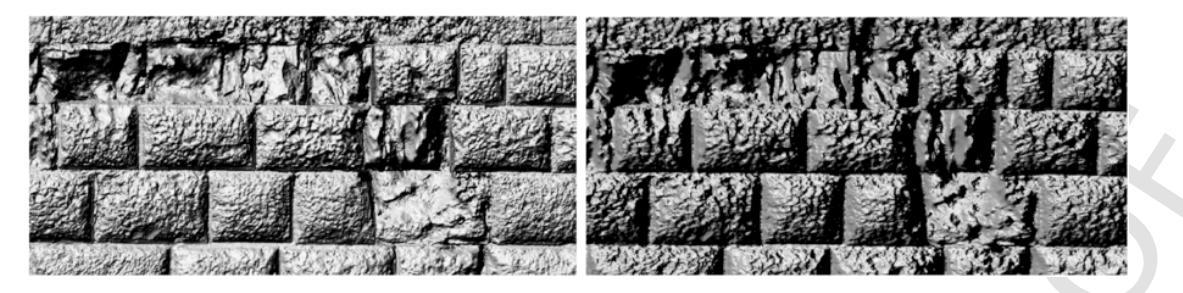
Fig. 8. Simulation of photographic texture of the point cloud (left) and the polygonal mesh (right) of the same portion.
