ACOUSTO-ULTRASONIC EVALUATION OF INTERLAMINAR STRENGTH ON CFRP LAMINATES

Claudia Barile^{a,b}, Caterina Casavola^a, Vincenzo Moramarco^a, Giovanni Pappalettera^a, Paramsamy Kannan Vimalathithan^a

Abstract

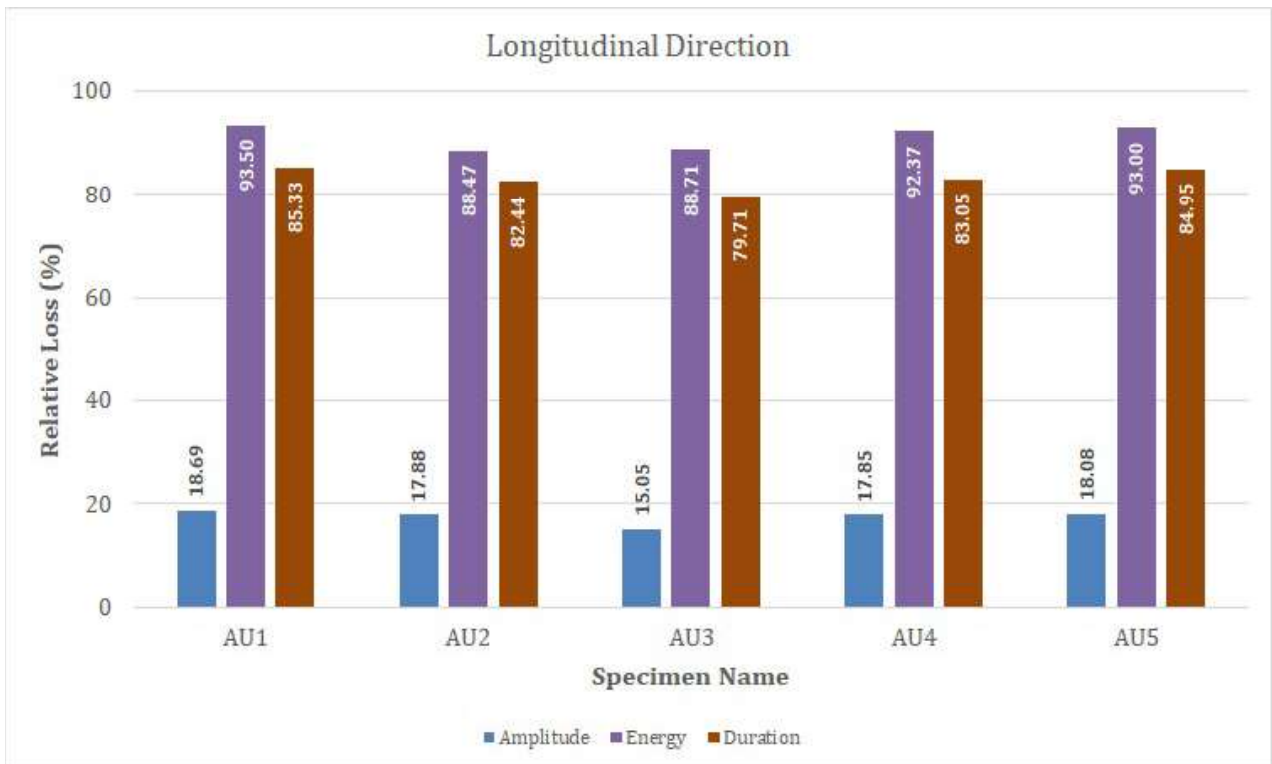
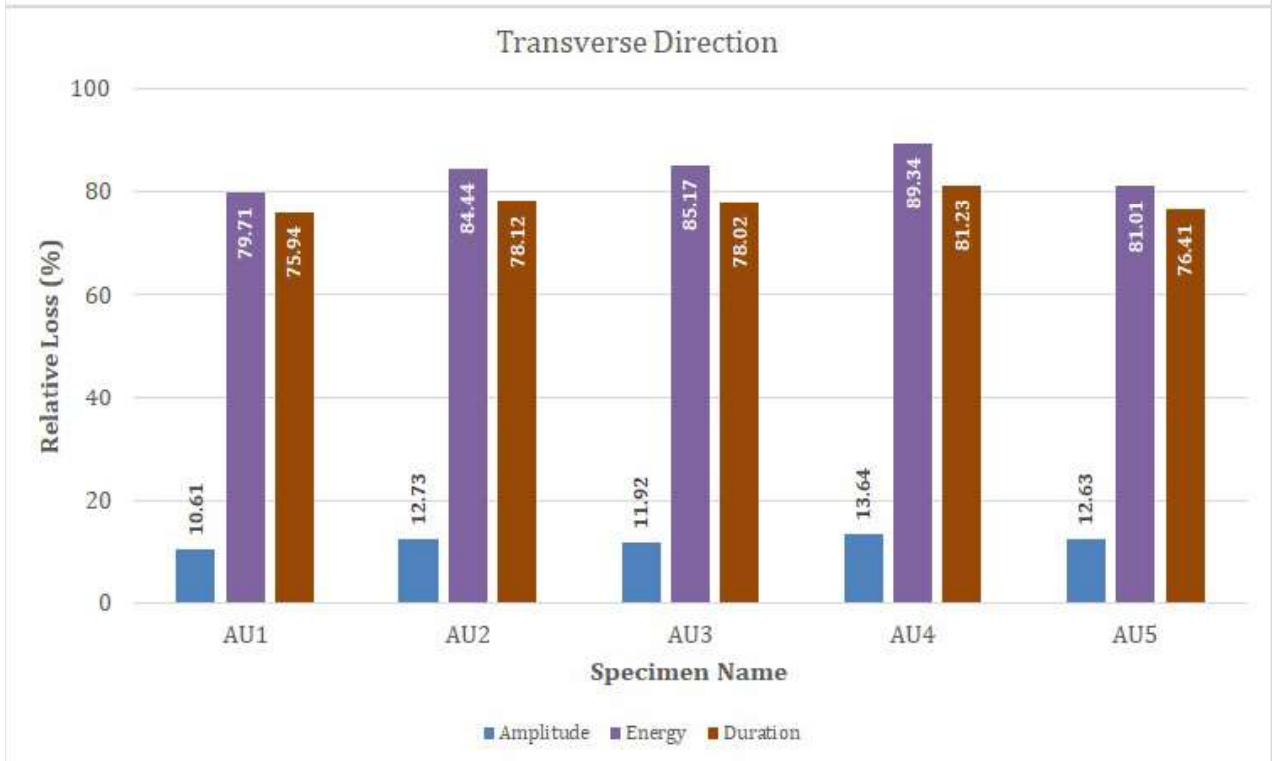
Figure 3 – AE descriptor loss in percentage along longitudinal and transverse directions before the impact event

The relative loss (in percentage) between the sent and received AE descriptors along both the directions are presented in Figure 3.

The phase direction of the material along which the interlaminar strength is low also has the lowest acoustic energy (Figure 3). Supposedly, an assumption can be made to understand the relation between the structural response and the acoustic signal transmission. The phase direction of the material which has the lowest interlaminar strength permits the easy propagation of the acoustic signal. This maybe the reason why the AE descriptor loss along the transverse direction is less than the longitudinal direction.

Considering the relative loss of AE in transverse direction (Figure 3) between the different specimens, AU1 and AU5 have the lowest AE energy loss (79.71% and 81.01%, respectively) when compared to the other specimens. Expectedly, these two specimens have the lowest mechanical properties (interlaminar properties). The assumption initially made for understanding the relation between the AE descriptors and the interlaminar property of the material seems to hold true.

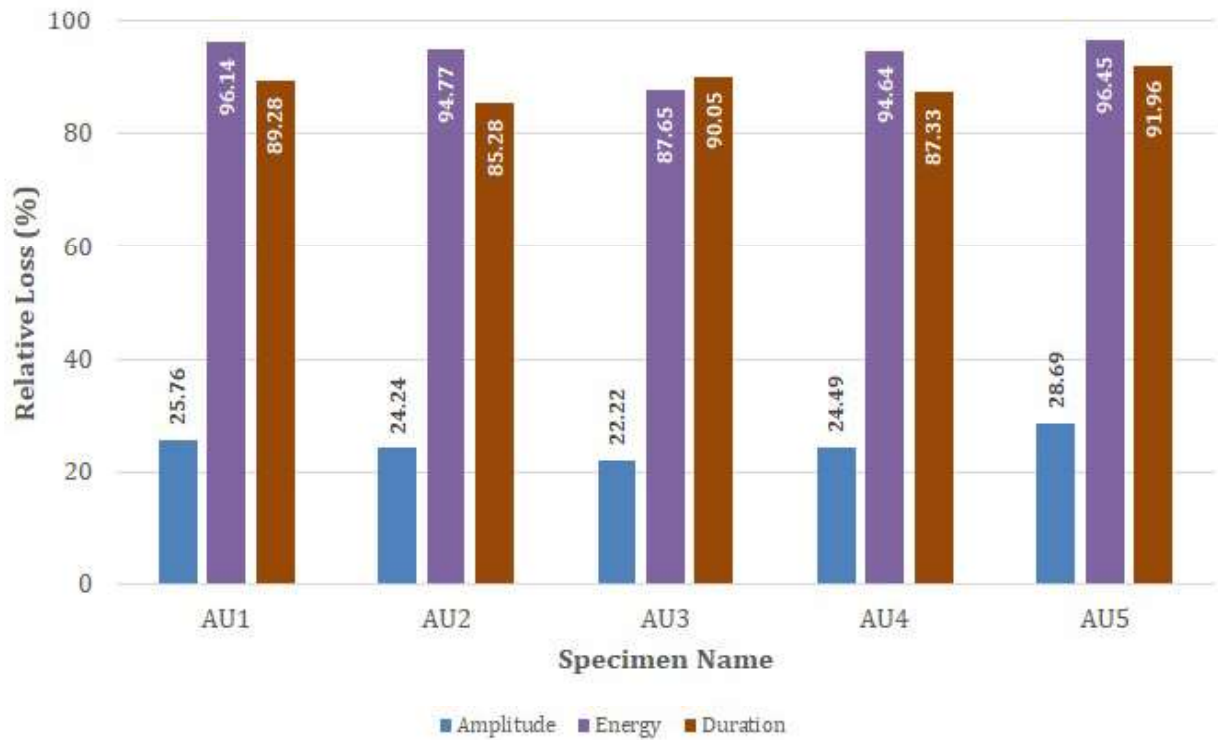
Figure 6 – AE descriptor loss in percentage along longitudinal and transverse directions after the impact event

Similar to the previous instance, the relative loss in the AE descriptors between the signal sent and received are presented in Figure 6.

However, to verify this hypothesis more elaborately, the acousto-ultrasonic approach was tested on the specimens after the drop weight impact event and the results are presented in Table 4 and Table 5. Similar to the previous instant, the relative loss between the AE descriptors are also provided in Figure 5. From the results, it can be noted that the relative loss of AE energy along both the longitudinal and transverse directions are quite higher (average loss of 95%). Along the longitudinal direction, the specimen AU1 and AU5 experienced the maximum loss (97.91% and 97.37%, respectively); in transverse directions as well the same AU1 and AU5 have experienced the maximum loss. The transmission medium of the acoustic signal was disrupted by the fiber breakage along the transverse direction. This results in the loss of acoustic energy in transverse direction to increase from 79.71% to 96.14% in AU1, before and after impact and 81.01% to 96.45%

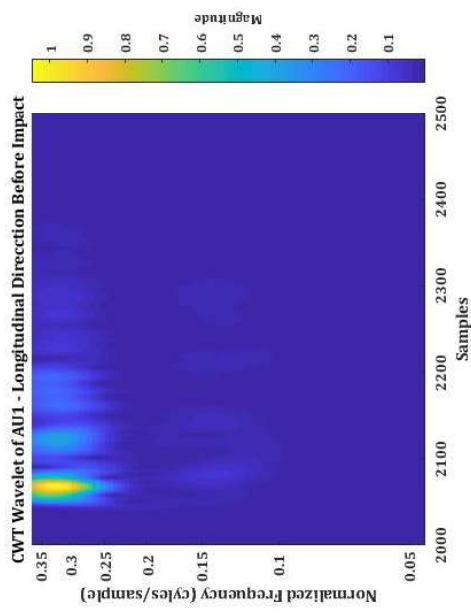
Figure 8 – CWT Wavelet of signals received along Longitudinal Direction before Impact

The CWT wavelet of signals received along the longitudinal and transverse directions, before impact, are produced in Figure 8 and Figure 9, respectively. In the similar way, the CWT wavelet of signals received along the longitudinal and transverse directions, after impact, is presented in Figure 10 and Figure 11, respectively.

The CWT wavelets of the signals received along longitudinal direction, before impact, (Figure 8) has the maximum magnitude of 1.6 in the 0.3 to 0.35 normalized frequency region. Unlike the input signal, the received signals are modulated over longer time intervals. Moreover, the wavelet can be seen in two distinguishable frequency domains, one being above 0.25 normalized frequency and the other one, between 0.1 and 0.25 frequency domain. The two distinguishable frequency domains can represent the acoustic wave propagated through the fiber and the polymer matrix, respectively. A similar two frequency domains were observed in the previous study on the acoustic wave propagation in CFRP. [12]

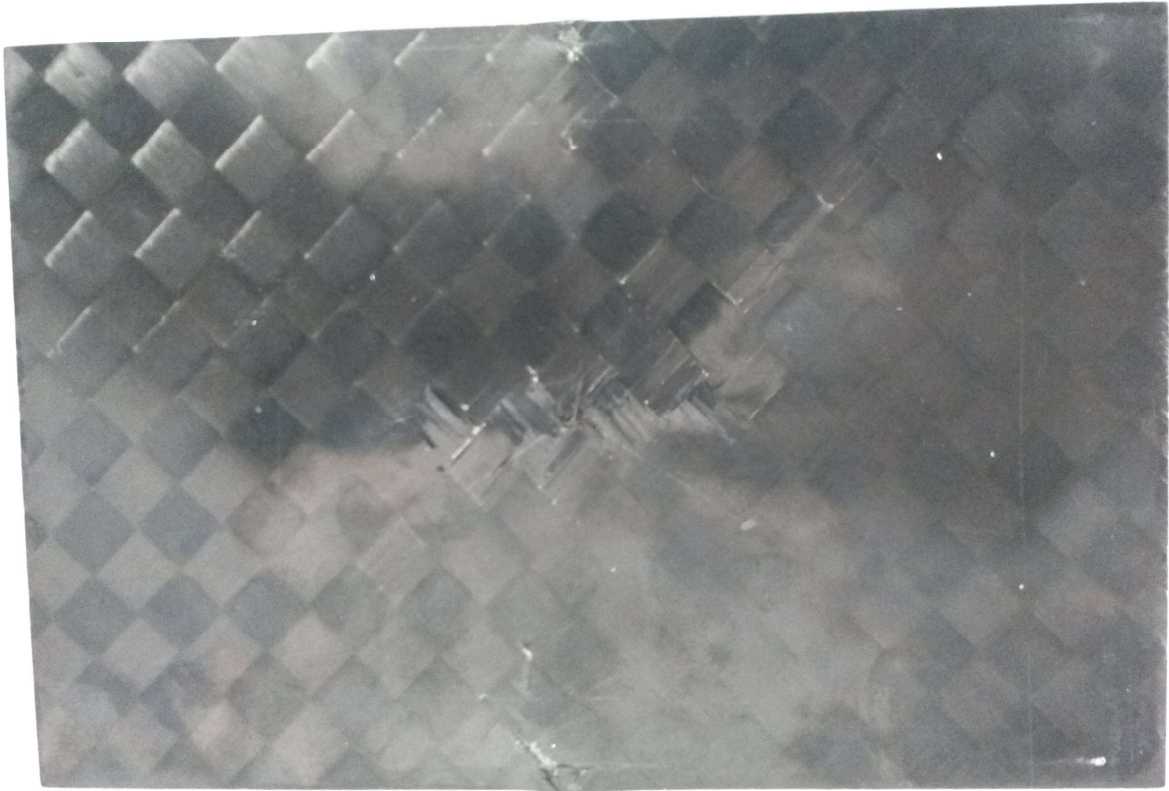
Figure 12 – Top and Bottom surface of the specimen after Drop Weight and CAI tests

longitudinal direction is more than the transverse direction. This result, when compared with the specimens after the drop weight impact, becomes even more intriguing (Figure 12).

After the drop weight event, the specimen is measured for the BVID. It can be observed that a residual indentation is formed on the top surface of specimen; while the impact energy has transmitted through the surface and severe damage can be seen at the bottom surface. In all the specimens, the fibers along the transverse direction has been broken by the impact. Although the extent of interlaminar damage cannot be observed through visual inspection, it can be explained through the results obtained.

After the drop weight event, the fibers in the transverse direction have broken. This shows that the drop weight impact energy did not transmit symmetrically through the specimen. The fiber breakage in the transverse direction represents that the interlaminar strength along the transverse direction is low and it is responsible for the fiber breakage along that specific direction.
