Politecnico
di Bari

Repository Istituzionale dei Prodotti della Ricerca del Politecnico di Bari

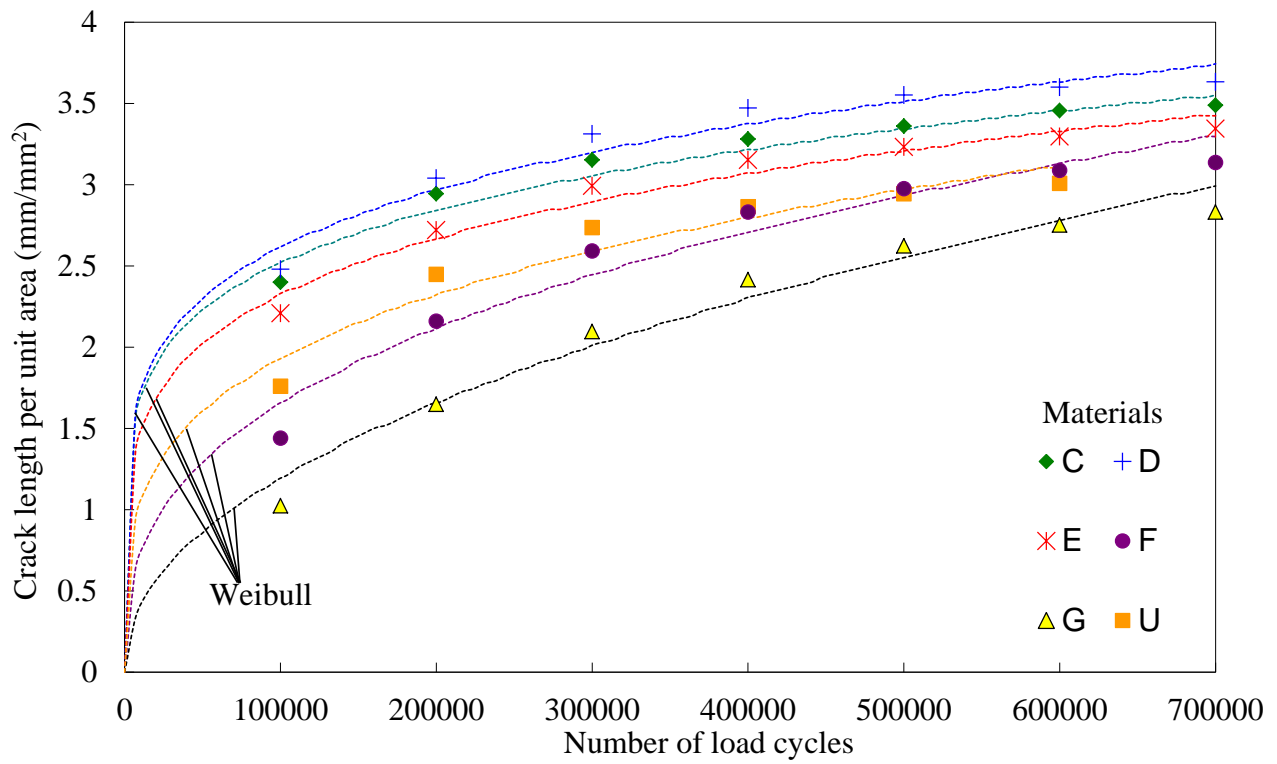
Figure 6. Effect of fatigue cycles on surface crack length density

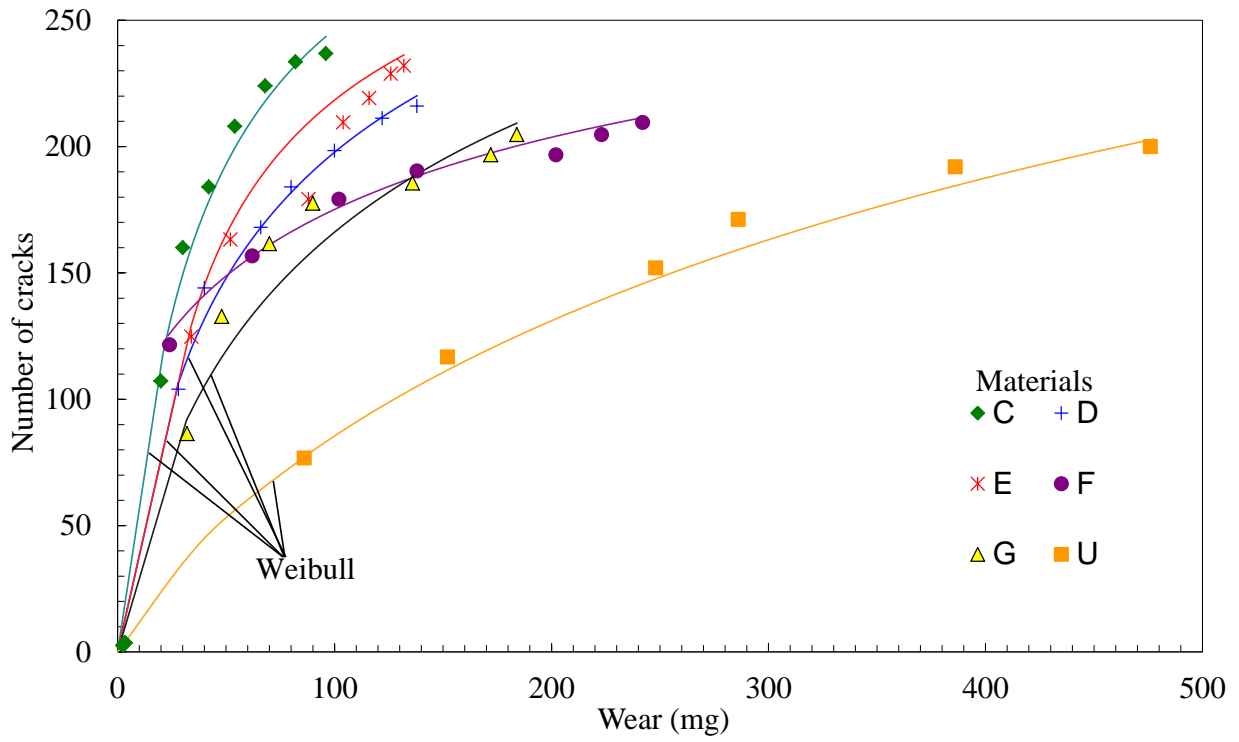
Figure 8. Effect of wear on the number of cracks

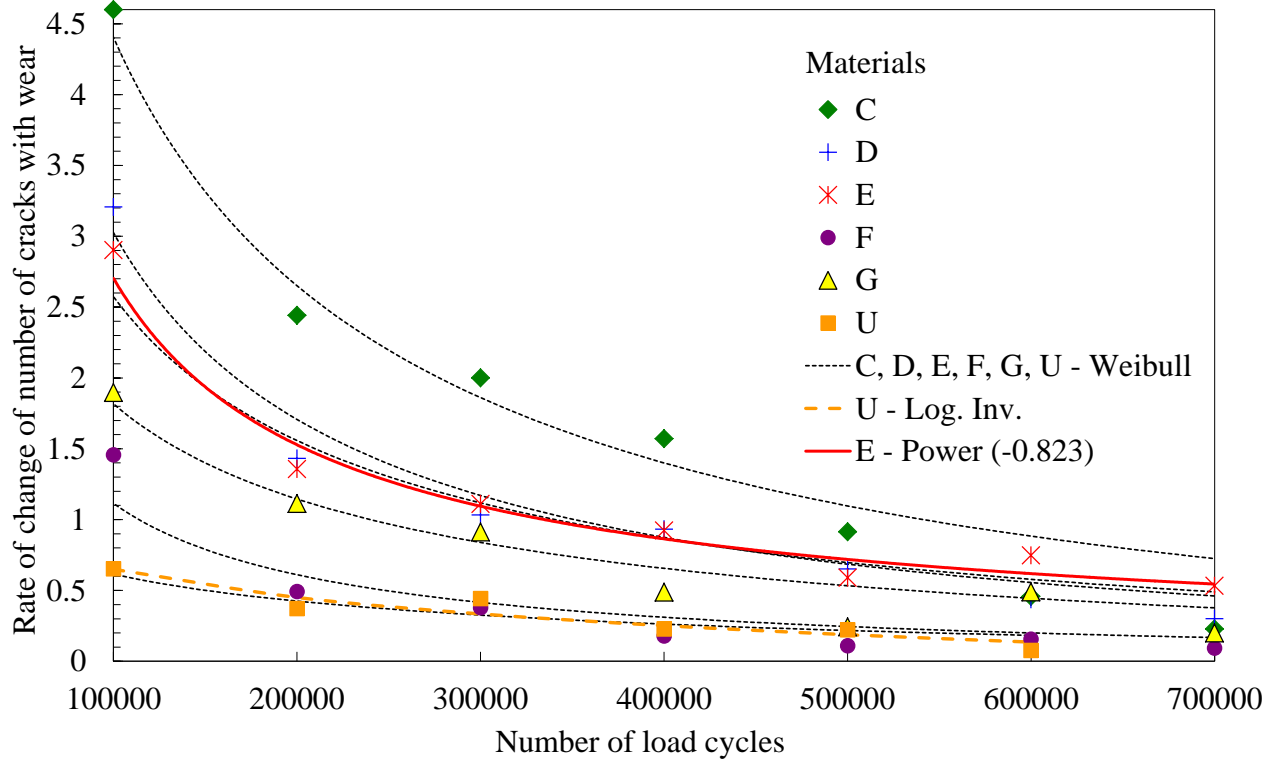
Figure 10. Rate of change of number of cracks with wear ($\partial N_{CR}/\partial W$) as fatigue cycles progress.

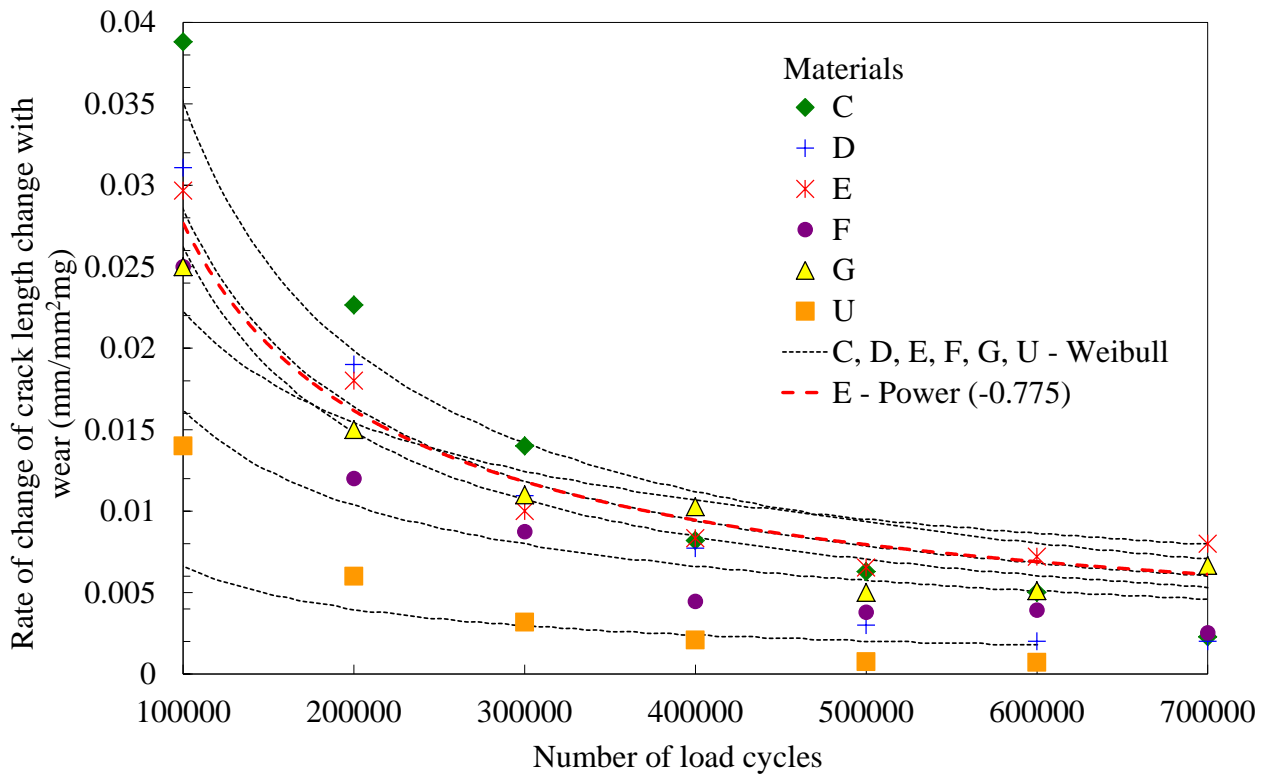
Figure 11. Rate of change of average crack length with wear ($\partial L_A/\partial W$) as fatigue cycles progress.

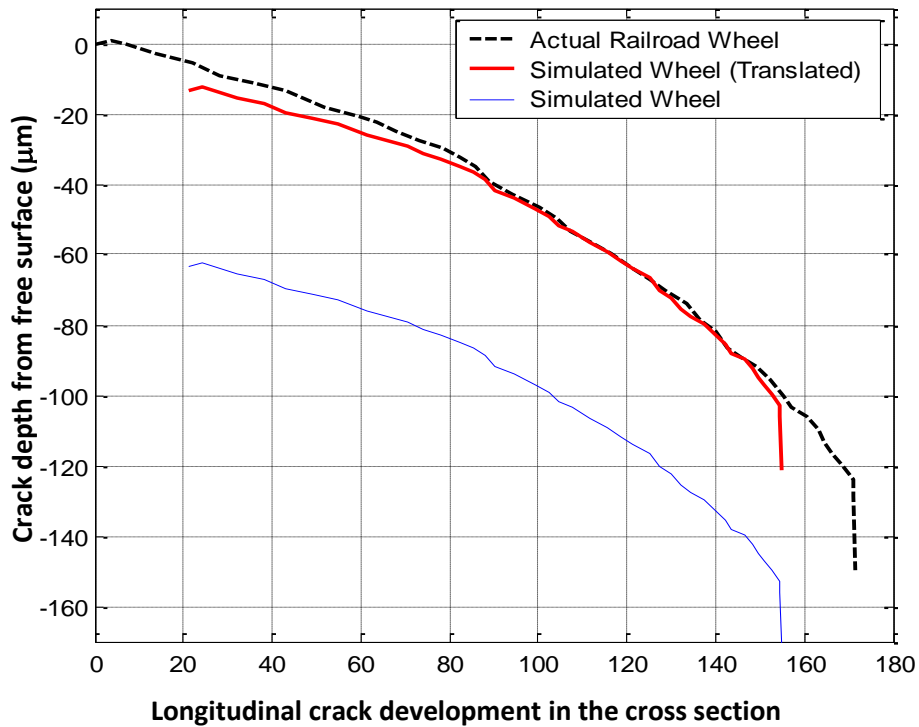
Figure 13. Comparison of real crack pattern and crack pattern generated in the experiments; the y-axis represents the depth of the crack starting from the free surface, while the x-axis represent the longitudinal crack development of the crack starting from the initiation site. Refer to Fig.12 for the real image.
