Article

# Digital Image Correlation Comparison of Damaged and Undamaged Aeronautical CFRPs During Compression Tests

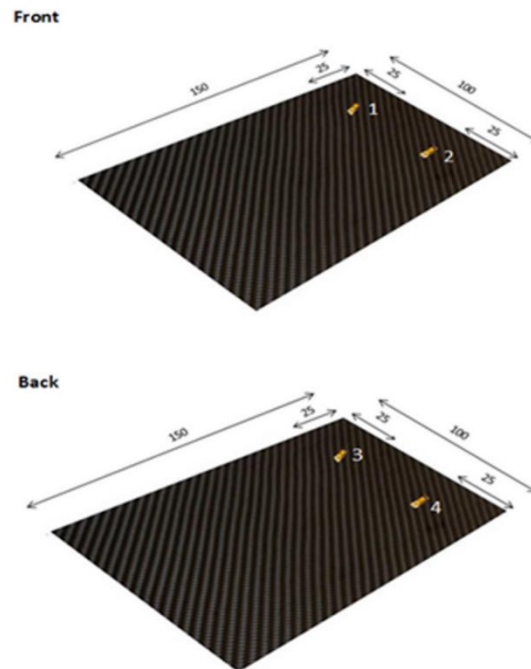
According to the standard, the evaluation of the local strain was obtained by applying four electrical strain gauges (Figure 1), two for each side of the samples [22].

**Figure 1.** Strain gages application on composite materials [dimensions in mm].

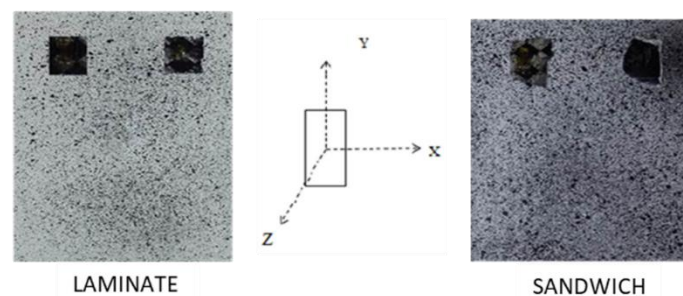
In order to allow strain field analysis by DIC, a random speckle pattern was preliminarily painted over the surface of the samples to be analyzed. This was done by spraying the specimen with a white matte spray to obtain a uniform white background and, successively, by spraying black speckles on the surface (Figure 2).

**Figure 2.** Real components sprayed for Digital Image Correlation (DIC) analysis.

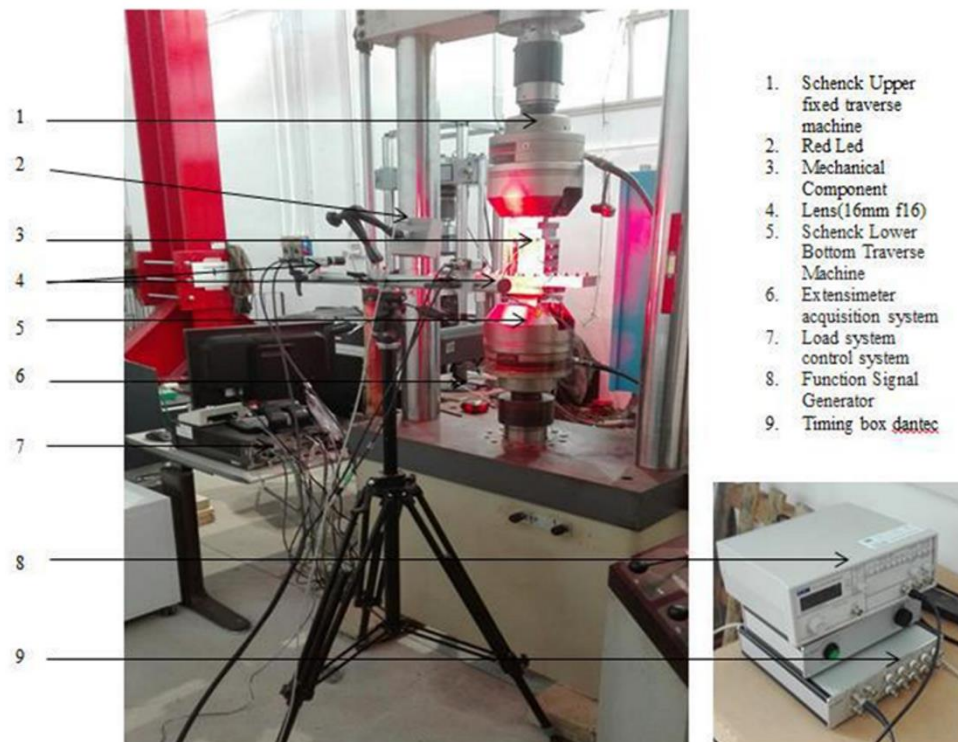
Denmark). It is equipped with ISTRA 4D software (Dantec Dynamics A/S, Skovlunde, Denmark), and it includes two  $1628 \times 1436$  pixels GigE CCD Manta by AVT (Allied Vision Technologies GmbH, Stadtroda, Germany) industrial cameras, equipped with Ricoh 16 mm lenses based the extensions of the area under analysis. The two cameras are mounted on the same support bar in order to compensate vibrations. Image acquisition is triggered by a synchronization unit including National Instruments® NIDAQ 9171 acquisition card (National Instruments Italy S.r.l., Assago, Italy), which converts the acquired signal analog to digital. The synchronization units are connected both with the loading machine and a PC dedicated to the system management. The starting of the acquisition was synchronized with the starting of the test by using an output TTL (Transistor-Transistor Logic) signal from the loading machine. The signal was active as soon as the test started and was used to trigger the synchronization unit. A frequency of 1 Hz was set for the tests. A led source is used to stably and evenly illuminate the area to be analyzed. By using this kind of illumination, higher intensity stability, in time, is achieved. This results in a more stable correlation process. Initial tuning of the illumination level was performed in order to optimize the acquisition by avoiding both saturation and low illuminated pixels in the whole object area. An optic with a small focal length was chosen due to the possibility of capturing suitably large test specimens and to monitor the whole component (Figure 3).

Figure 3. Overview of experimental set-up.

- Span length between cameras 40 cm
- Object's distance from the cameras 50 cm
- Cameras' Inclination  $21.8^\circ$
- Diaphragm opening  $f/8$

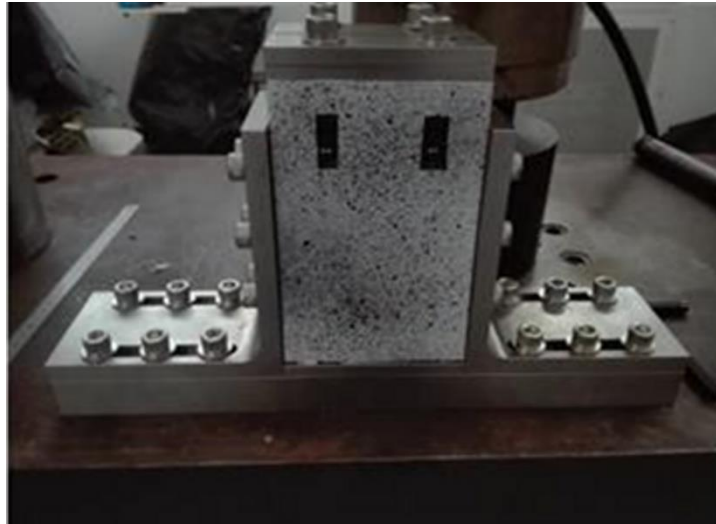
The compressive fixture used for the anti-buckling tests is shown in Figure 4. It includes adaptable retaining plates (base and top plates, and two slide plates) for supporting the specimen and prevent buckling during the load application. The fixture allows regulation for considering small variations in

specimen sizes. The side plates are shorter than the specimens to ensure the proper sample absorption of the load. The configuration of the features could deeply affect the test results. In the standard test fixture, the base and the top supports provide no clamping but only some restraints to local out-of-plane rotation.

**Figure 4.** Edge-constraint structure adopted in the experiment.

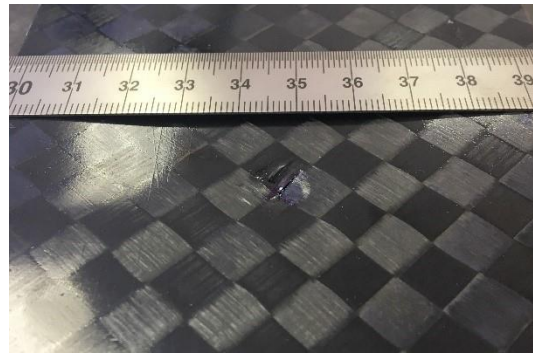
According to the standard [22], the specimens used for that kind of test were previously subjected to drop-weight impact per Test Method D7136 [23] prior to application of compressive force. As prescribed by the standard, the specimen was placed on a fixture base and aligned with the dropping axis by using guiding pins. Once finished, the alignment operations the specimen was clamped by four rubber terminated toggles. Velocity of the impactor was determined by optical sensors (manufacturer, city, country) placed along the dropping axis to determine accurately the impact energy. Experiments were led at room temperature at two levels of energy, respectively, 50 J for CFRP and 10 J for foams. Impact was obtained by a hemispherical impactor (manufacturer, city, country) having 16 mm of diameter, as prescribed by the standard. The rebound catcher system was activated during the test to avoid rebound of the impactor on the tested sample. These drop tests are most used in the aeronautic field for simulating the impact of a structure with birds. With the new composite materials, this aspect is of great interest for industry in order to evaluate the delamination effects occurring. Moreover, they generate a damage on the specimens whose shape and dimensions depend on the energy level of the test, as well as on the structural lay-up of the materials. According to the producer's requirements, the above indicated energy levels set for the two materials were selected, after preliminary tests, to ensure a Barely Visible Impact Damage (BVID) of about 1 mm in depth (Figure 5). The extension of the damaged area was 1 cm for both the analyzed class of materials. The BVID is the name given to damage in a composite material caused by a low-velocity impact from objects. Low-velocity impacts cause only minor damage to the surface of the composite, which is generally not readily detectable by visual inspection, hence the term BVID. However, they can cause structurally considerable damage internally within laminate composites, such as delamination, matrix cracking, fiber fracture, and fiber pullout. The aim of the CAI tests was to evaluate the compression residual strength properties of CFRP.

**Figure 5.** Shape of the damage created on each specimen.

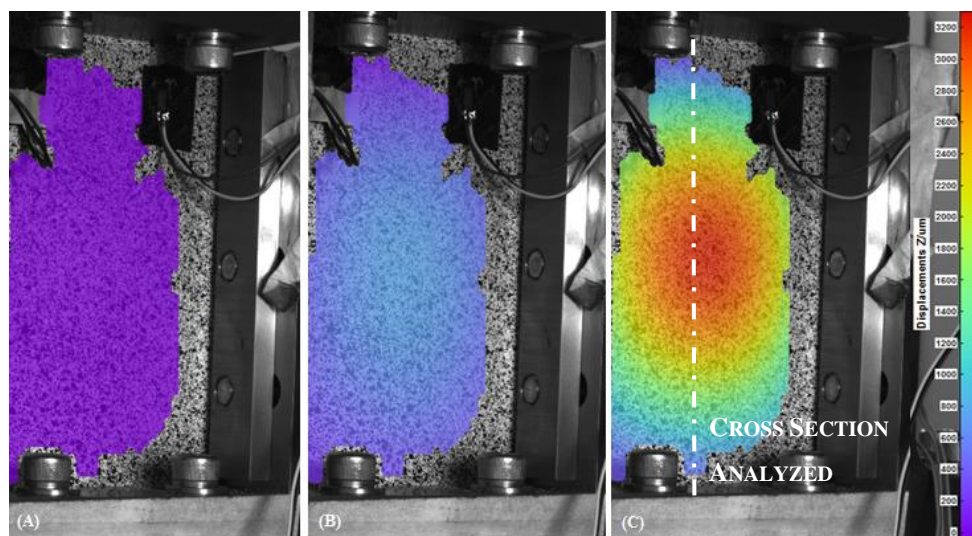
In Figures 6–9, the out-of-plane displacement field obtained at different instant times during the uniaxial compression tests on CFRPs and foams, damaged and undamaged, are shown. Main analysis settings for this evaluation are listed as follows: 3D residuum lower than 0.4 pixels, facets size 19 pixels, and accuracy 0.1 pixels [16]. A total of 1180 grid points are computed on average in the ROI.

**Figure 6.** Out-of-plane displacement of the undamaged Carbon Fiber Reinforced Plastics (CFRP) recorded by DIC at  $t = 0$  s (A),  $t = 80$  s (B) and  $t = 116$  s (C).

Referring to the laminate specimens and from the analysis of the out-of-plane displacements, several considerations can be done. First, it can be observed that, both the fixture and the low displacement rate (1.25 mm/min) contribute to keep low the amount of the out-of-plane displacement in the initial part of the test, for both the CFRP and foam components.

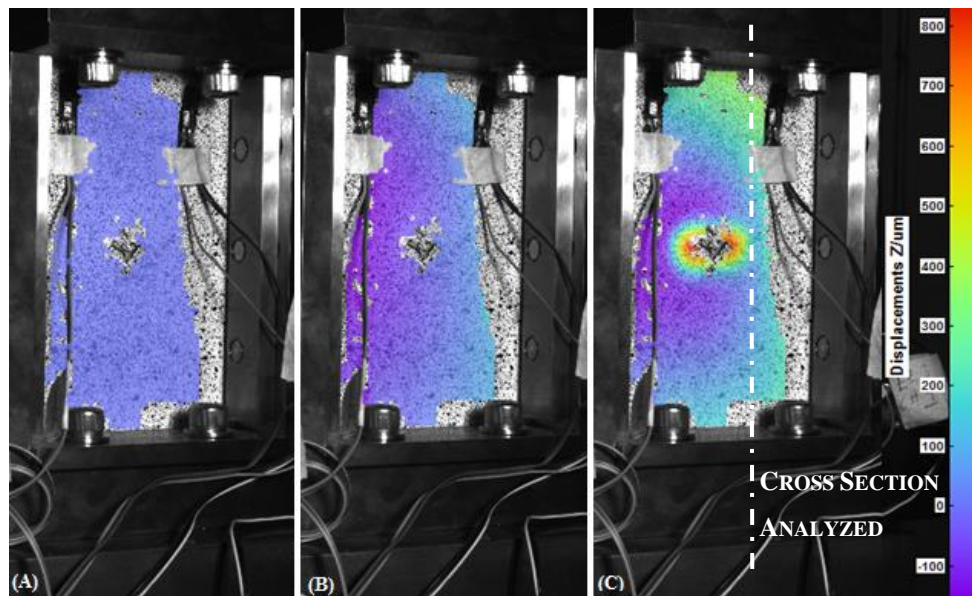
**Figure 7.** Out-of-plane displacement of the damaged CFRP recorded by DIC at  $t = 0$  s (A),  $t = 60$  s (B) and  $t = 101$  s (C).

The longitudinal deformation  $\varepsilon_{yy}$  along the median cross section of the CFRP specimens is shown in Figure 11, under conditions of maximum deformation. Cross-section was chosen in order to avoid regions where no correlation was observed as shown in Figure 7. The \* indicates areas with no information due to the impossibility of recognizing speckle pattern by the DIC system. The lack of information is caused by the shadow zones created by the fixture.

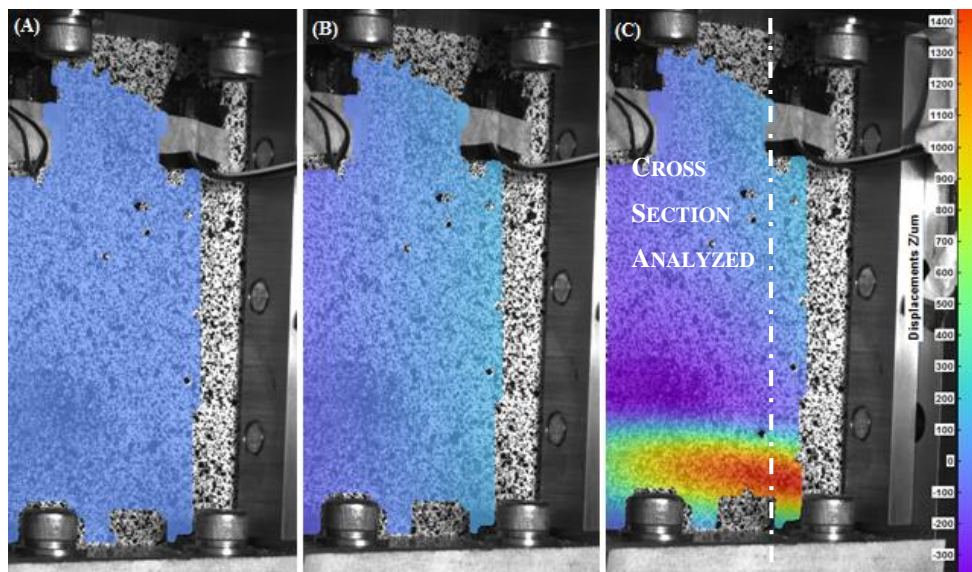
**Figure 8.** Out-of-plane displacement of the undamaged foam recorded by DIC at  $t = 0$  s (A),  $t = 45$  s (B),  $t = 60$  s (C).

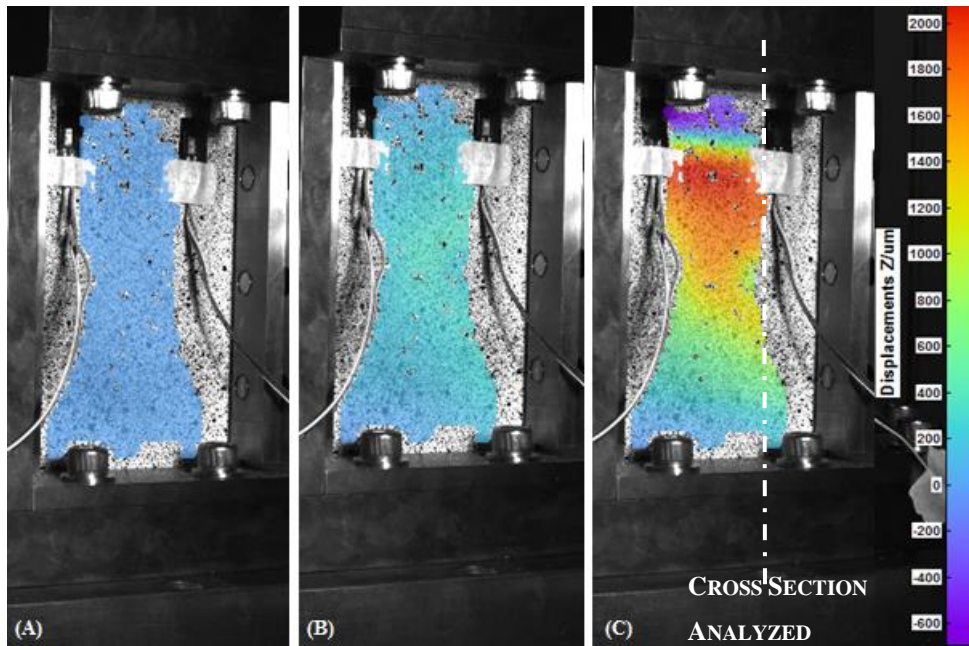
**Figure 9.** Out-of-plane displacement of the damaged Foam recorded by DIC at  $t = 0$  s (A),  $t = 55$  s (B) and  $t = 70$  s (C).

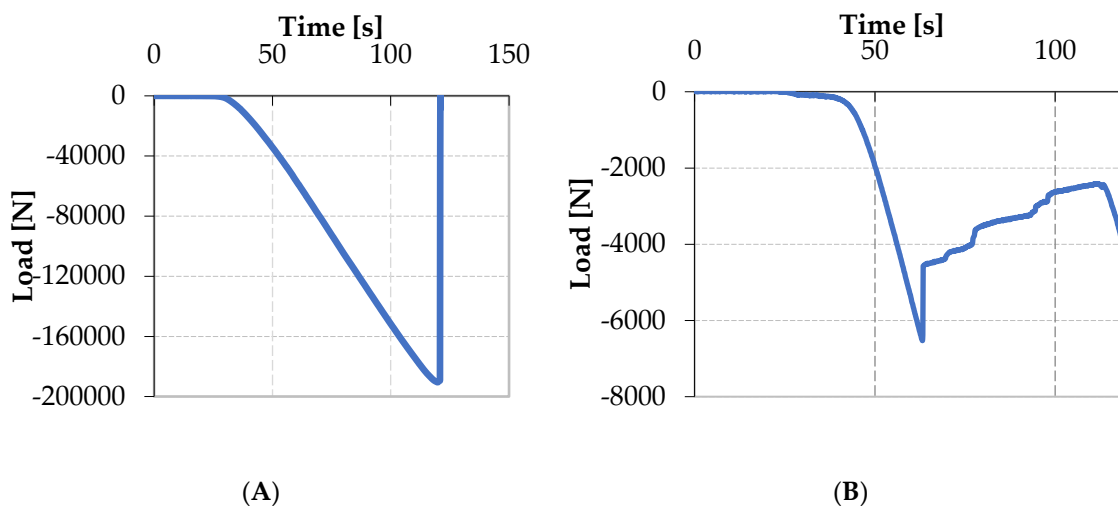
Initial settlement of the loading plate is observable in the first 20 s of the test, as shown in Figure 10A. From that point, on load starts to be effectively transmitted to the sample. The CFRP laminates begin to collapse after 80 s (inflexion point) from the start of the test, when an out-of-plane displacement of  $800 \mu\text{m}$  is clearly recorded by the DIC system. After 116 s, out-of-plane displacements become more evident and they reach a maximum value of  $3200 \mu\text{m}$ , while the specimen broke soon after, namely at 120 s. The abrupt cut of curve is caused by the failure of the component. This happened for a load equal to  $-200$  kN.

**Figure 10.** Load law evolution of the machine for the CFRP specimen (A) and foam composite (B).

Similar analysis, but different considerations, can be done for the foam specimens, as shown in Figure 10B. In this case, an initial stage of adjustment of the loading fixture is observed. Starting from  $t = 45$  s, load is effectively transmitted to the specimen and a linear trend is followed until a rapid collapse of the specimens occurred at  $t = 63$  s, when the applied load reached a value of  $-6.6$  kN. This value corresponds to the maximum resistance of the face sheets of the sandwich. After that,

differently from the previous reported case load is still recorded as a consequence of the presence of foam which is, in this stage, still capable to transmit load. Load starts to increase again at time  $t = 122$  s due to the reached contact between the upper and the lower part of the fixture. It should be observed that, in this situation, appearance of instability is not directly inferable by the temporal load law.

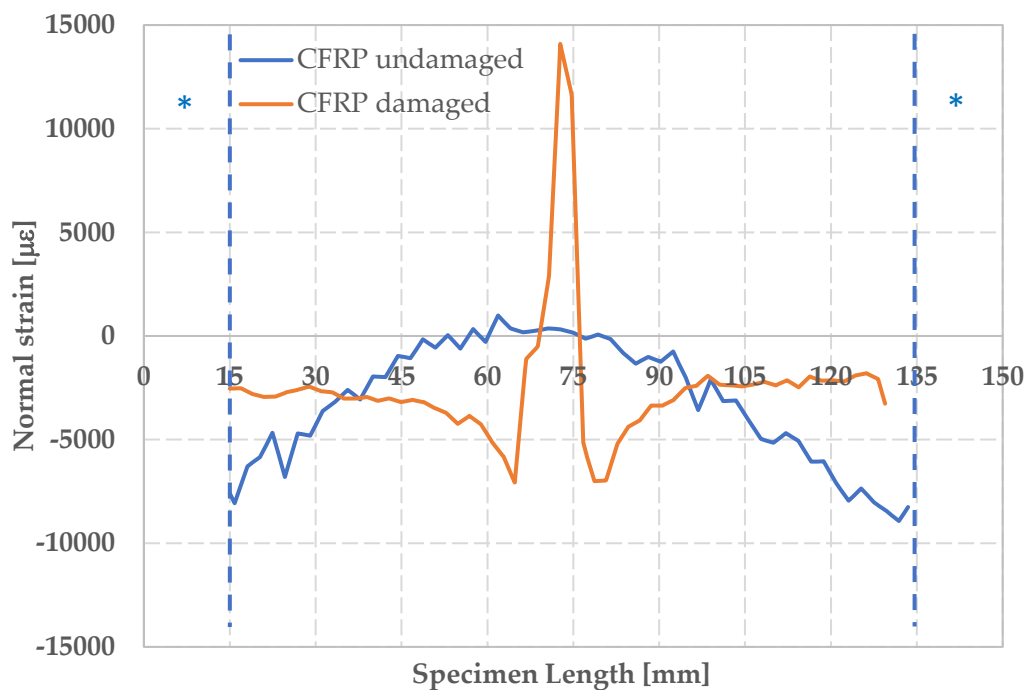
**Figure 11.** Maximum normal strain  $\varepsilon_{yy}$  for damaged and undamaged CFRP.

A different behavior is clearly observable for the damaged and the undamaged components: the mean values of maximum load are  $-102,714 \pm 8286$  N and  $-192,674 \pm 10,081$  N, respectively, while the mean values of maximum CAI stress are  $-202 \pm 15$  MPa and  $-385 \pm 20$  MPa, respectively. The undamaged specimen displays a normal strain negative in the outlying areas, showing a symmetrical shape with respect to the middle part of the component. This is in accordance with what was expected for undamaged component under fixed-fixed column constraints conditions. The damaged composite undergoes a more evident buckling deformation in the center of its structure.

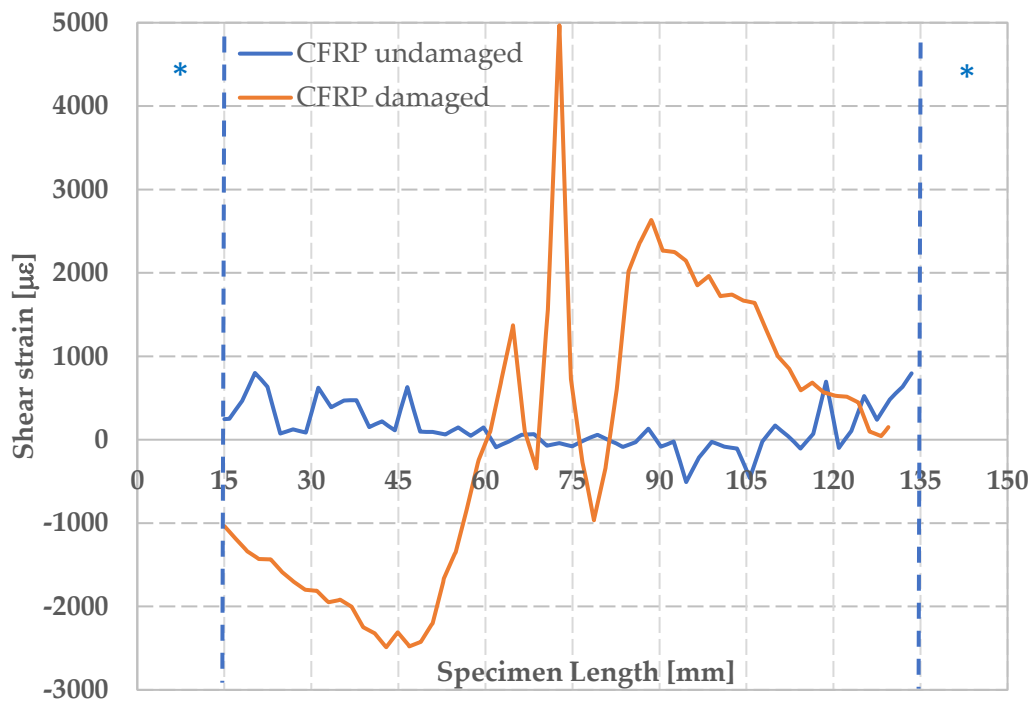
In Figure 12, the maximum shear strain for damaged and undamaged CFRPs is also reported. No points of maximum shear strain concentration, along the analyzed cross-sections, are observable for the undamaged CFRPs. For the damaged CFRPs, instead, a very different behavior is observed with a clearly evident maximum at the center of the component with a positive strain of  $5000 \mu\text{m}$ . Rupture of the component occurs in correspondence of the area of maximum shear strain. A symmetric

behavior in the lower part of the sample with respect to the upper part is observed, indicating the presence of a relative rotation of the two parts during the test.

Figure 12. Maximum shear strain  $\epsilon_{xy}$  for damaged and undamaged CFRP.

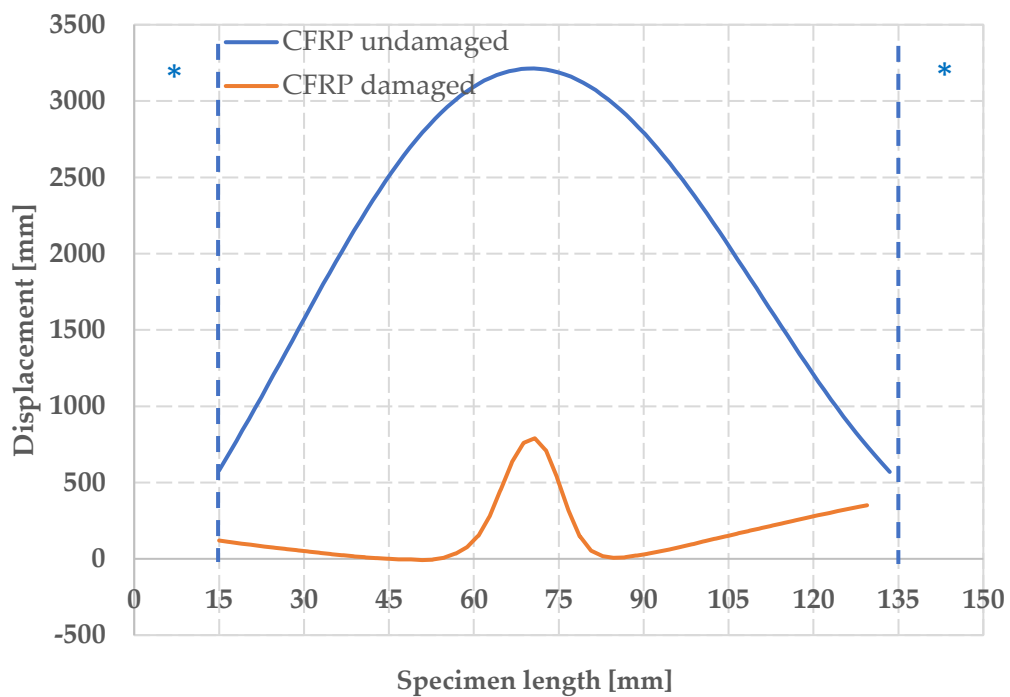
The off-plane displacement behavior allows to localize the buckling (Figure 13). For the damaged CFRPs, it results located exactly at the center, reaching a value  $w$  equal to 750  $\mu\text{m}$  at 75 mm along the  $y$  axis, and a value of  $w$  equal to 3200  $\mu\text{m}$  for the undamaged CFRP.

Figure 13. Out-of-plane displacement  $w$  for damaged and undamaged CFRP.

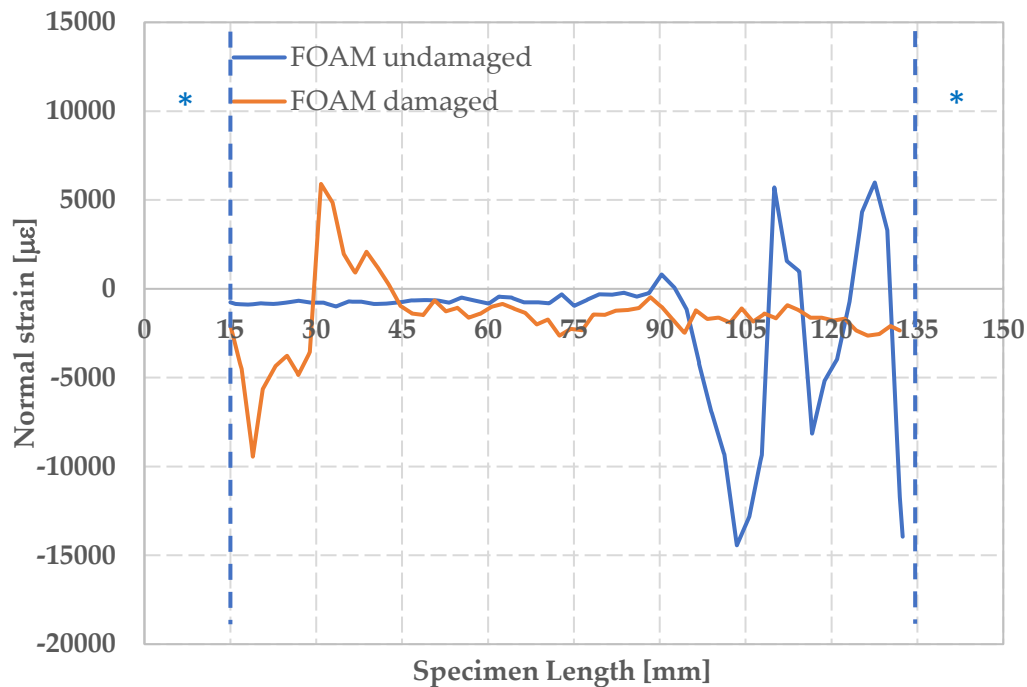
In Figure 14, the trend of longitudinal deformation along the cross-section for the foam specimens is reported under conditions of maximum longitudinal deformation. The maximum values of  $\varepsilon_{yy}$  along the median cross section are, respectively,  $-8000 \mu\varepsilon$  for the undamaged foam and  $-9700 \mu\varepsilon$  for the impacted foam. The correspondent mean values of maximum load are  $-6618 \pm 206 \text{ N}$  and  $-4178 \pm 413 \text{ N}$ , respectively, while the mean values of maximum CAI stress are  $-84 \pm 3 \text{ MPa}$  and  $-53 \pm 5 \text{ MPa}$ , respectively.

**Figure 14.** Maximum normal strain  $\varepsilon_{yy}$  for damaged and undamaged foam.

The maximum deformations of the component are not recorded at the center. It is noticed that the not impacted specimens buckle in the lower part while the impacted foams reached the buckling in the upper part.

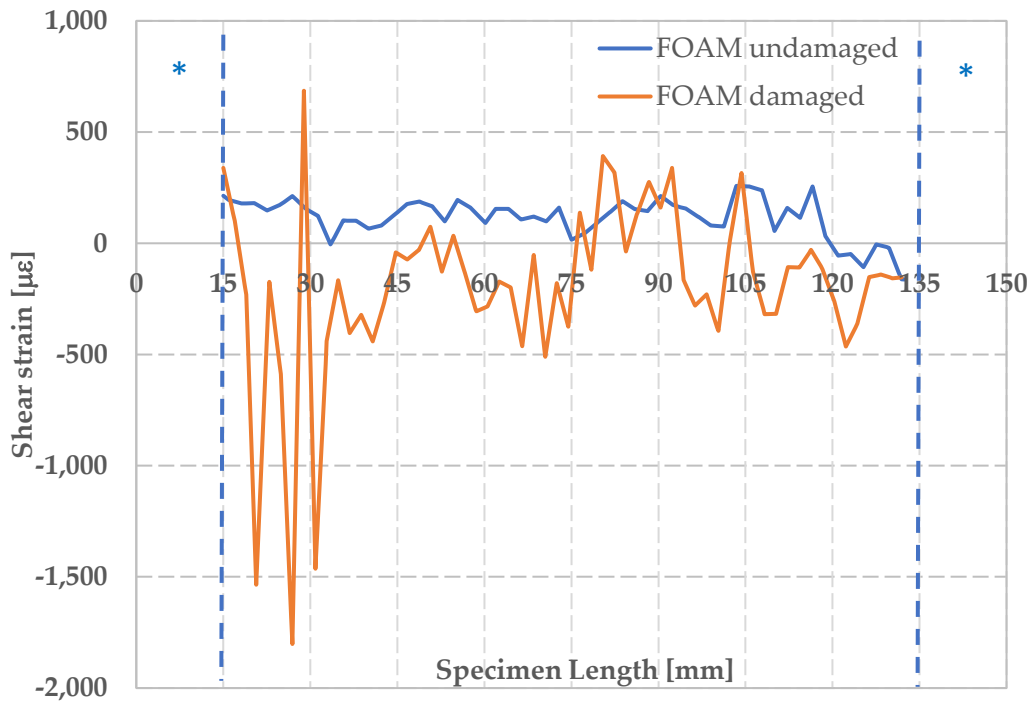
In Figure 15, the maximum shear strain recorded under conditions of maximum deformation is shown. It can be observed that the shear strain, for the undamaged foam, is quite uniform along the plotted cross section. In the case of damaged foam, we can observe points of shear strain concentration along the analyzed cross section; in particular high negative values of shear strain are recorded in correspondence of the upper part of the component reaching a minimum value of  $\gamma_{xy}$  of  $-1800 \mu\text{m}$ , that corresponds to the region where skin instability occurs.

Figure 15. Maximum shear strain  $\gamma_{xy}$  for damaged and undamaged foam.

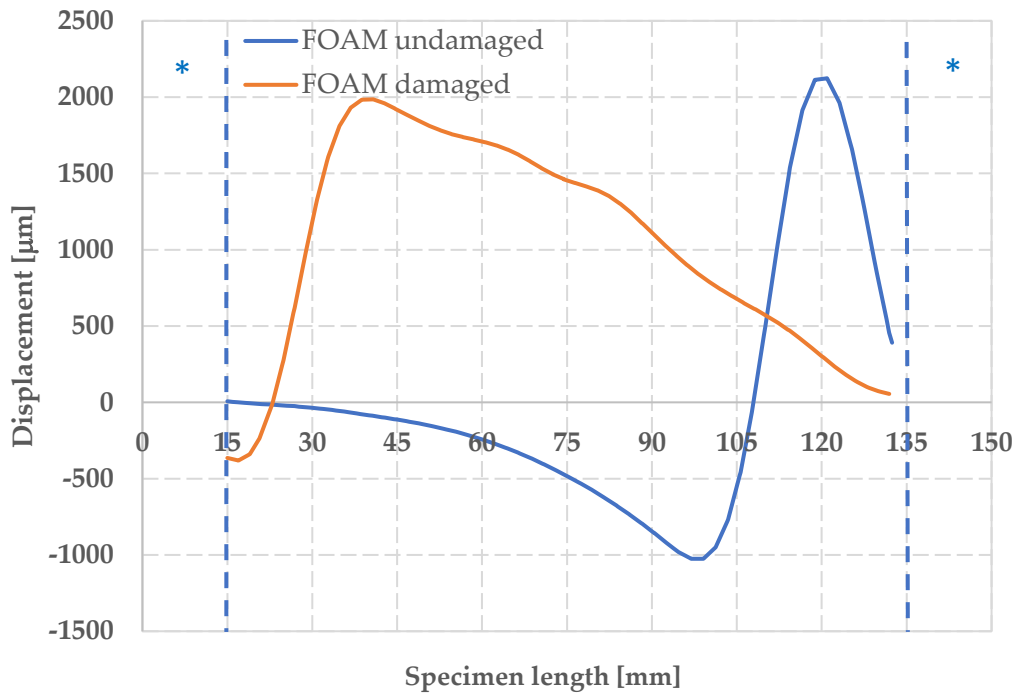
For the undamaged foam, the graph of the out-of-plane displacement (Figure 16) shows a maximum value of  $w$  equal to  $1400 \mu\text{m}$  in correspondence of a length of 120 mm, just before the rupture at  $t = 62 \text{ s}$ .

Figure 16. Maximum out-of-plane displacement  $w$  for damaged and undamaged foam.

In the damaged foam, a globally higher out-of-plane displacement field is observed, reaching a maximum of  $w = 2000 \mu\text{m}$  in the upper area of the specimen.
