## Acousto-Ultrasonic Evaluation Of Interlaminar Strength On CFRP Laminates

Acousto-Ultrasonic Evaluation Of Interlaminar Strength On CFRP Laminates / Barile, C., Casavola, C., Pappalettera, G., Paramsamy Nadar Kannan, V.. - In: COMPOSITE STRUCTURES. - ISSN 0263-8223. - STAMPA. - 208:(2019), pp. 796-805. [10.1016/j.compstruct.2018.10.061]

# ACOUSTO-ULTRASONIC EVALUATION OF INTERLAMINAR STRENGTH ON CFRP LAMINATES

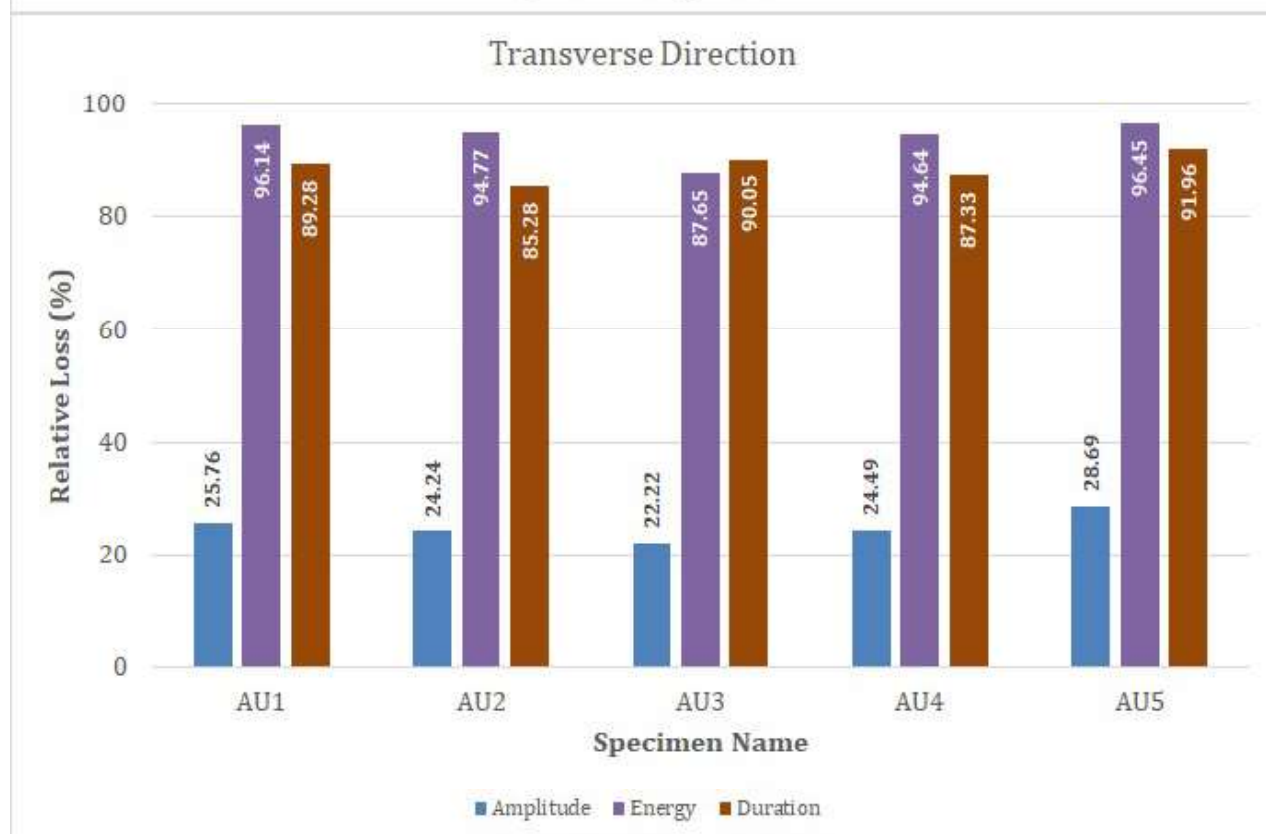
*Figure 6 – AE descriptor loss in percentage along longitudinal and transverse directions after the impact event*

Similar to the previous instance, the relative loss in the AE descriptors between the signal sent and received are presented in Figure 6.

However, to verify this hypothesis more elaborately, the acousto-ultrasonic approach was tested on the specimens after the drop weight impact event and the results are presented in Table 4 and Table 5. Similar to the previous instant, the relative loss between the AE descriptors are also provided in Figure 5. From the results, it can be noted that the relative loss of AE energy along both the longitudinal and transverse directions are quite higher (average loss of 95%). Along the longitudinal direction, the specimen AU1 and AU5 experienced the maximum loss (97.91% and 97.37%, respectively); in transverse directions as well the same AU1 and AU5 have experienced the maximum loss. The transmission medium of the acoustic signal was disrupted by the fiber breakage along the transverse direction. This results in the loss of acoustic energy in transverse direction to increase from 79.71% to 96.14% in AU1, before and after impact and 81.01% to 96.45%

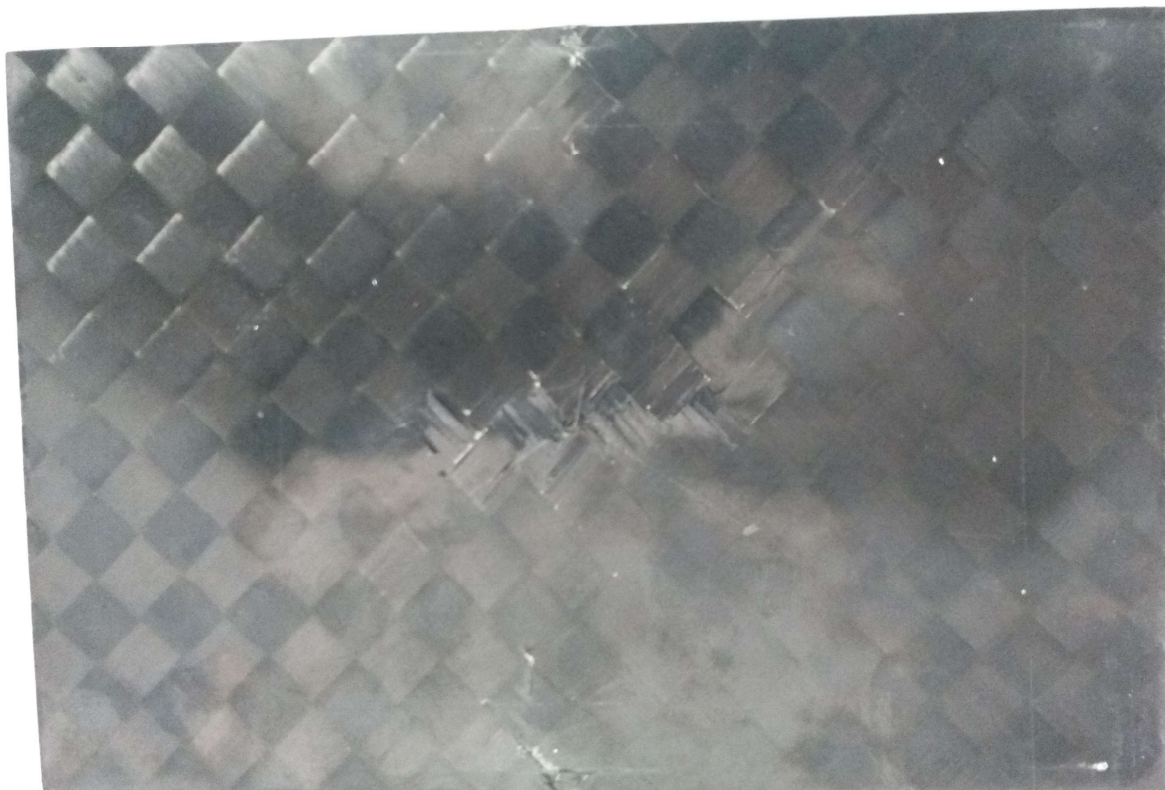
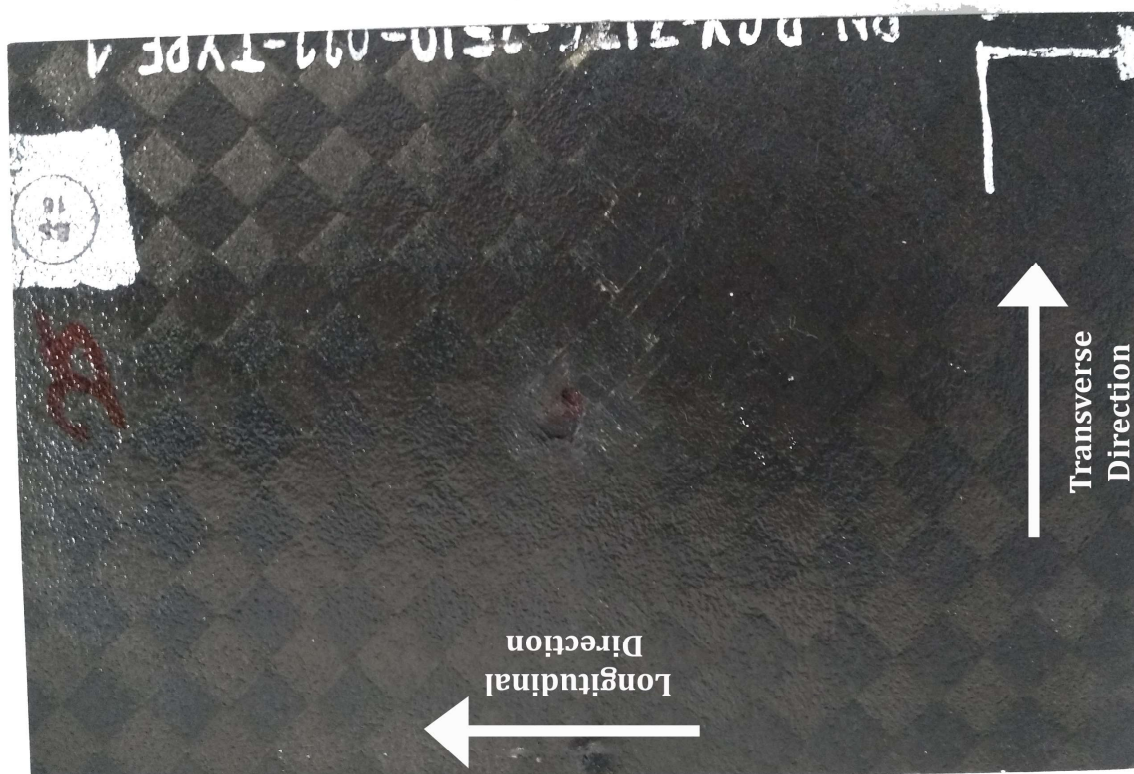
*Figure 12 – Top and Bottom surface of the specimen after Drop Weight and CAI tests*

longitudinal direction is more than the transverse direction. This result, when compared with the specimens after the drop weight impact, becomes even more intriguing (Figure 12).

After the drop weight event, the specimen is measured for the BVID. It can be observed that a residual indentation is formed on the top surface of specimen; while the impact energy has transmitted through the surface and severe damage can be seen at the bottom surface. In all the specimens, the fibers along the transverse direction has been broken by the impact. Although the extent of interlaminar damage cannot be observed through visual inspection, it can be explained through the results obtained.

After the drop weight event, the fibers in the transverse direction have broken. This shows that the drop weight impact energy did not transmit symmetrically through the specimen. The fiber breakage in the transverse direction represents that the interlaminar strength along the transverse direction is low and it is responsible for the fiber breakage along that specific direction.
